THE EFFECT OF OVERLOAD OF A BOLTED CONNECTION ON ITS FATIGUE LIFE: A CASE STUDY

Shahin Shadlou¹, Leon D. Wegner², Timo Tikka³

Abstract:

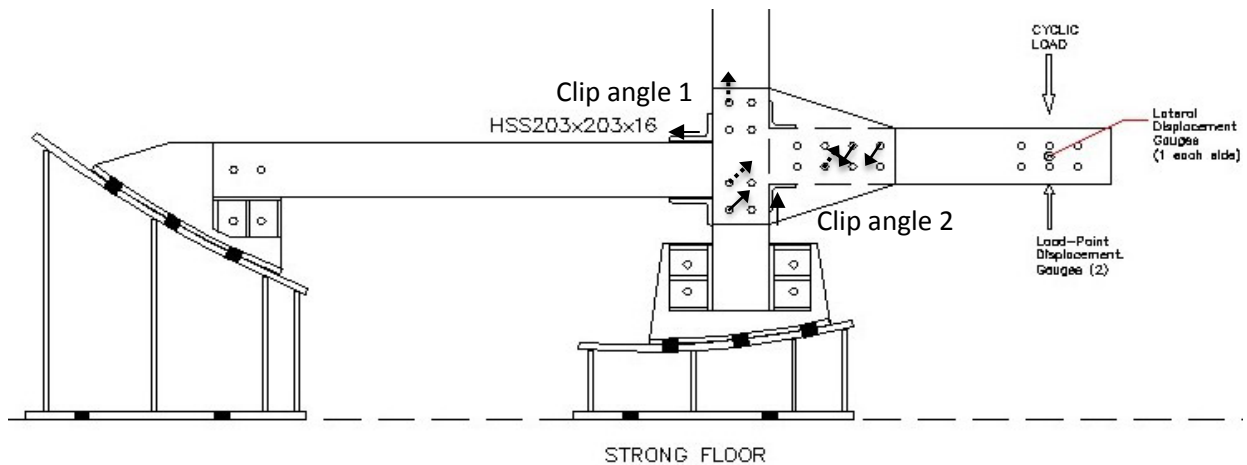
Figure 5: The sources of slippage on the structure; the dotted arrows show the direction of movement of bolts on west gusset and the solid arrows show the direction of movement of bolts on the east gusset.

Based on the FE results, bolts 1, 2, 9, and 12 were exposed to a load close to the slip critical value. Figure 5 shows that after the overload all these bolts except for bolt #2 had slipped, which agrees with FE results. However, as mentioned before, in addition to these bolts (predicted by FE), some other bolts also showed signs of slippage, including bolts 3, 6, and 8. This can be attributed to the fact that slippage of the bolts not predicted by FE analysis was secondary to the initial slippage of those that were predicted. Moreover, further dis-assembly of the structure revealed that the coating of some surfaces in contact was partially worn off, which could have been due to the previous cyclic loadings or the overload itself. Lack of proper coating and/or pre-tension could explain the premature slippage of the mentioned bolts.

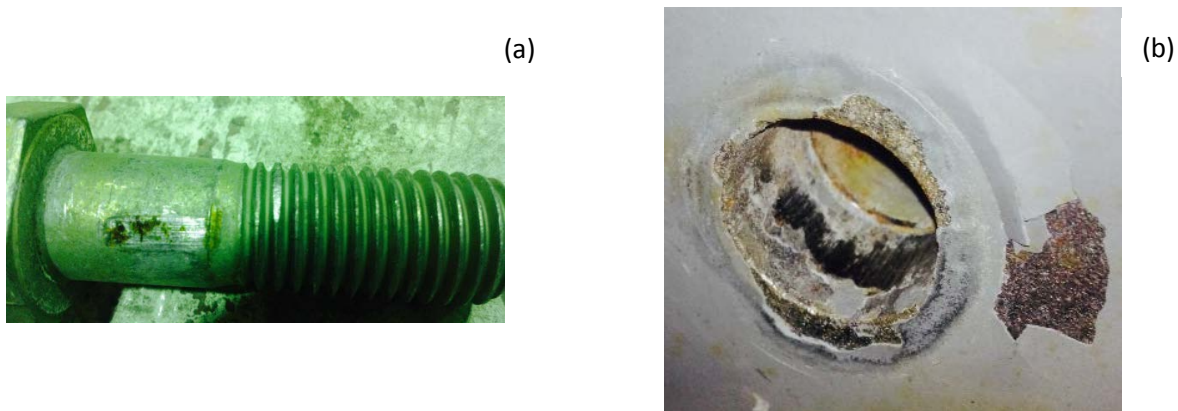
Four of the bolts on the gusset plate which showed sign of slippage were taken off and investigated for damage to bolt threads and bolt-hole. As shown in Figure 6, there was some sign of local scratches on the bolt shank and damaged threads, confirming that the bolt came in contact with the bolt-hole in the gusset plate. However, there was no sign of cracking on any of the bolts or bolt-holes.

Figure 6: Typical surface damage on a (a) bolt and (b) gusset plate bolt-hole

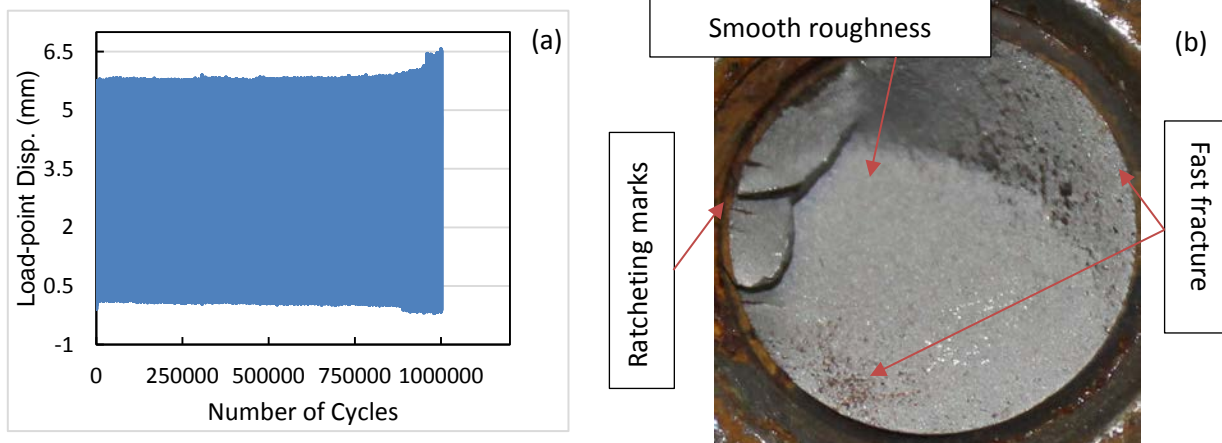
After replacing the investigated bolts with new ones, the accelerated fatigue test was continued at 93 kN. During this stage of the test, bolt #19 failed. The load-point displacement for this test is depicted in Figure 9(a). As can be seen, an increase in the range of displacement started at about 900,000 cycles and a shift occurred at 970,000 cycles. The first change (i.e., the gradual increase in the range of displacement) could be associated with loosening of some bolts in the structure (bolts 20 and 24 and their symmetric neighbours, which were not included in the FE analysis). The second change (i.e. the shift) is likely associated with breakage of the bolt. It is noteworthy that there is no sign of change in the values or range of displacement prior to 900,000 cycles and it looks much more uniform than was observed during the two previous stages (i.e., 42.6 kN and 85 kN). This suggests that the bolted joint had settled in as a result of the overload and possibly during the previous stages of cyclic loading.

The fracture surface of the bolt is shown in Figure 9(b). Crack initiation occurred between the 9 and 11 o'clock positions; some ratchet marks are also visible in this region. The smooth fracture roughness from ratcheting marks toward the central region of the bolt indicates steady fatigue crack growth and the fracture region with higher roughness close to outer surface of bolt from 12 to 6 o'clock position is a sign of static fast fracture. After replacing the broken and loosened bolts, the next stage of accelerated fatigue test continued at 103 kN. At this stage, no incident occurred, except for a small increase in the range of the load-point displacement. The next stage of testing was conducted at 113 kN and stopped at 500,000 cycles because of failure of two bolts at the support of the structure. Since these two bolts were not in the region of interest for this study, the details of their fracture are not discussed here. At the time of writing, additional testing is planned.

Figure 9: (a) Vertical load-point displacements over one million cycles at the 93 kN load level;
(b) Fracture surface of bolt #19
