OBSERVATIONS OF THE WIND DAMAGE IN THE ANGUS (ONTARIO) TORNADO OF JUNE 17, 2014

Emilio Hong, Derek Stedman, Gregory A. Kopp
Boundary Layer Wind Tunnel Laboratory, Faculty of Engineering
University of Western Ontario, London, Ontario, Canada, N6A 5B9

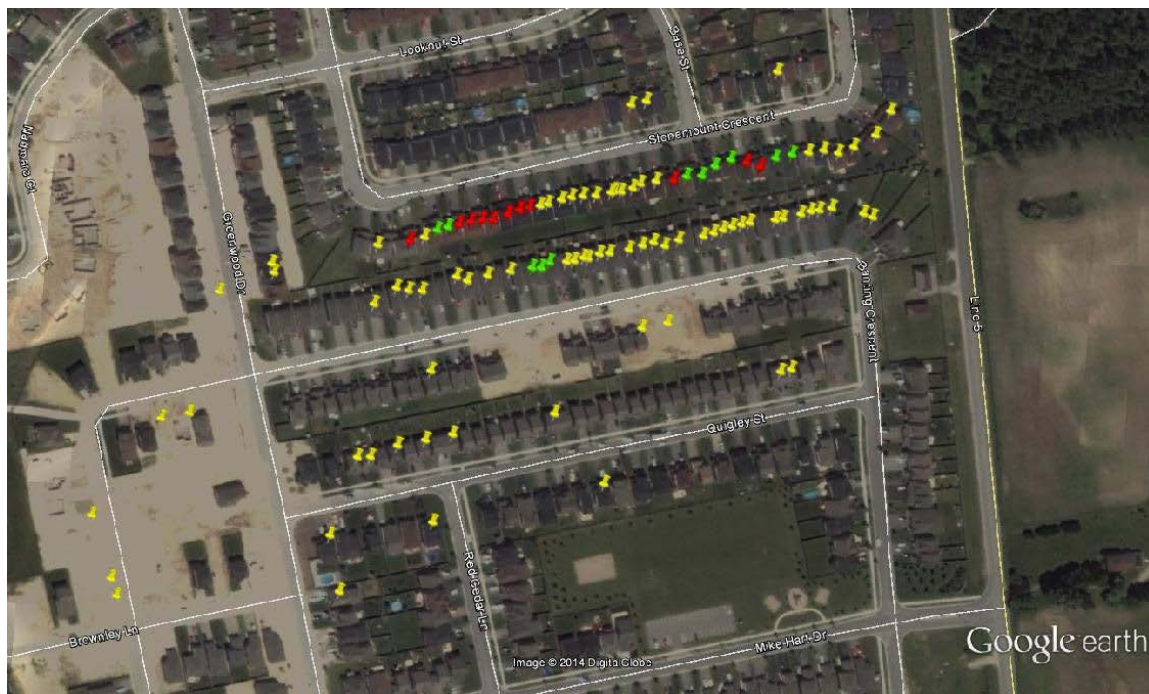
Figure 1 shows the survey area within Angus and the locations of houses with damage. This figure illustrates that much of the damage was located on two streets, Stonemount Cres. and Banting Cres., and that away from these two streets there was only scattered damage. Additionally, the further away the houses were from the centre of the path of the storm, the less severe the damage was. In total, 101 houses were identified with visible damage from the storm. Figure 1 also shows that there were 11 houses that lost their roofs, and that these were located in close proximity to each other on Stonemount Cres. In addition, many (8) of the roof sheathing failures occurred close to these complete roof failures on Stonemount Cres., with only 3 sheathing failures observed on Banting Cres. The difference in the damage level on these two streets is dramatic, as can be seen in Figure 2. The centre of the tornado track appeared to be between these two streets, perhaps through the backyards between the houses. In fact, it was observed that most of the debris was contained to these two streets.

Figure 1. Summary of all damage observations in Angus, ON, from survey of June 18, 2014. Red symbols indicate global roof failure, green symbols roof sheathing failures (while the roof structure remained in place), while yellow symbols indicate all other damage. Note that construction was still occurring in this neighbourhood, so not all houses appear in the Google earth map.

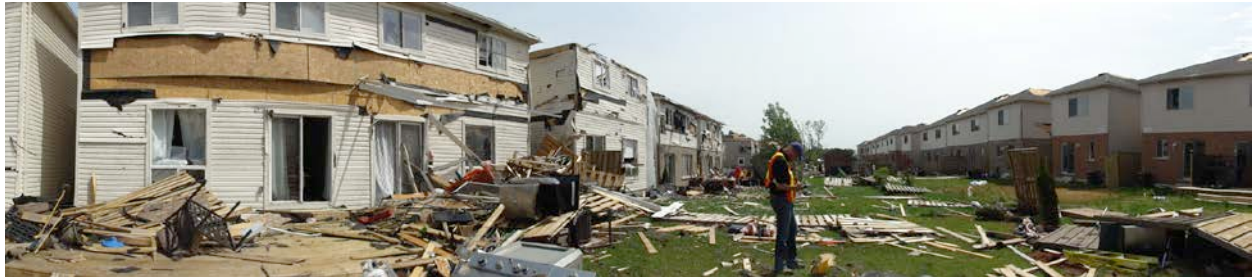
Figure 2. Photograph of the backyards of the houses on Stonemount Cres. (left side of photograph) and Banting Cres. (right side).

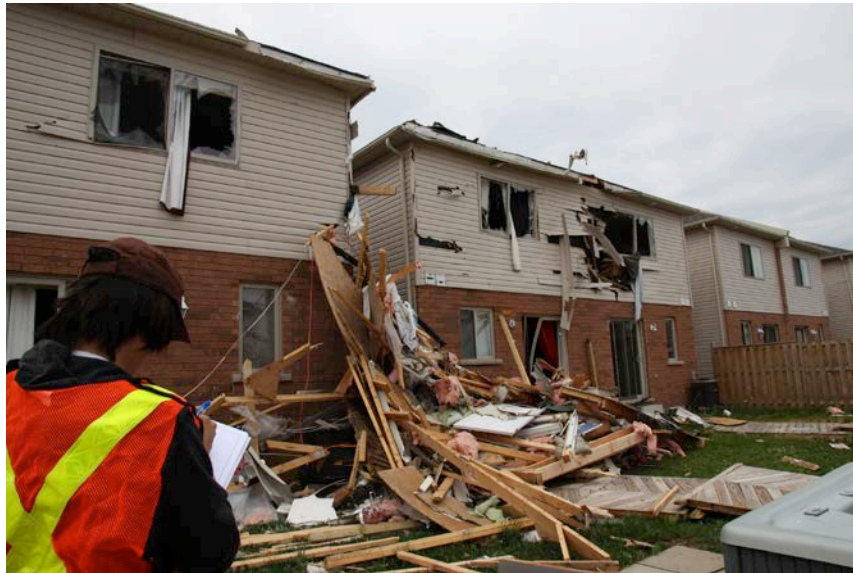
The most severe damage was roof structure failure. Houses that had experience roof structural failure are usually condemned and demolished. Most of these also lose most of their contents due to rain (and wind) damage. Ten of the 11 houses with complete roof failure had the roof becoming detached and blowing off of the walls. On the other house with roof failure, the roof was displaced, but did not blow off. The blown-off roofs travelled eastward, along with other debris, and in some cases impacted adjacent houses. Figure 3 shows one of the roofs, which travelled from Stonemount Cres and impacted two houses on Banting Cres. The source house, with the roof failure, was not unidentifiable. Such roof trusses often penetrated the roof and wall sheathing.

Figure 3. An example of damage caused by debris impacts. This roof had collided with the side of the two houses and as seen in the picture. Many roof trusses are seen in the pile; this roof had blown from a house on Stonemount Cres., across the backyards, ending by impacting these houses on Banting Cres.

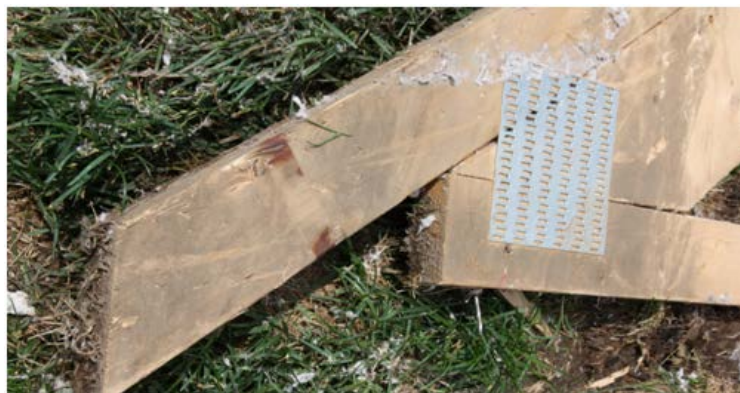
Figure 4. Roof truss from a house on Stonemount Cres. This roof truss had only 1 toe-nail in the connection, rather than the code-required 3.

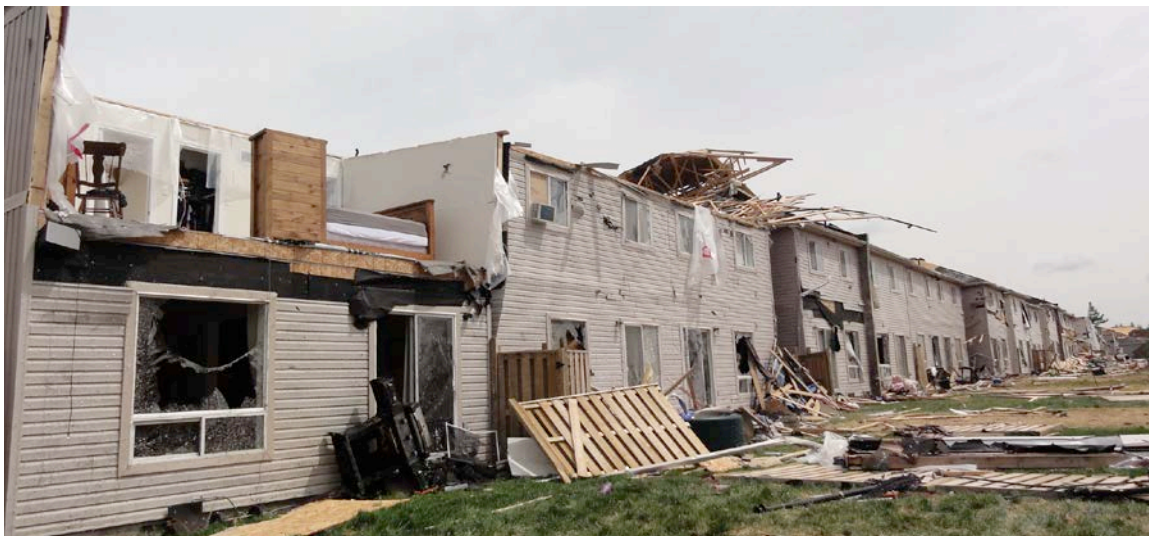
As seen in Figures 1 and 5, many of the houses that had lost their roofs were adjacent to each other. There are three main factors that could be the cause of this. Firstly, closely spaced houses with nearly continuous ridge-lines can increase the wind loads. In Angus, it is not clear if this played any role since these houses had hip roofs such that the ridge-lines were discontinuous. Secondly, the authors examined the connections for all of the failed roof trusses that could be identified on the ground and from high-resolution photographs of those remaining on the roof which could be seen from the yard. Practically all of toe-nailed roof-to-wall connections (RTWC) were found to be below code requirements, with cases of 0, 1, and 2 nails in the connections, rather than the code-required 3. However, only a relatively small number of RTWC could be definitively identified, so any conclusions based solely on this evidence is tentative. (There is additional evidence of poor construction quality associated with wall failures, which is discussed further below.) Figure 4 shows an example of one roof truss, there was evidence of only a single nail being present. Thus, improper toe-nailed RTWC undoubtedly played a role in (at least some of) the roof failures. Finally, in the Vaughan, ON, tornadoes in August of 2009 (see Morrison et al., 2014), internal pressures clearly contributed to roof failures. In contrast, the Angus tornado does not appear to have similar internal-pressure-related failures, although it is possible that these played some role, because of the direction of flight of the roofs relative to the locations of openings (which were on the same side of the structures). All three of these points could use further examination to determine their relative contributions to the failures.

Figure 5. House with observed roof and wall failure. The second story of this house has been blown open. The connections have come apart and the wall has been fallen nearby.

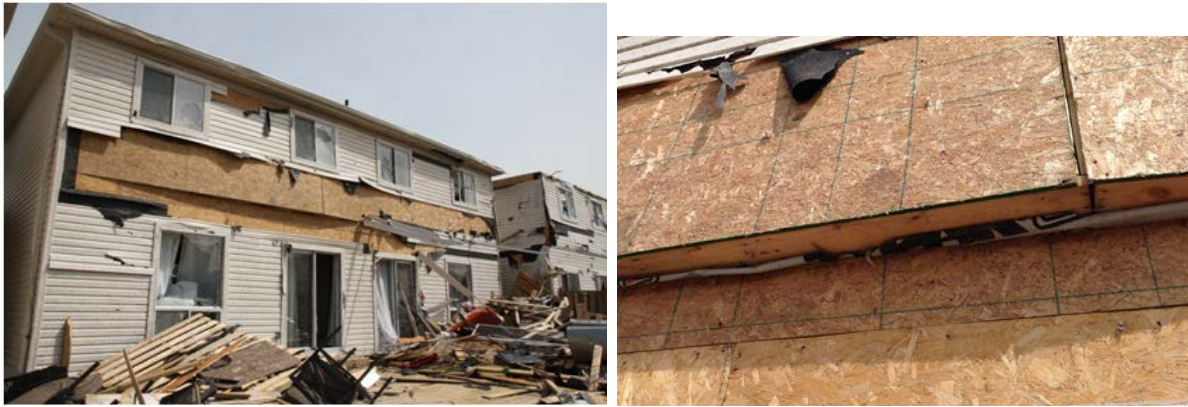
As discussed above, there were two main causes of structural wall damage: wind-induced pressures and impact from wind-borne debris. There were 6 houses believed to have had pressure-driven wall failures. Many of these failures were unique. Half of these houses had also lost their roof, which compromised the wall as a result – Figure 5 shows one of these. Figure 6 shows a house with the roof still attached, which has clearly experienced wall damage. Here the siding had been blown off revealing the failure in the inter-storey, wall-to-floor connections

Figure 6. Wall failure due to missing inter-storey connections.

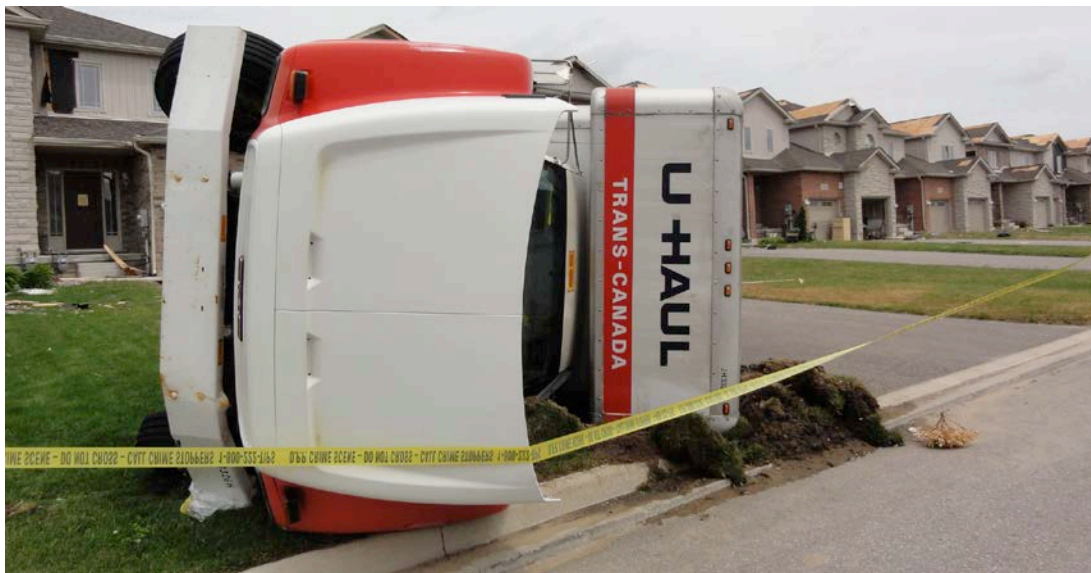
One of the interesting failures in Angus was a U-Haul truck which was overturned by the wind, as shown in Figure 7. Of particular interest are the repetitive failures of shingles, sheathing and garage doors in the background. In the Enhanced-Fujita Scale (EF-Scale), damage to one and two-family wood-frame houses is categorized into 10 Degrees-of-Damage (DOD). For DOD-4, the damage is indicated as “uplift of roof deck and loss of significant roof covering material (20% or more); collapse of chimney; garage doors collapse inward; failure of porch or carport.” This is precisely what has been observed on Banting Cres. The EF-Scale suggests that this level of damage is associated with wind speeds in the range from 130 – 187 km/hr, and an expected value of 156 km/hr. This is in the EF-1 range of wind speeds. Our interest here is to assess by studying blow-over speeds for a U-Haul Truck in a wind tunnel. Such a scenario was examined by Stedman (2012), where details can be found.

Figure 7. Overturned U-Haul truck in the foreground with repetitive shingle, roof sheathing and garage door failures on houses on Banting Cres. in the background.

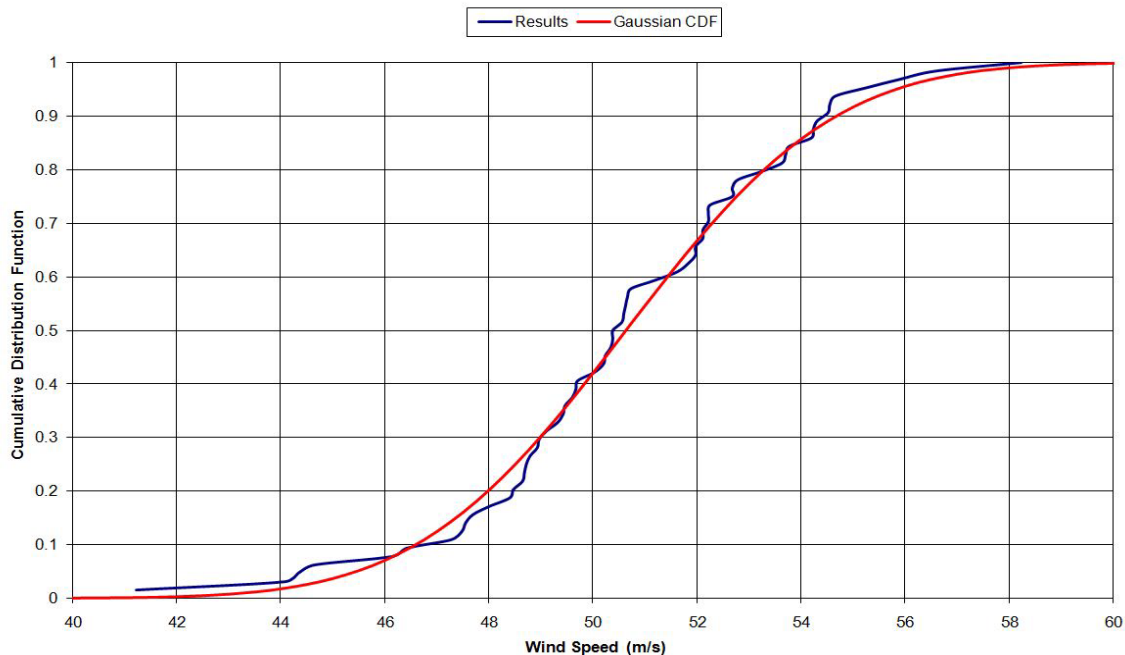
Figure 8. Cumulative Distribution Function of failure gust wind speeds of a 27 ft U-Haul truck measured in the wind tunnel.

Figure 8 shows results from Stedman (2012), which indicates a range of possible overturning speeds for an empty U-Haul Truck of 45 – 56 m/s (162 – 202 km/hr) for the range from the 5th – 95th percentile. This range considers all wind directions. Thus, there is substantial overlap in the range and the EF-Scale appears to give reasonable values based on this single study. Thus, the overturned truck is consistent with, and highly-correlated to EF-1 damage.
