Vancouver, Canada

ABOVEGROUND STORAGE TANK FOUNDATION REINFORCEMENT DURING CONSTRUCTION

Warners, Jason, 1,3 and Ballard, Geoff²

- ¹ Stantec Consulting Ltd., Canada
- ² Enbridge Inc., Canada
- ³ jason.warners@stantec.com

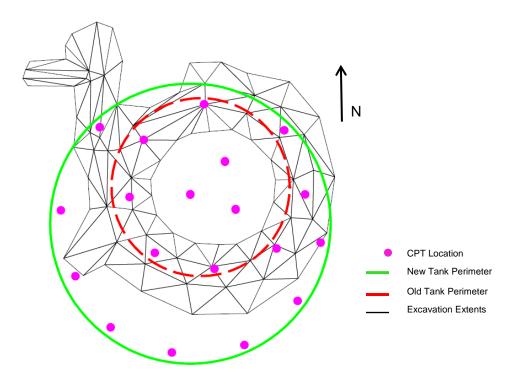
Figure 1 – Cone Penetration Testing Locations

In Figure 1, above, the pink dots indicate the locations of the CPT soundings, the red dashed line indicates the location of the demolished tank ring, the green line indicates the location of the new tank ring, and the polygon lines indicate the extents of the excavation to remove the previous tank foundation. The polygon extending north in the upper left corner is a pipeline that tied into the decommissioned tank. Another pipeline on the east side of the tank was also removed, but it is not shown in the attached drawing as it was mostly within the existing excavation and extended outside the proposed new foundation area.

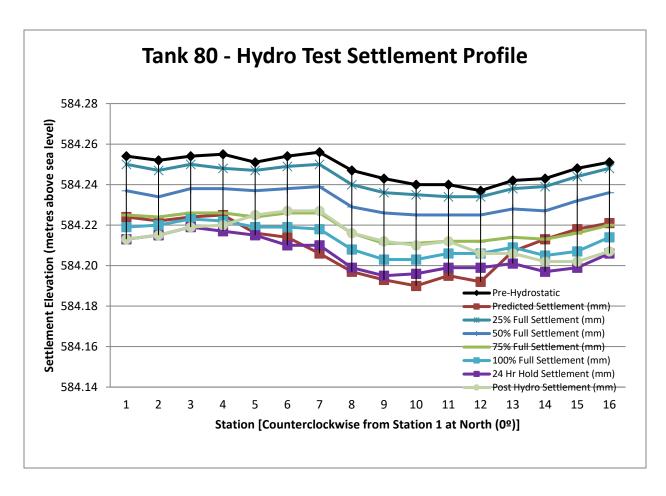
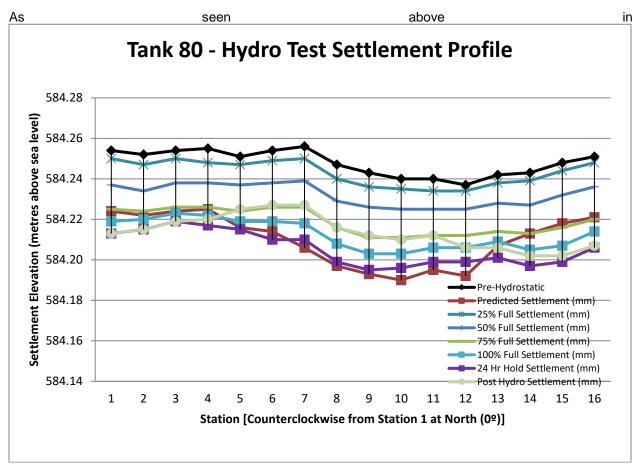
Figure 5 – Hydrostatic Test Settlement Profile: - Estimated and Measured Values (MacWhirter, 2015)

, there is good correlation between the predicted settlement and the values measured during the 24-hour hold period of the hydrostatic testing. Along the northwest side of the tank, there is variance between predicted and measured, with the measured values following a more uniform profile. In general, the measured settlement followed a more uniform settlement profile than was predicted, which was the main goal during the backfill of the previous tank foundation excavation and during revisions to the foundation design.
