THREE IMPORTANT WIND-RESISTANT DESIGN LESSONS FROM TWO VISITS TO AREAS DEVASTATED BY ONE SUPER TYPHOON

Aquino, Ronwaldo Emmanuel^{1,3}, and Tamura, Yukio²

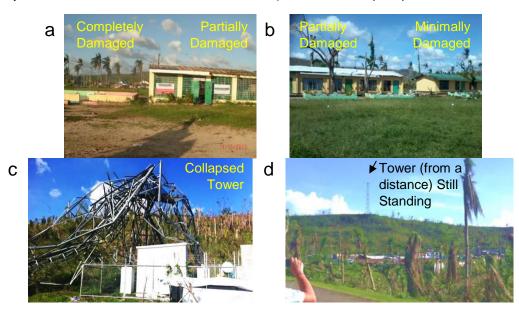
Figure 2: Examples in Samar of (a and b) two side-by-side buildings with different levels of damage, and (c and d) two lattice towers within a kilometer of each experiencing different levels of damage as well.
