Vancouver, Canada

May 31 – June 3, 2017/ Mai 31 – Juin 3, 2017

## HARVIE PASSAGE ON BOW RIVER: USING A PHYSICAL MODEL TO EVALUATE POST-FLOOD REHABILITATION OPTIONS

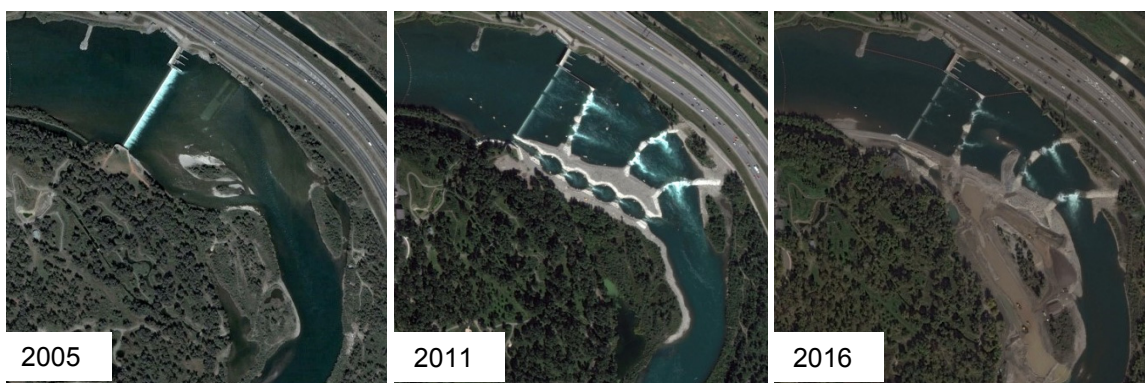
Figure 1: Aerial photo of the Calgary weir (left) and Harvie Passage before the 2013 flood (middle) and after the 2013 flood (right). *Imagery source: Google Earth.*

The unprecedented flood of June 2013 resulted in the near 1:100-year flood discharge being conveyed through Harvie Passage, which caused major infilling of the LWC, minor damage to the HWC drop structures, and reduced tailwater levels below HWC Drop #4 (Figure 1, right image). Rehabilitation measures currently

underway include repairing damaged areas, eliminating unsafe hydraulic conditions, re-establishing fish passage, and construction of a new LWC.

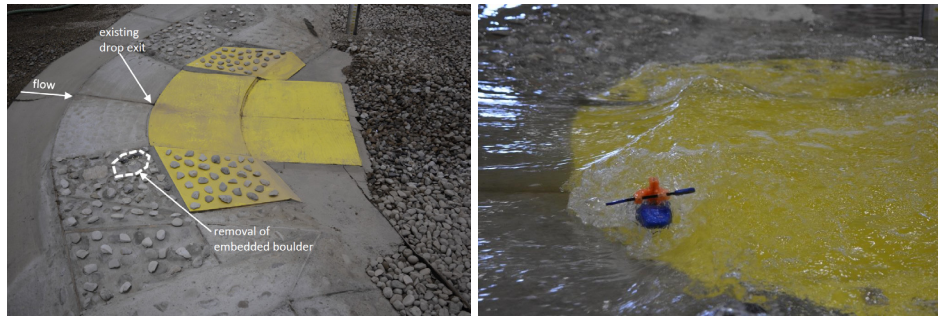
Figure 2: Side view looking at the recommended design of the rehabilitation of HWC Drop #4 (left) and the wave forming on this drop at a river discharge of 150 m<sup>3</sup>/s (right).

Different geometric modifications to HWC Drop #4 were evaluated in the physical model. The recommended final design modifications included: (i) adding a 16H:1V sub-plate below the existing drop exit followed by a horizontal sub-plate; and (ii) extending the high-flow channels downstream to the Bow River (Figure 2). The recommended final design of HWC Drop #4 performed satisfactorily over the range of flow conditions examined in the model. The safety hazard below HWC Drop #4 was eliminated and replaced by non-retentive hydraulic features that are expected to flush boaters and other types of river users downstream. Furthermore, the proposed extensions to the high-flow channels of HWC Drop #4 are expected to re-establish upstream fish passage at this drop structure.

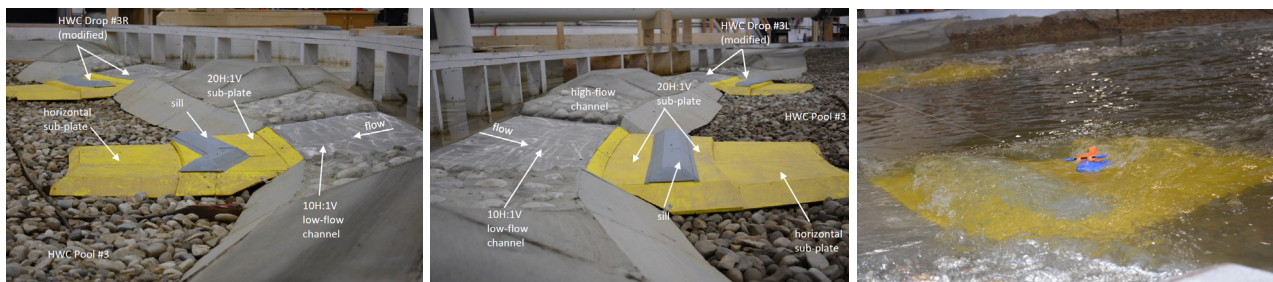
Figure 3: View looking downstream at the recommended design of HWC Drop #3L (left) and HWC Drop #3R (middle); and the playwave forming on HWC Drop #3R at a river discharge of 150 m<sup>3</sup>/s (right).

Different design modifications were also evaluated on HWC Drops #3L and #3R. The recommended final design modifications to these drops consisted of: (i) reducing the longitudinal slope of the existing low-flow channel from 8H:1V to 10H:1V; (ii) installing two sub-plates in series below the low-flow channel, the first one comprised of a 20H:1V longitudinal slope and the downstream one set horizontal; and, (iii) installing a sill (V-shaped in planform on HWC Drop #3L and linear on HWC Drop #3R) across the width of the 20H:1V sub-plate near its downstream end (Figure 3). Model testing confirmed that the recommended design modifications successfully improved the hydraulic conditions at the drops by making them less retentive, thus more appealing to a wider range of recreational users. An enhancement to the existing design of these two drop structures included the formation of a secondary hydraulic that may be suitable for recreational usage under certain flows.
