ASSESSMENT, OPTIONS, AND REMEDIAL WORK FOR LEAKING SEWAGE LAGOON IN KUGLUKTUK, NUNAVUT

Johnson, Kenneth^{1,3}, and Alam, Shah²

¹ Stantec / Cryofront, Canada

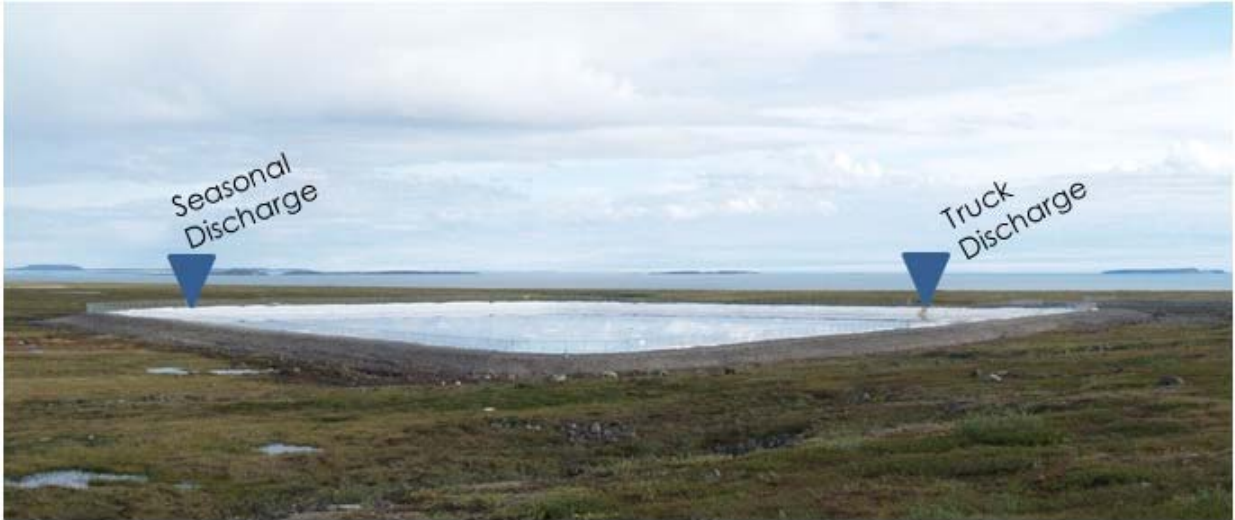
Figure 1: Kugluktuk sewage lagoon with white HDPE liner.

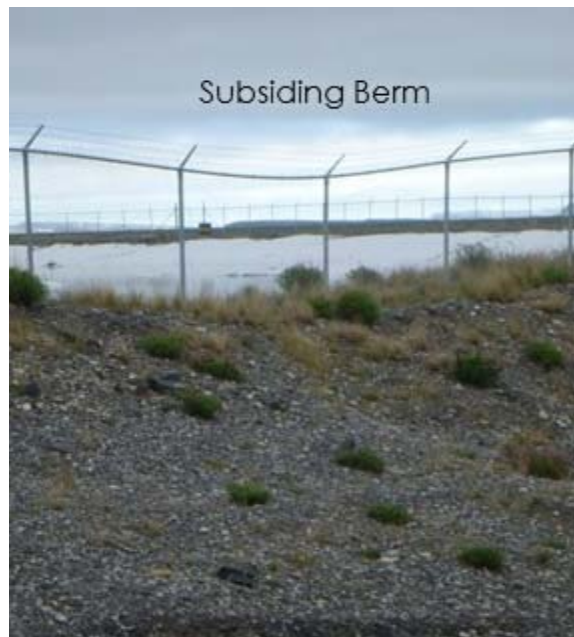
Figure 2: Forty centimetre subsidence in Kugluktuk sewage lagoon berm.

A site inspection in 2015 verified the previous observations, and documented that the subsidence in the east berm of the lagoon was 42 centimetres at the centre of a berm length of 20 metres. A clear crack was also observed along the same section of the berm where the HDPE liner is keyed into the top of the berm.

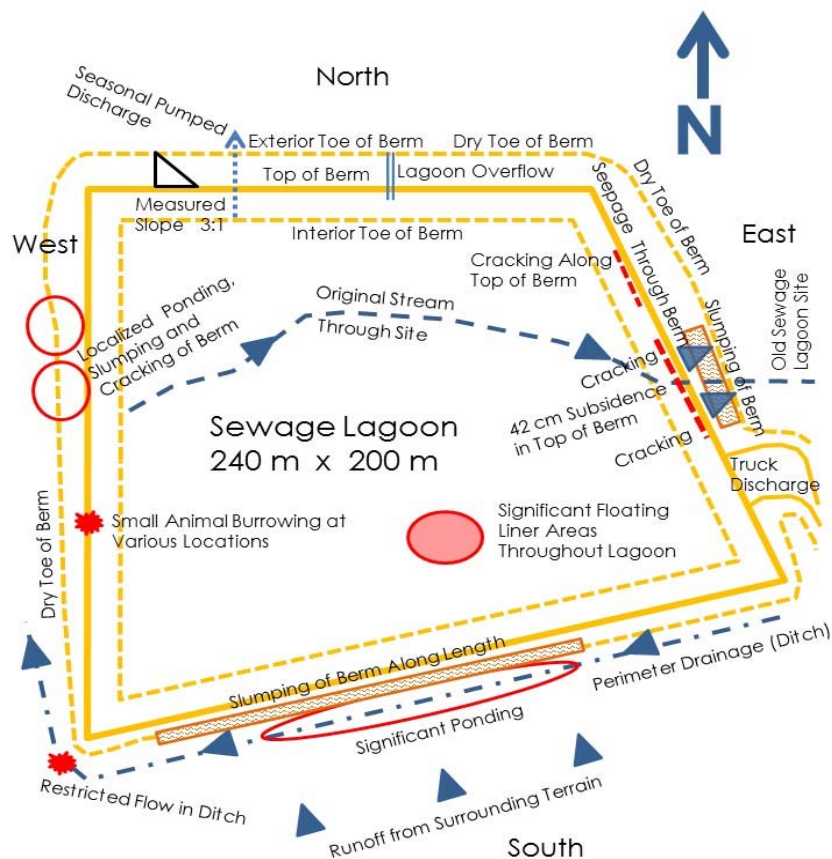
The notable slumping along the east side berm is coincident with the area of subsidence in the top of the berm. Coincident with the slumping and subsidence is the seepage along the berm toe, and the extent of the seepage could not be determined because the toe of the berm lies within a wet area of an old sewage lagoon facility. The remainder of the berm base along the east side, and north side have no significant elements of deterioration.

The base of the berm along the west and south sides has several ponded areas which were causing localized slumping of the exterior slope of the berm. No other deterioration of the berm structure was visible in the areas.

Figure 3: Lagoon features and issues observed at the Kugluktuk sewage lagoon.

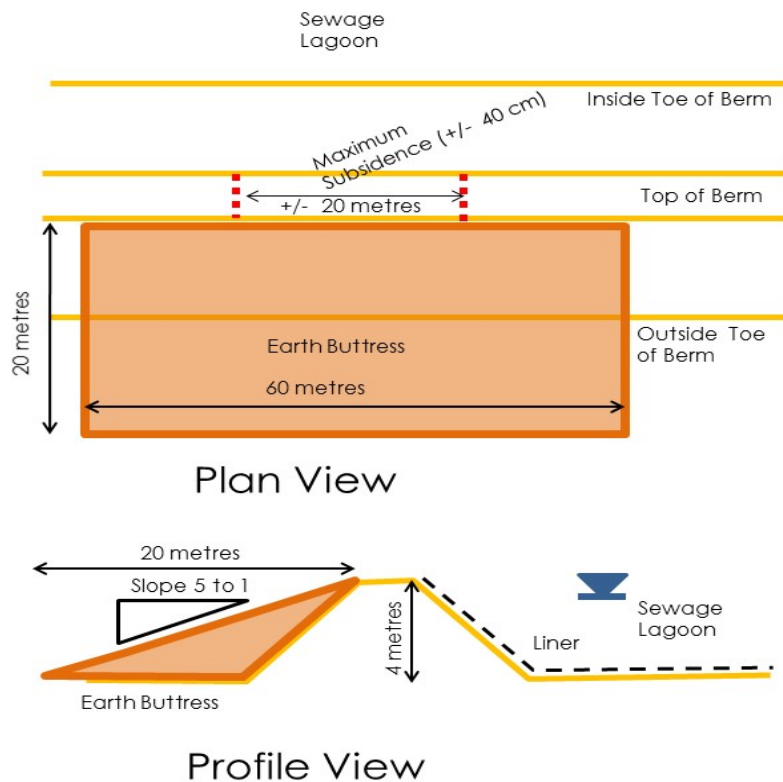
Figure 4: Earth buttress concept for Kugluktuk sewage lagoon.

The construction of an earth buttress would be a more cost effective measure in consideration of an earlier construction start up, and locally available equipment and granular materials. Conceptually, the placement of a buttress at the base and part way up the berm is likely the most logical short term remedial measure. In order to advance this measure, some combined seepage and slope stability assessments would be required to determine the current and future factor of safety. An opinion of the probable cost of a buttress to stabilize the berm on an interim basis was \$170,000.

For the purposes of a conceptual design, a structure 60 metres long and 18 metres wide, with 5:1 slope was identified for construction. Some excavation beneath the buttress may be necessary to provide a stable foundation.

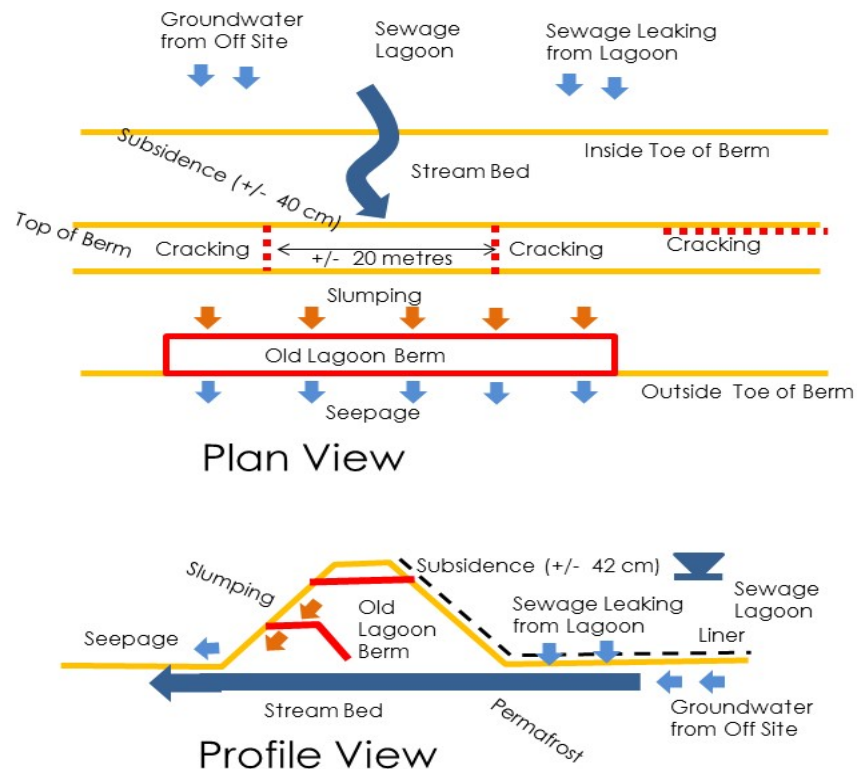
Of importance to the deterioration appears to be an underlying stream bed which bisects the sewage lagoon. The existence of the stream bed was confirmed with a visible channel in a satellite image. As well, the topographic information presented in the design drawings clearly identifies a low area corresponding to a stream channel.

Figure 5: Conditions influencing deterioration of Kugluktuk sewage lagoon berm.

The potential influencing conditions are: permafrost underneath the berm that may be degrading; an old and potentially unstable stream bed beneath this section of the berm; flow from the leaking liner of the sewage lagoon; flow from “groundwater” originating from off site; and a potentially unstable berm from an abandoned lagoon that is situated beneath this section of the new lagoon.
