CASE STUDY: HISTORY AND REFURBISHMENT OF 145 YEAR OLD RAIL BRIDGE PIERS, SOUTHWEST MIRAMICHI RIVER BRIDGE IN MIRAMICHI, NEW BRUNSWICK

¹ GEMTEC Consulting Engineers and Scientists Limited, Fredericton, NB

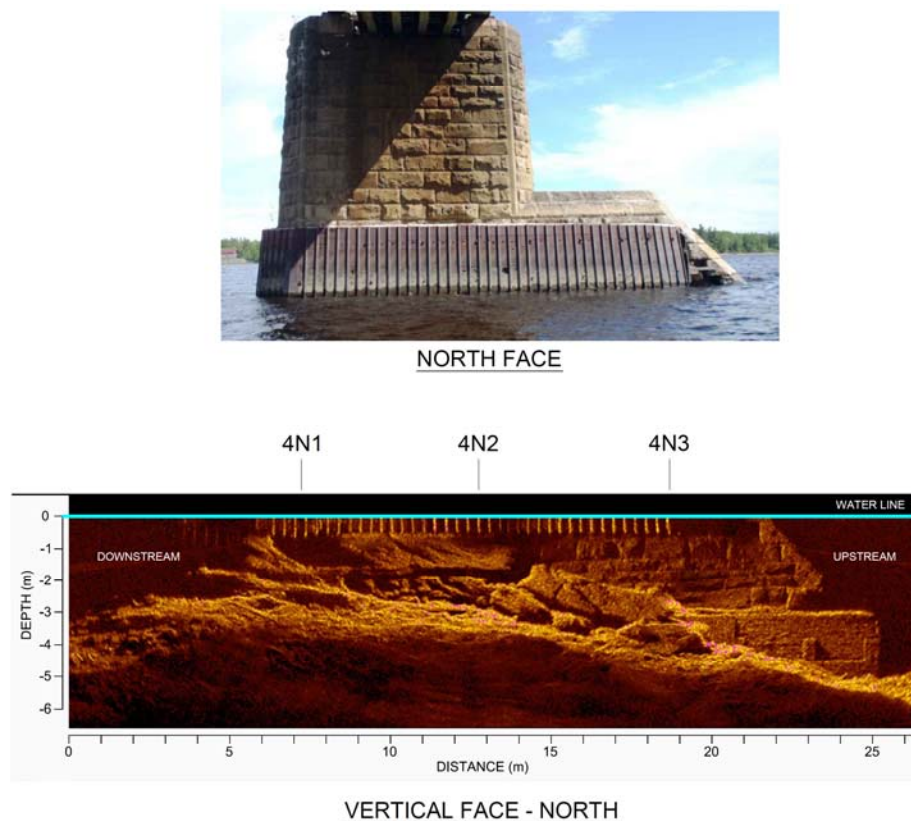
In 2011, 2015, and 2016 underwater inspections indicated that a considerable amount of the lower concrete encasement had deteriorated and fallen off along with some of the concrete infill between the steel sheeting and masonry. Mortar joints in the masonry were significantly deteriorated, especially on the upstream noses, and the lower portion of the steel sheeting was extensively perforated by corrosion. Figure 6 shows a high resolution scanning sonar image of one of the piers in 2015 (Amec Foster Wheeler 2015). Remnants of the concrete encapsulation are visible along with the steel sheeting above it. The original caissons appeared to be in good condition, although some of the exterior wood formwork was damaged or missing.

Figure 6: High resolution scanning sonar imagery of Pier 4 (Amec Foster Wheeler 2015). Note caisson, remnants of previous concrete encasement, stone masonry, and steel sheeting.

Scour holes were noted around the upstream ends of the piers and very little riprap was visible. The 2015 hydrographic survey revealed that the magnitude of local scour varied from 0.5 to 3.8 m around Piers 2, 4 and 5 (see Figure 1 for pier numbering). Probing of the river bottom around the piers indicated that there was riprap buried under the sand bottom. A detailed review of the 2011, 2015, and 2016 inspections, historical records, and the hydrology/hydraulics of the site indicated that there was a total deficiency in scour protection around the piers in the order of 400 to 1,500 m³ compared to recommendations set out in the TAC Guide to Bridge Hydraulics (Transportation Association of Canada 2001).

The Southwest Miramichi River is an internationally recognized major salmon river. The nature and timing of construction activities in the waterway therefore required careful consideration of the potential environmental impacts, as well as approvals from regulatory agencies. The scope of the present refurbishment was limited to the portion of the piers below the high water level, with the intent being to restore their original section and to further extend their service life. Repairs to the piers consisted of removing the remaining concrete encasement, steel sheeting, and concrete backing, and constructing a new reinforced concrete encasement 0.6 m thick from the top of the original caisson to above the high water level as shown in Figure 7.

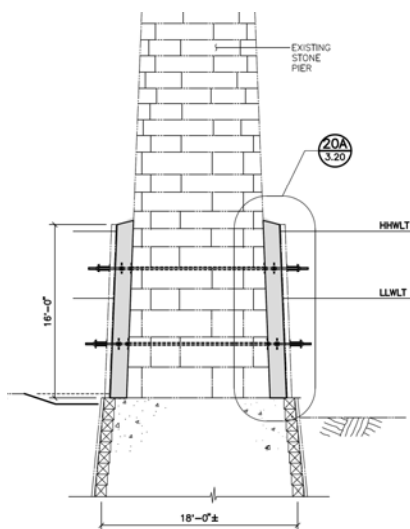
Figure 7: General refurbishment scheme.

During the design phase, due consideration was given to the methodology a contractor could practically employ in undertaking the proposed repairs. The presence of buried riprap around the caissons, along with the likelihood that the caissons would not be water tight, and limited overhead clearances, made the construction of cofferdams impractical. Thus, the approach was to carry out the work underwater by aid of divers with concrete being placed by tremie methods. Steel nosing was added to the face of the new concrete encasement on the upstream ice breakers. Following the placement of the concrete encasement and steel nosing, the open mortar joints were filled by pumping grout through tubes that had been placed in the joints beforehand. The encasement was dowelled to the existing masonry and high strength pre-stressed anchors were installed through the masonry to further reinforce the piers. Additional riprap was placed around the piers to fill the existing scour holes and to provide adequate scour protection.

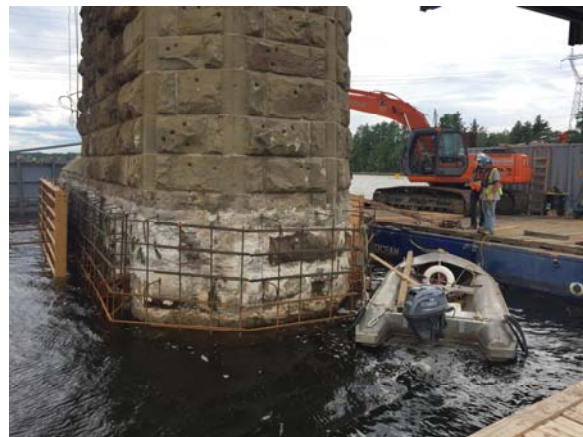
Figure 8: Repair work in 2017.

Repairs to two piers were successfully completed in 2017. Figure 8 shows a photo taken during the 2017 work. The contractor constructed a temporary wharf on the north river bank to facilitate movement of equipment, concrete, formwork, etc. by barge to the piers. Floating work platforms were also constructed around the piers to facilitate the work. The contractor installed current deflectors on the upstream ends of the piers to minimize the effects of tidal currents on the divers' underwater work. The remaining three piers are scheduled for rehabilitation in 2018.
