Fredericton, Canada

STRUCTURAL MANAGEMENT OF AN AGING CONCRETE BOX GIRDER VIADUCT ON THE AUCKLAND MOTORWAY NETWORK

Coleman, Liam^{1,4}, Klopper, Johan² and Dean, Alyson³

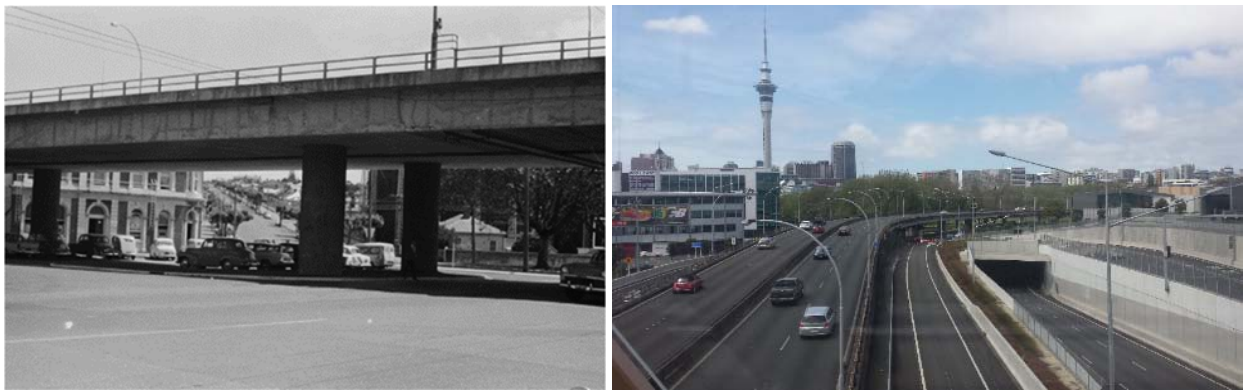
Figure 3: 1962 View of VPV and ASR Cracks (left), View of VPV and VPT looking South (right)

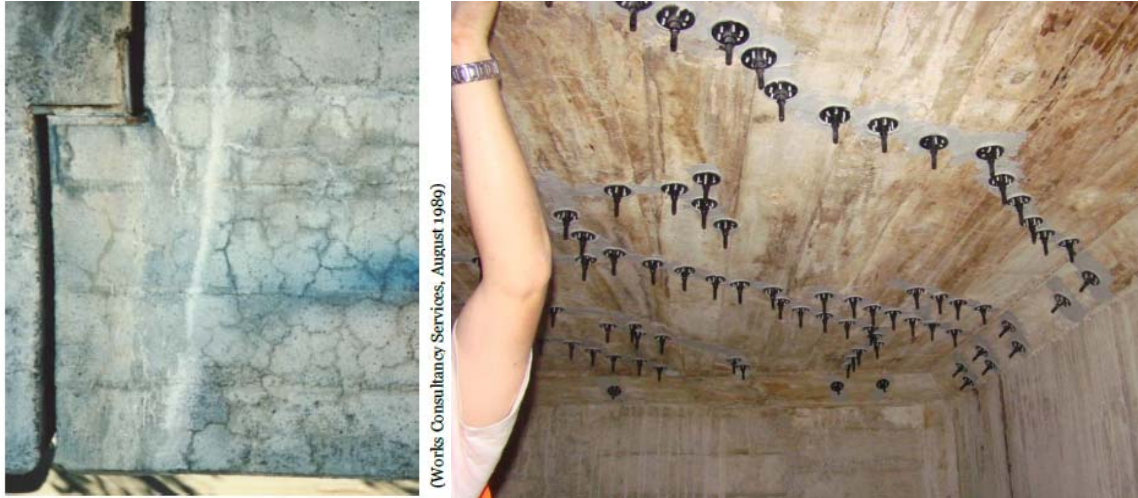
In the 1980s, a number of AMA structures were displaying signs of Alkali-Silica Reaction (ASR), including VPV. Numerous concrete investigations have been carried out since then, confirming the presence of ASR in VPV. Due to the extensive nature of the cracking (Figure 5), concern was raised about the capacity of the asset. Literature reviews conducted by WSP/Opus on the subject concluded that the presence of ASR may reduce the tensile capacity and Young's Modulus of the concrete. The reviews also found that ASR may increase the shear capacity of sections through the pre-stressing effects of the expanding concrete.

Figure 5: ASR Cracking to Half-Joint (left), ASR Cracking to Deck Soffit (right)

Until 1990, access was only possible to the external faces of the structure. Due to the extent of cracking on the external faces and investigations confirming ASR, the decision was made to create access hatches into all box girder cells to inspect hidden areas. Once inside the boxes, Engineers found extensive cracking, most notably to the deck slab soffits (Figure 5 – right) and pier diaphragms, along with what appeared to be shear cracking to the webs of the boxes.

In 2009, cracking to the deck slab soffit of the box girders was considered so extensive that in order to maintain serviceability and durability, all major cracks on the internal deck soffit were epoxy-injected. This was followed by the application of two-layer Fibre Reinforced Polymer (FRP) over the full soffit area to increase capacity.

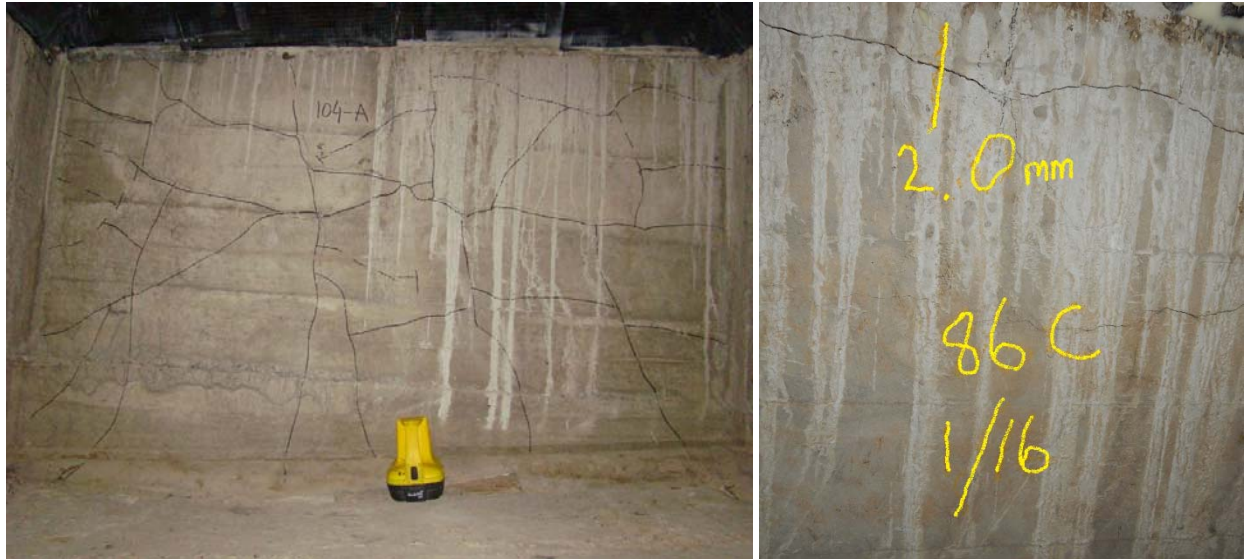
In 2011/12, WSP/Opus conducted an extensive crack mapping inspection regime on the inside of the boxes, which looked at the condition of all 66 boxes and 146 cells. Photographs from this inspection are shown in Figure 6, below. Significant cracks inside the structure were located and recorded, particularly

those in excess of 1mm. In 2015/16, this exercise was repeated and both the crack length and width were recorded for cracks exceeding 0.4mm in width. A diagram of crack lengths and widths is shown in Figure 7. In the years between inspections, it was noted that a large number of the cracks had propagated from the webs of the boxes into the floor. The propagation of the cracks within a short period warranted further investigation to establish a better understanding of their nature.

Figure 6: Example of Condition Inside Box Cells

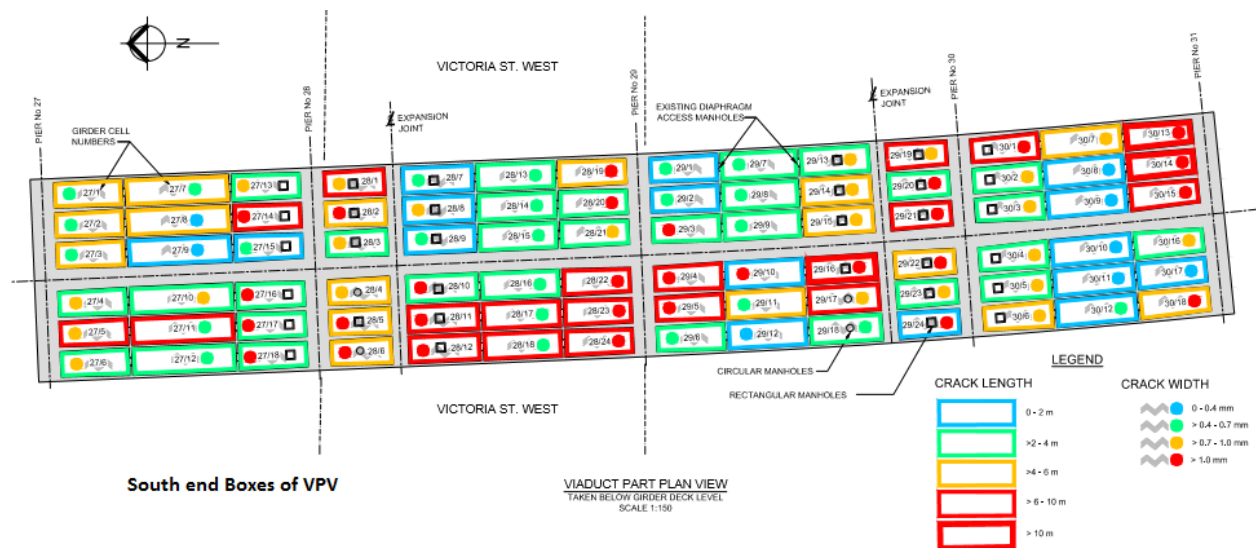
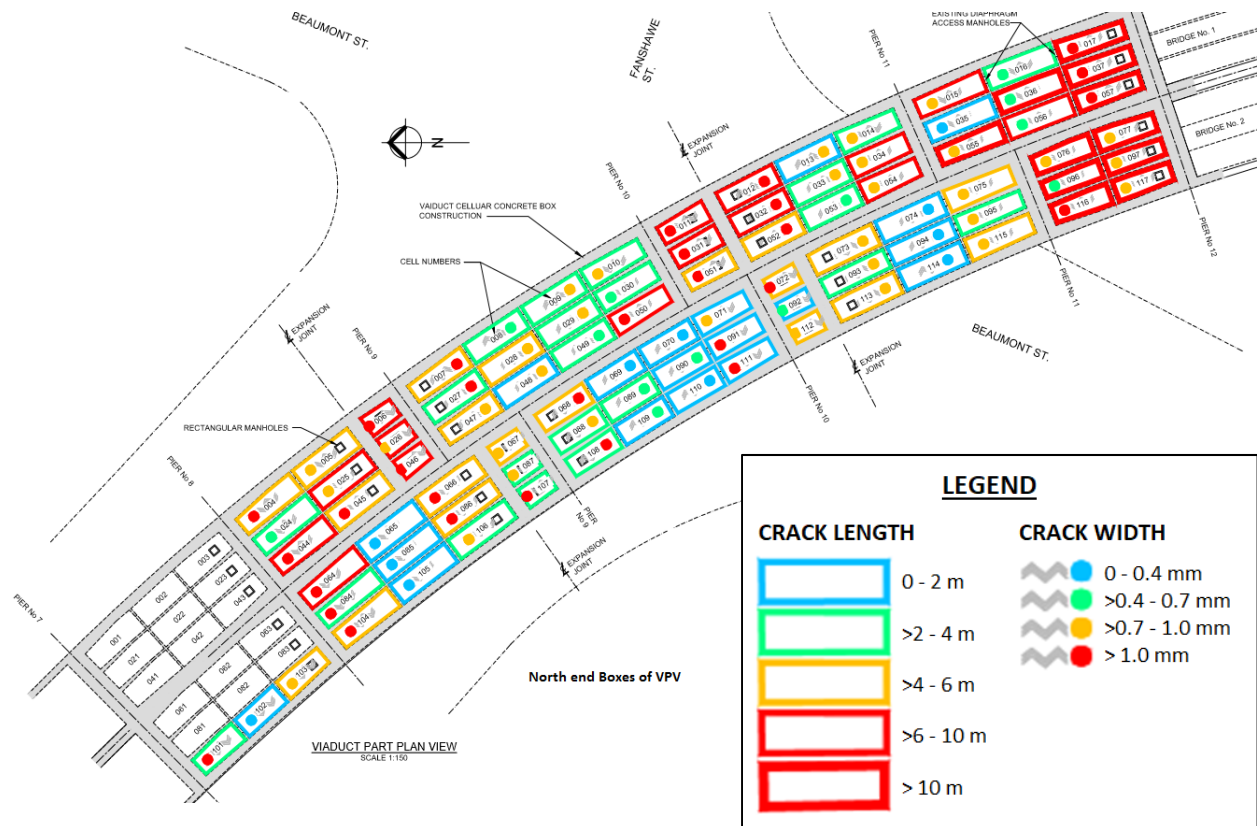
Research conducted by WSP/Opus on the structural behaviour and effects of ASR-type cracking on the durability of VPV specifically highlighted that cracks with a width of less than 1mm in the webs did not detract from the web capacity. It also showed that cracks with a width of 0.7mm would not significantly reduce the durability of the structure, provided that the boxes remain dry. As such, the decision was made to carry out more rigorous analysis and load testing of the asset.

Figure 7: VPV Box Condition Diagram from 2015 Inspections – Crack Length and Width

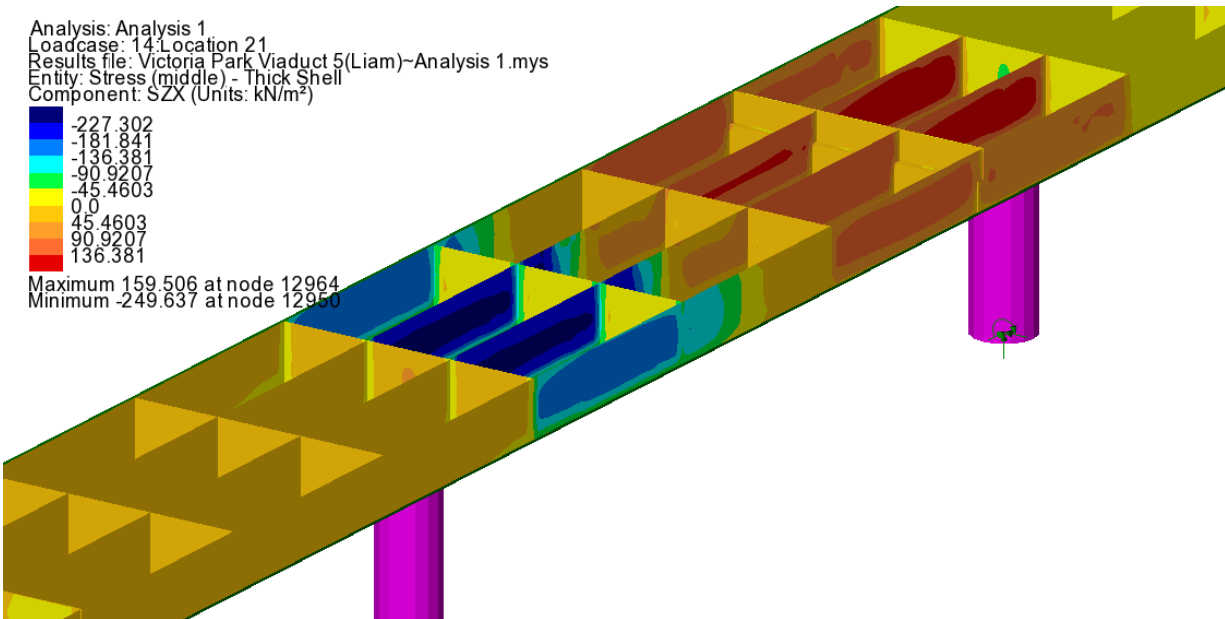
is shown below in Figure 8, which illustrates the distribution of shear stress in the webs. The stresses are indicated by colour (legend shown on the left, kN/m²), with higher stresses shown in blue and red.

Figure 8: Finite Element Model of South Box Structure over Victoria Street

Similar to the results from the 2013 grillage analysis, the evaluation using the FEA load distribution showed that the structure has adequate capacity for full HN-HO and HPMV loading. It also highlighted areas of maximum anticipated stress under loading (Figure 8), which will be closely monitored in future inspections.

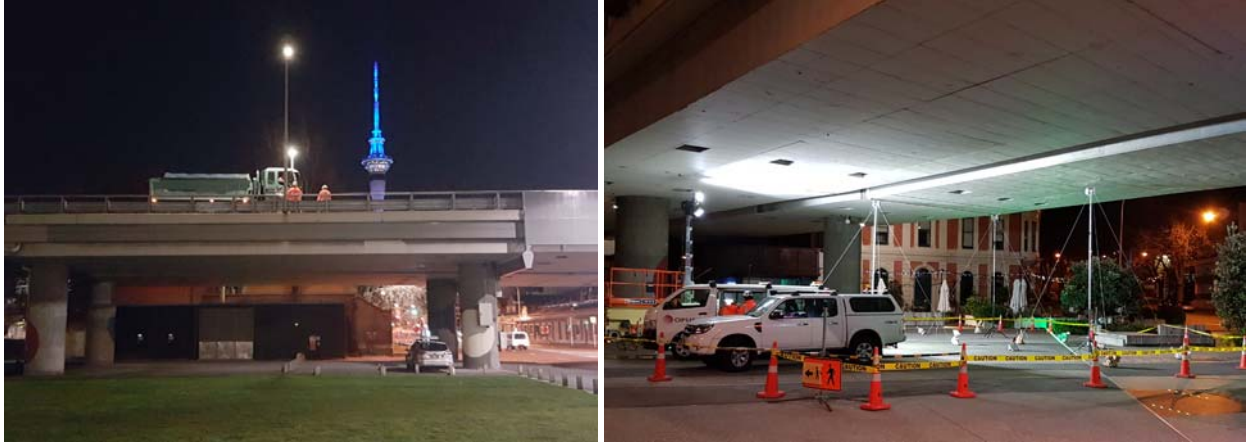
In September 2016, a load test of the SH1 South box structure was performed using two 20-tonne aggregated-filled dumper trucks of known weight and axle configuration. Photographs taken during the testing are shown in Figure 9. The test involved measuring the static vertical deflection at the half-joint of span 30 and at the outer edges of the deck. At each of the 21 loading points, the truck remained static for 120 seconds. This allowed sufficient time for the structure to recover and find its new deformed shape. Before and after the load test, daily rush-hour traffic movement was recorded to get a sense of scale between the live and static loading conditions.

Figure 9: Dumper Trucks during Load Test (left), View of VPV Monitoring System (right)
