FIELD INSPECTION AND CLASSIFICATION OF PAVEMENT DISTRESSES OF ST JOHN'S CITY IN NEWFOUNDLAND CANADA

Ali, A.¹, Hossain, K.^{1,4}, Dhasmana, H.², Safiuddin, M³, Bazan, C.¹ and Hussein, A.¹

¹ Memorial University of Newfoundland, Canada

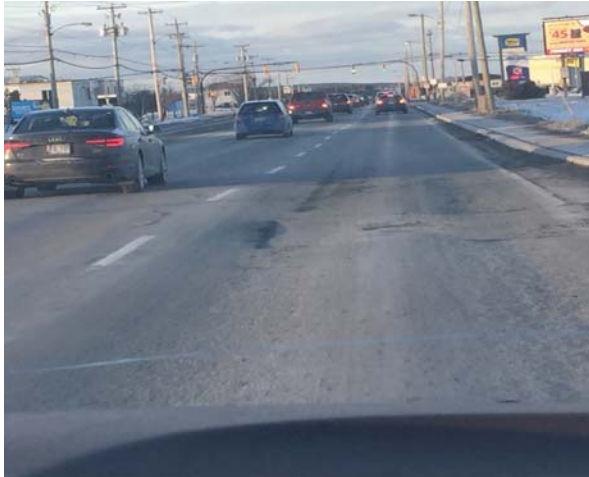
Location: Depressions can form over large areas of the road mostly along the wheel path. Figure 2 (a, b) shows examples of structural and abrasive rutting (due to studded tires) in the city of St. John's.

3. Mechanical deformation (Structural rutting): Lateral movement of unbound material in the lower layers (subgrade) results in wider ruts in the pavement structure. It generally occurs due to irregularities in elastic modulus of the asphalt mix (too stiff or high elastic modulus).

(a) Structural rutting

Measurement and Possible Repairs: Special recording devices such as a profilometer or straightedge can be used to record rut depths. A Data Collection Vehicle (DCV) can also be employed to measure the extent of pavement rutting (ODOT 2010). Minor surface ruts can be filled and deeper ruts can be covered with an overlay. If surface asphalt is unstable, recycling can be performed. In the case of subgrade inconsistencies, reclamation or reconstruction is the best option (Adlinge et al. 2009).

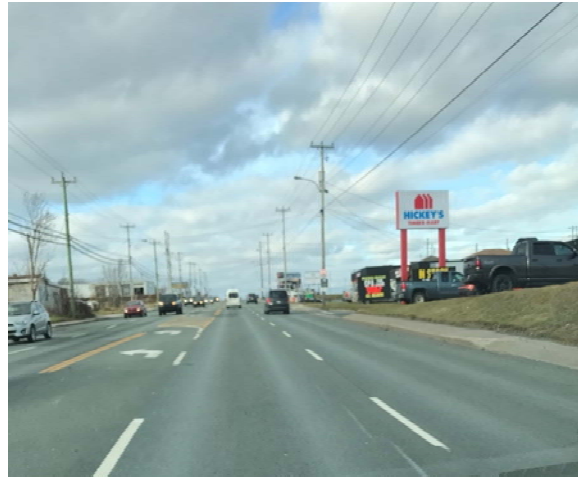
4. Abrasive rutting (Wearing): This is caused by the loss of mastic phase or fine grains of aggregate in surface layer from the impact of studded tires (Sarie et al. 2015). This phenomenon, in particular, is heavily observed in the city of St. John's.

(b) Abrasive rutting

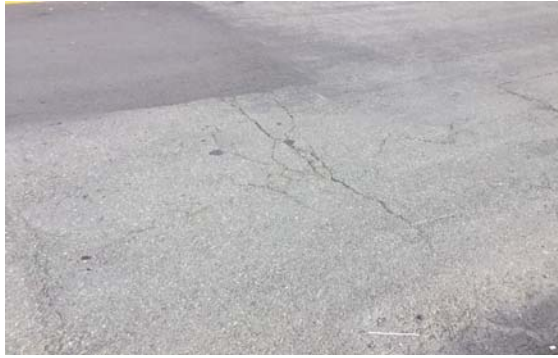
Levels of Severity: LOW (L): area with none or only a few interconnecting cracks and the cracks are not sealed or spalled, average crack width is 6 mm and the crack pattern is no more apart than 32.8 mm (Figure 3a) (FHWA 2009, Salvatore et al. 2006, Scott et al. 2012); MEDIUM (M): interconnected cracks forming a complete pattern with slight spalling and sealing, average crack width is 6 to 19 mm and crack pattern is no more apart than 150 mm (Figure 3b) (Scott et al. 2012); HIGH (H): severely spalled interconnected cracks and average crack width is 19 mm (Figure 3c) (FHWA 2009).

(a) Low Severity

Measurement and Possible Repairs: Linear distance of the affected wheel path or area of fatigue cracking in square meters is measured. Any zone is classified according to the level of severity. If fatigue cracking and rutting occur in the same zone, each distress should be treated separately (FHWA 2009). Changes in drainage pattern, base materials can be made. A full depth patch or spray patching can be performed for temporary repair (Ningyuan et al. 2001).

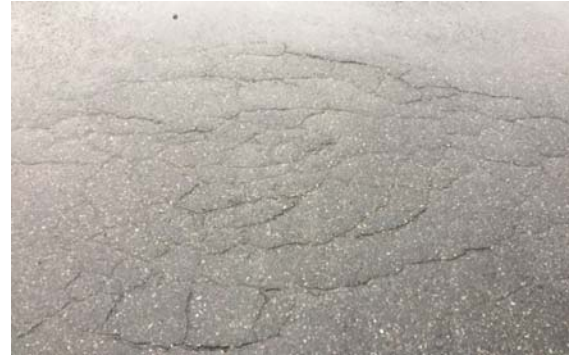
(b) Medium Severity

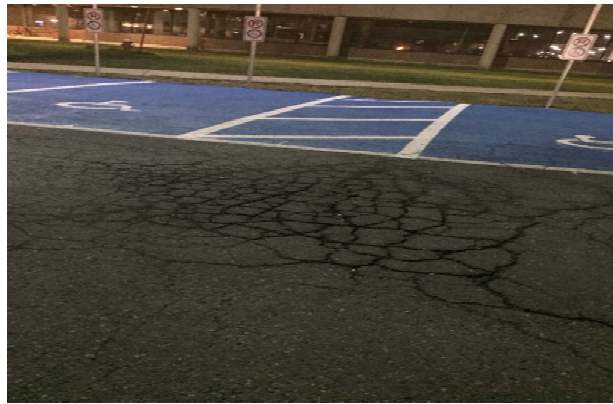
(c) High Severity

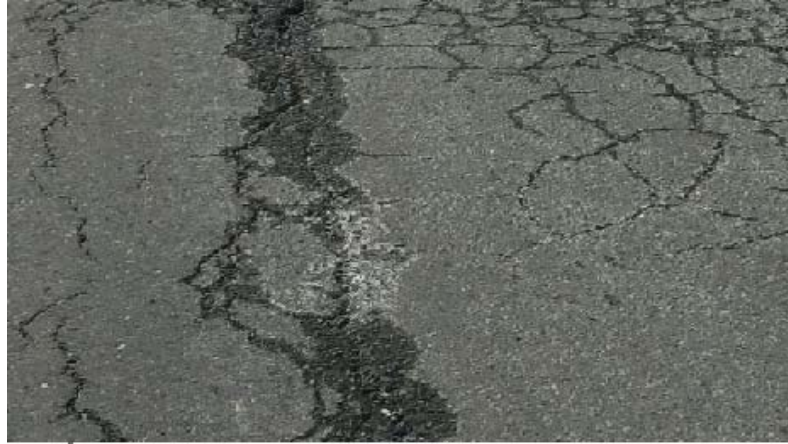
Figure 4: Block cracking

Location: Block cracking occurs throughout the pavement width and not just in the wheel paths. They usually extend only a short distance on the hot-mix asphalt (HMA) surface. Figure 4 shows an example of block cracking in the city.

Identifying distress causes: This type of cracking can be caused by inadequate compaction, shrinkage and hardening of the asphalt mix (FHWA 2009, FDOT 2015).

Measurement and Possible Repairs: Affected area in square meters or the length of pavement at each severity level is measured. Thin wearing course can be constructed to repair a low severity block cracking. For more severe situations, overlays and recycling can be performed. For base problems, the reclamation and reconstruction of the pavement can be proposed (Adlinge et al. 2013).

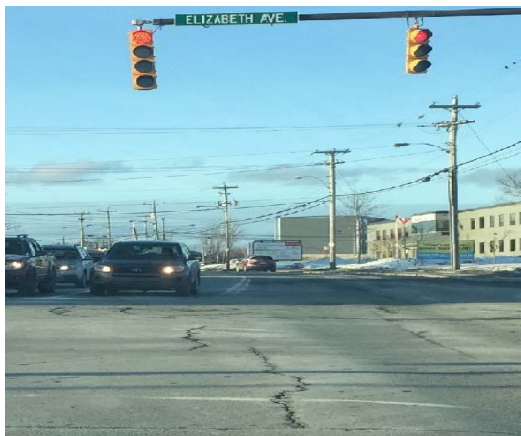
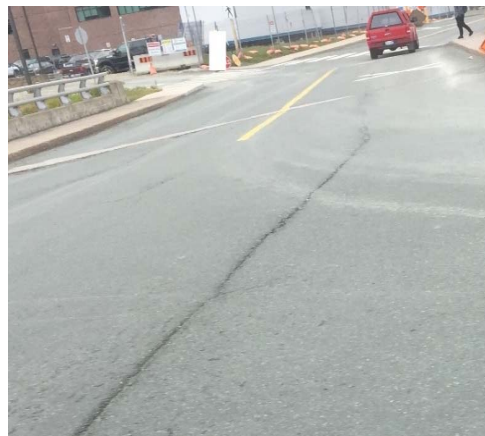
Figure 5: Longitudinal cracking

Location: Longitudinal cracks can exist anywhere between the centreline to the outer edge of the outer wheel path (Figure 5 (a, b)). Their position within the lane (wheel path or non-wheel path) is more critical.

Identifying distress causes: Longitudinal cracks can be caused by frost heaving or construction failures (low compaction or poor construction technique) between the construction lanes. They can also be load-induced. Other reasons include low temperatures causing surface shrinkage in the asphalt mix and creation and propagation of cracks beneath the surface course (Scott et al. 2012).

Measurement and Possible Repairs: The linear distance in meters of the affected area is measured at each severity level. Crack treatment or spray patching can be performed to repair the damage.

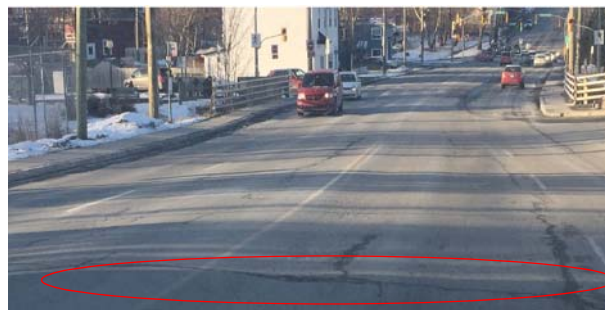
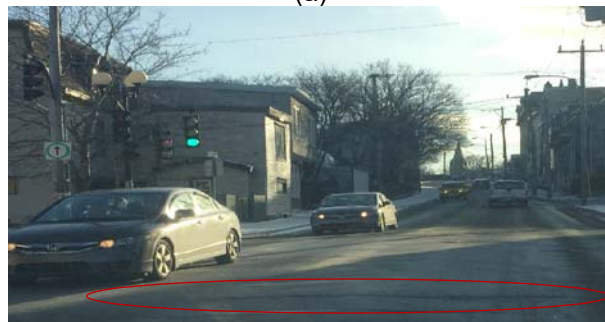
Figure 6: Transverse cracking

Identifying distress causes: Transverse cracks are normally caused by shrinkage of the surface due to low temperatures, reflective cracks induced by the cracks beneath the surface, and a poorly constructed paving lane joint (Hall et al. 1993).

Levels of Severity: LOW (L): tight cracks with average width of 6 mm and slightly spalled or sealed cracks with a width that is difficult to determine; MEDIUM (M): cracks with average width between 6 to 19 mm, cracks less than 19 mm average width and low severity random cracking (FHWA 2009); HIGH (H): cracks with average width greater than 19 mm and cracks with average width less than 19 mm and medium to high severity random cracking (Miller et al. 2003). Severe spalling can also be noticed. Figure 6 (a, b) illustrates some examples of transverse cracking.

Measurement and Possible Repairs: Number and length in meters of cracks at each severity level are measured. Sealing can be performed for low severity cracks and an overlay can be placed for high severity cracks.

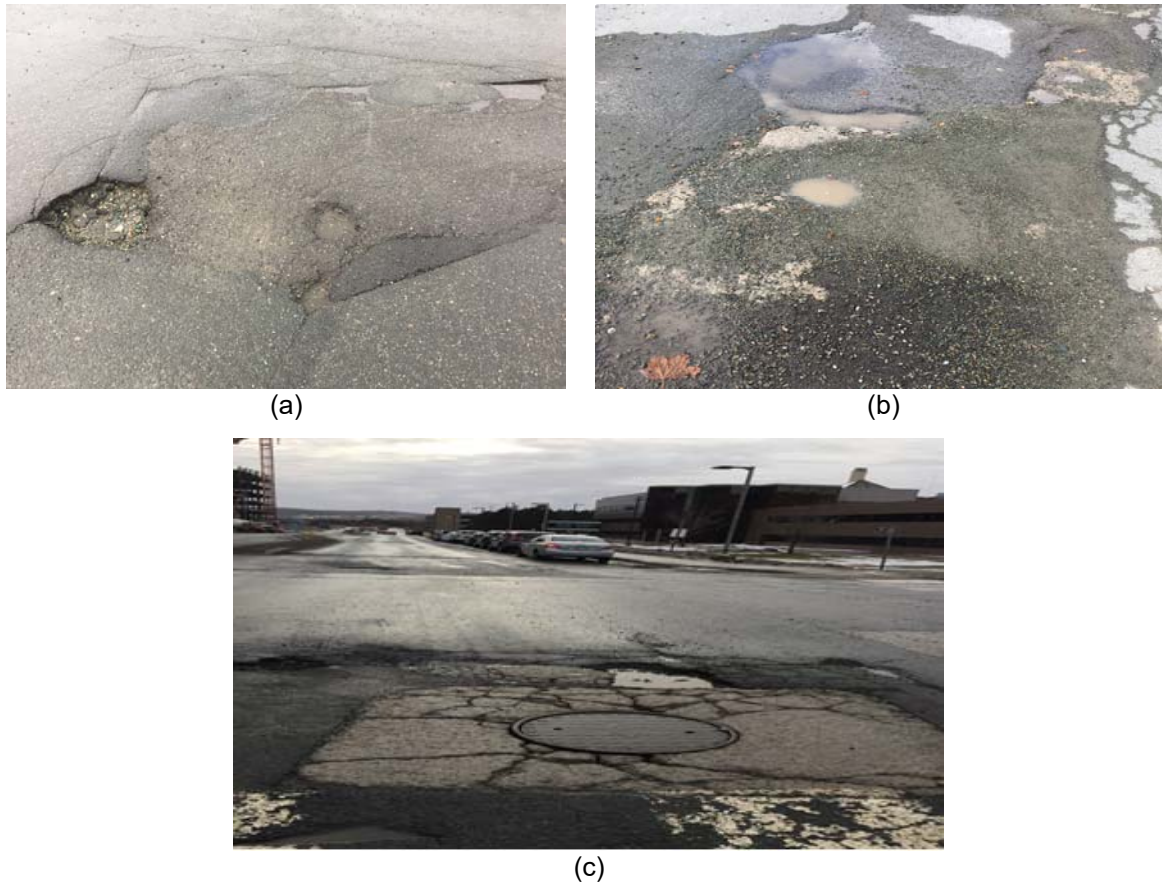
Figure 7: Potholes

Location: Potholes often form in the areas of poor drainage and high traffic of slow-moving vehicles. Figure 7 (a, b, c) shows some examples of potholes filled with water.

Identifying distress causes: Depressions are formed when pavement progressively deteriorates due to fatigue cracking or inadequate strength in one or more layers of the pavement structure. Small fragments of the pavement are removed and the distress then gradually propagates in the lower layers.

Measurement and Possible Repairs: Number of potholes and the affected area in square meters are measured for each severity level. They can be repaired by patching or excavation and rebuilding. Patching is a very common technique used to cover up the potholes on a regular basis. However, when done incorrectly patches can result in uneven roads causing discomfort to the drivers.

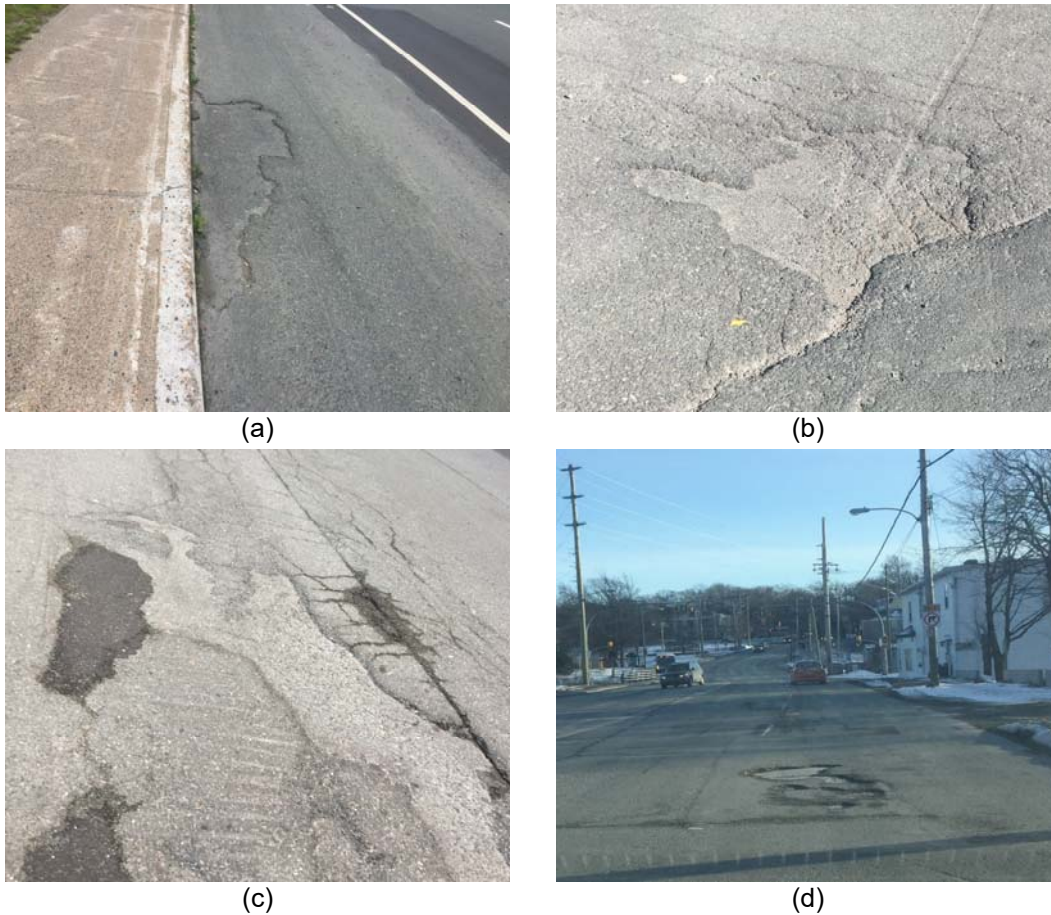
Figure 8: Delamination

Location: Mostly happens on the wheel path or shoulders of the pavement (Figure 8 (a, b, c, d)).

Identifying distress causes: Poor interfacial bonding between different layers, water percolation and heavy traffic loads are the major causes of delamination.

Measurement and Possible Repairs: Non-destructive test methods such as Ground Penetrating Radar or strain gages can be used to identify surface or subsurface delamination effectively. It can be treated by

milling off the surface layer, replacing the wearing course or placing a thin asphalt overlay (Celaya et al. 2011).
