## **SERVICE LIFE EXTENSION: OYSTER CREEK BRIDGE REHAB CASE STUDY**

Dukuze, Augustin<sup>1,3</sup>, Evans, Darrell<sup>2</sup>

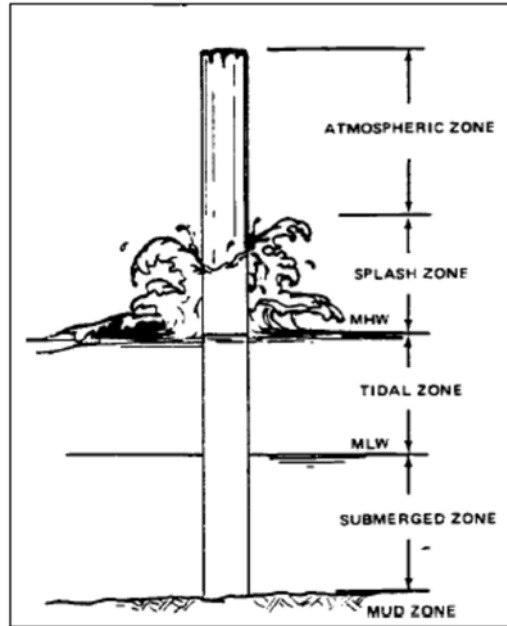
Built in early 1950's, the bridge is a short span timber structure supported on timber piles. In 2008, a routine inspection revealed that the timber piles of the west bent were severely damaged due to excessive loading from the backfill lateral pressure and/or overloading. Located in the river channel, the piles of the mid span bent were also subjected to significant deterioration due to ice lift and abrasion in the splash and tidal zones (Fig. 1).

Fig. 1 Submerged Pile: Typical Degradation Zones (UFC 4-150-07, 2012)

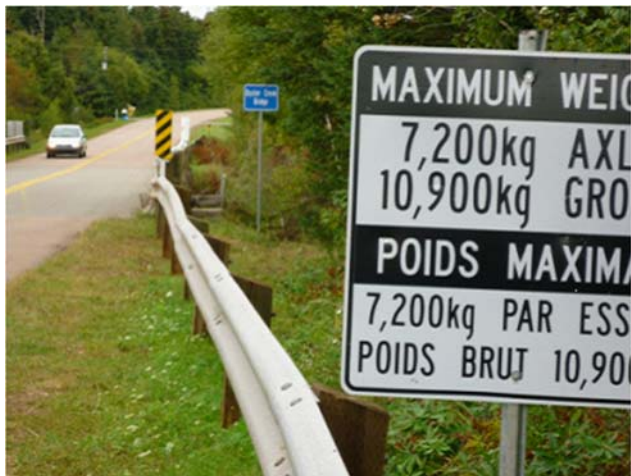
Due to the structure advanced condition, it was slated either for replacement or major rehabilitation. Meanwhile, the bridge was posted to limit the allowed traffic weight/load (Fig. 2 (a)). After in-depth consideration and discussions, the PEI-DOT maintenance department decided to investigate the use of FRP composites in order to strengthen the substructure elements made of timber piles. Although it showed sign of aging, the deck was still in a better shape as opposed to the piles.

a) Weight Restriction

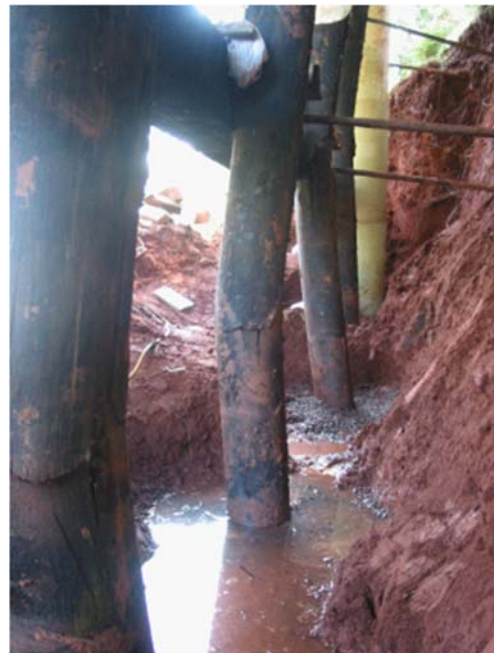
As a first step, an excavation was conducted to expose the on-shore timber piles. It was then evident that these piles c/w tie-backs had practically failed (Fig. 2 (b)). Hence, several options were investigated and it was decided to strengthen these piles with PR jackets. These jackets were prefabricated of GFRP sheets and pre-molded with 2 to 4" gap to fit 12"-dia timber piles. The gap size depended on the pile condition.

b) Excavation Below Mud Line of the On-Shore Timber Piles

To ensure that the repairs were sound, the 15-ft PR-Jackets were extended by 3-ft below the failure location of each pile. Once secured in-place, the space between the pile and the inside diameter of the jackets was filled with high strength tremie grout. A total of seven timber piles were strengthened by using this method as shown in Figs 3 (a) & (b). It should be noted that prior to jackets placement, clamps were installed at damaged locations in order to secure these piles during the repair process while allowing the posted traffic over the bridge to be uninterrupted.

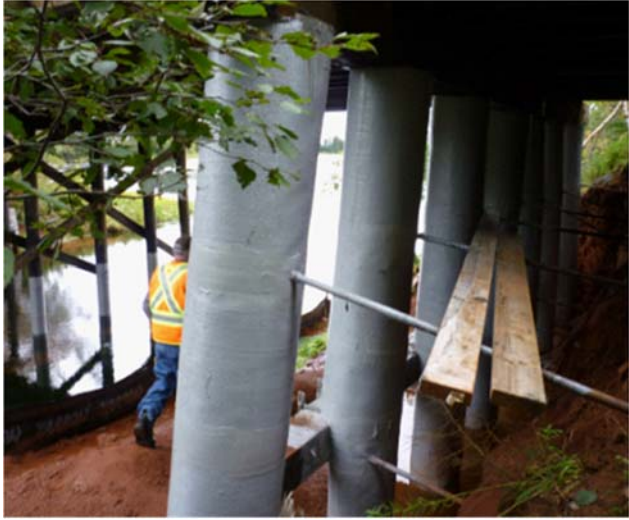
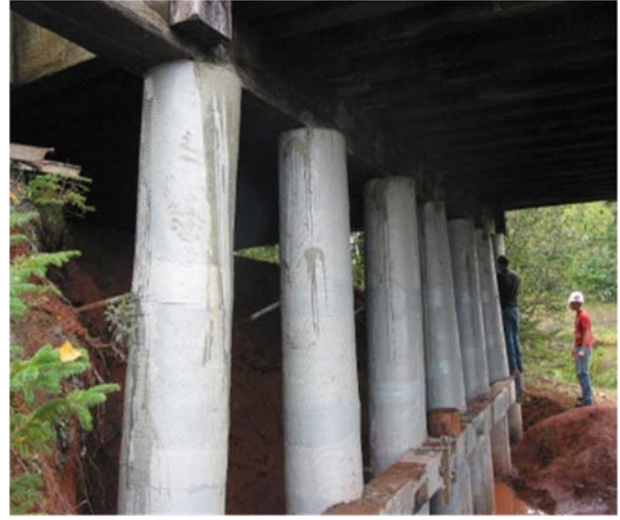
Fig. 3 Oyster Creek Bridge (PEI) 2008

a) PR Jackets after Grouting (Looking North)

b) PR Jackets after Grouting (Looking South)

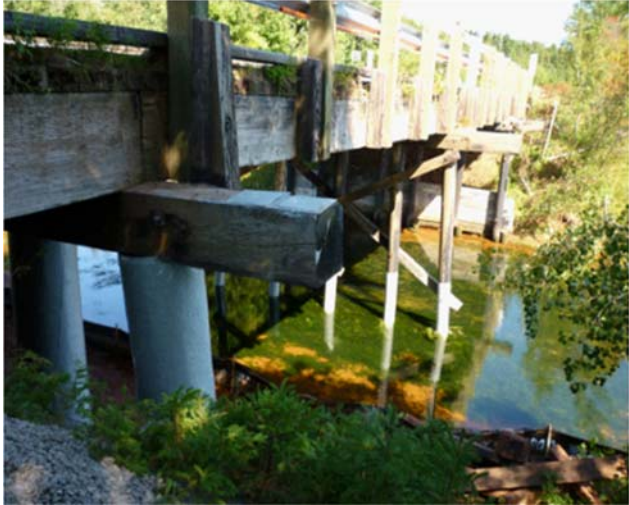
a) Wrapping of Mid-Span Timber Piles

Subsequently, the piles at mid-span that extend into the water were also wrapped with two layers of GFRP in order to protect their respective tidal and splash zones against adverse effects of the tides as well as the ice abrasion (Fig. 4 (a)) The application of FRP layers was as per the wet lay-up method (Karbhari 2007, Hollaway and Teng 2008).

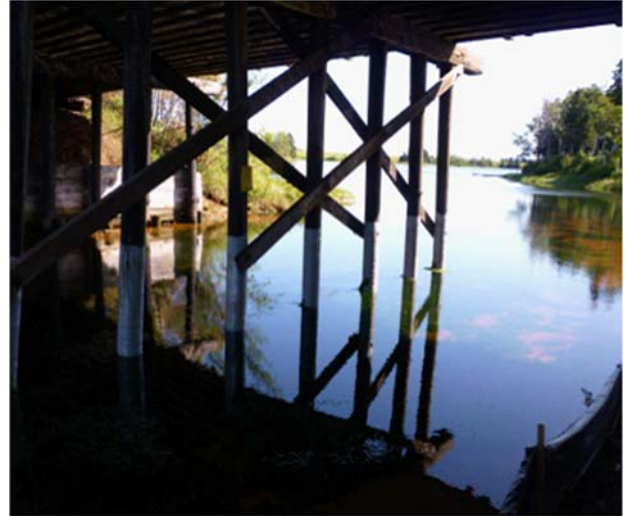
The whole operation was completed over five (5) working days by certified applicators. By using GFRP PR jackets, the cost of the whole operation was reduced. Hence, the overall repair cost was around CA\$ 50,000.00; this constitutes a tiny fraction of what would have been if the structure had to be partially (i.e. driving new piles) or totally replaced. As aforementioned, while these repairs were being implemented, the structure remained open to traffic. Hence, there were practically no traffic disruption over the bridge during the rehabilitation phase. Subsequent to aforementioned repairs, the bridge posting was removed. As repaired, the structure is still in service today; a Fall 2017 site inspection/visit indicated that the structure was still performing well (Fig. 4 (b)).

b) Fall 2017 Site Inspection/Observation
