HOW TO TEACH AN OLD DOG NEW TRICKS: BONNIE DOON LEISURE CENTRE REHABILITATION EDMONTON

Abstract: A small community focused aquatic facility, could have been levelled and built anew, but instead is undergoing a transformation. The term 'rehabilitation' does not accurately describe the level of rejuvenation undertaken to prolong and re-capitalize this facility. The project exemplifies many fundamental challenges of altering existing buildings. Not only did the building require restoration of key structural elements that suffered significant deterioration due to 50 years of use; new programming and operational requirements resulted in significant changes to all systems (mechanical, water treatment, electrical and architectural and structural). Alterations include upgrade of mechanical ventilation systems requiring the addition of two very large AHU and HRV units. Addition of the new building envelope system (recladding) requiring assessment of concrete block integrity and structural capacity of exterior walls. Upgrade to salt water treatment requiring perimeter pool gutter (surge tank, salt storage, acid room, various mechanical and electrical upgrades). How to work within the design

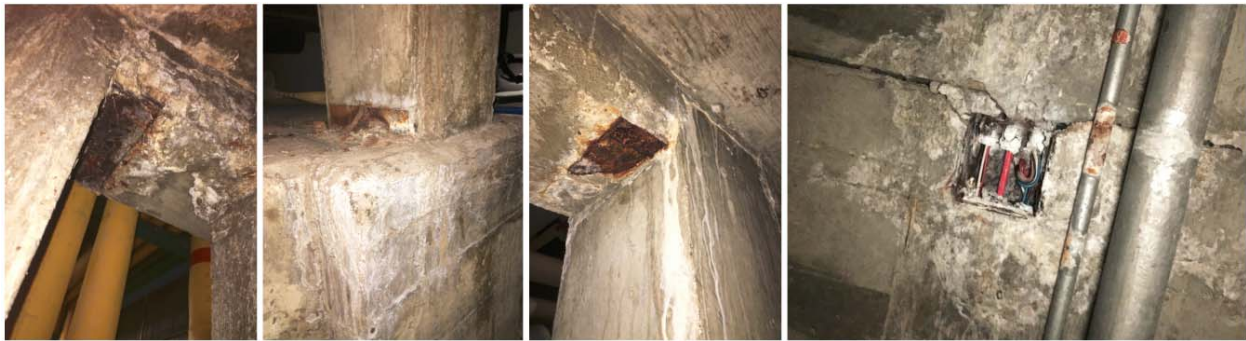
Evidence of water seepage from the deck slab into the tunnel below was observed, and as a result significant efflorescence and spalling/delamination was present. In some locations exposed corroded reinforcing was visible. Although localized, some areas of deterioration are significant. The likely cause of the deterioration is a failure in the waterproofing membrane primarily at the construction joists in the deck slab. The tunnel is also a small confined area with little to no ventilation resulting in a high humidity environment, add in the corrosive pool water treatment chemicals, and a prime environment for reinforcing corrosion and concrete spalling has been created.

Figure 3: Tunnel deterioration

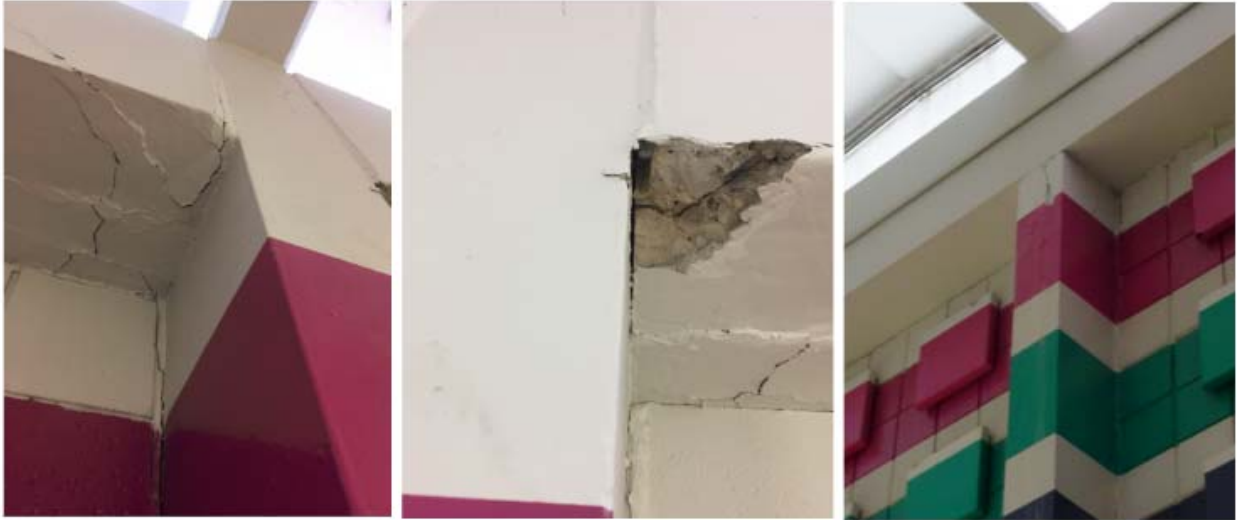
On the east and west end of the natatorium space, the precast roof lin tees bear on precast beams. The precast beams at the north and south elevation bear on precast columns and connect to the side of the column at the end of the beam span. The next beam is simply supported between columns. At the center bay, the precast beams cantilever over columns, meeting at the center of the building. The connections between the beams/columns are embeded steel angle supports, that have been painted repeatedly over the years. At the south and north elevations and the center bays where the beams cantilever, the beam is dowelled into the top of the columns. Moisture appears to have travelled through the exterior wall and corroded the steel connection brackets and column-beam dowels. Figure 4 shows the vertical cracking that has occurred at the top of the columns and at the connection brackets.

Figure 4: Natatorium precast beams and columns

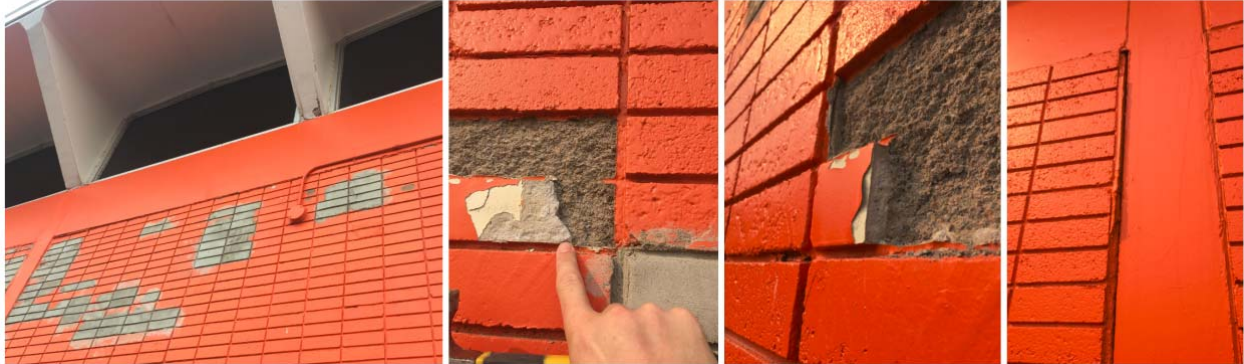
All elevations of the building were observed to have areas that had been previously patched. Upon closer inspection, it was apparent that the portion of the block that protrudes to form the 'brick' pattern had broken away and in many areas been repaired repeatedly. The face shell concrete in select areas was highly degraded and had become 'soft' or easily crumbled.

combination with freeze-thaw cycles has led to delamination of the exterior 'brick' surface, and overall degradation of the concrete face shell.

Figure 5: Exterior masonry

To revitalize the building's exterior appearance and protect and preserve the condition of the exterior walls, full building envelope cladding was required. Due to the level of deterioration observed on the exterior face shell of the concrete, concerns regarding successfully fastening the cladding girts to the exterior walls were identified. A building envelope contractor and anchorage manufacturer carried out anchorage loads tests on the exterior walls in all conditions identified: sound block, deteriorated block and previously repaired block. The anchors were tested to failure to determine the anchorage capacity that could be achieved in the masonry face shell. These results were provided to the cladding contractor for cladding design purposes. Destructive testing at the vertical joint between the masonry infill and precast columns was also performed. The mortar joint was consistently deteriorated. Repointing of this joint was incorporated into the rehabilitation to maintain the structural system of the building as originally designed.
