Montréal, Québec
May 29 to June 1, 2013 / 29 mai au 1 juin 2013

Analysis of Liquefaction during Van Earthquake

Alper Turan¹, Hany El Naggar², Hesham El Naggar³, Ramazan Livaoglu⁴, Yucel Guney⁵

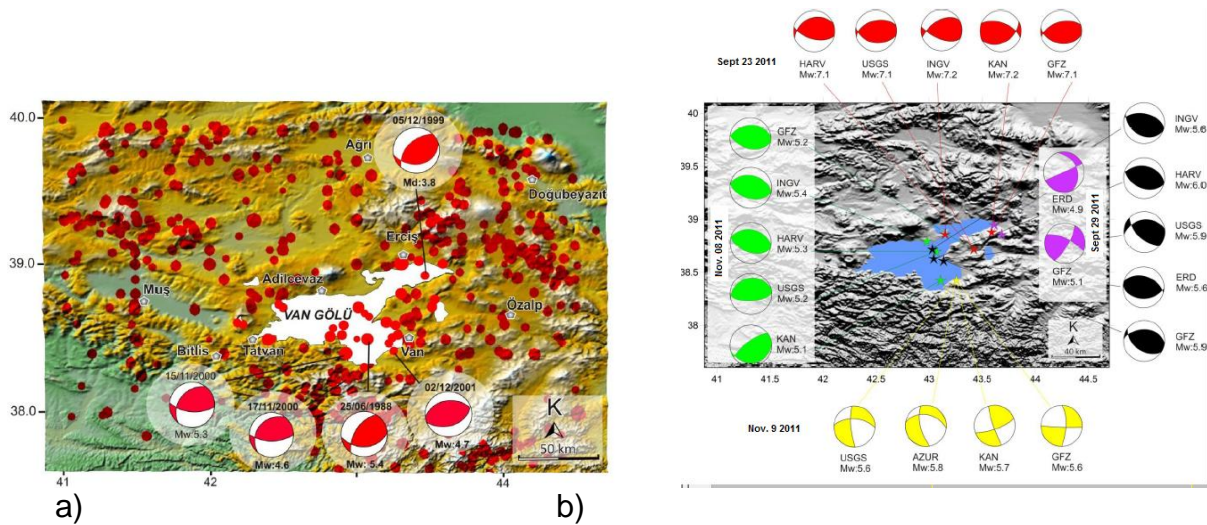
Figure 3. (a) Locations and magnitudes of historical earthquakes in Lake Van basin between 1990 and 2011; (b) Locations and magnitudes October 2011 Van earthquake (main shock) and aftershocks according to various sources (after TMMOB-JMO, 2011)

A comprehensive summary of the historical seismic activities are given in TMMOB-JMO, (2011. Figure 3 (a) and (b) depicts the locations and magnitudes of historical earthquakes (1990-2011) and October 2011 Van Earthquake (main shock) and aftershocks, respectively.

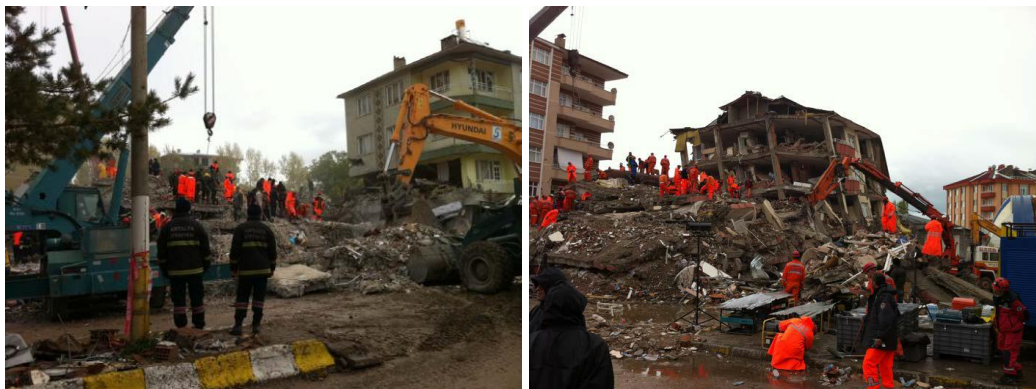
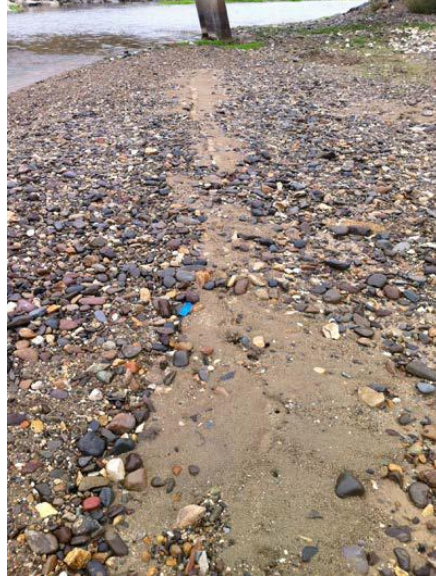
Figure 12. (a) Structural Collapse at Vanyolu district, (b) sand boiling in Zilan River (after Cetin et al., 2011)

Post earthquake field observations indicated that pockets of the area investigated have experienced liquefaction. Despite the difficulty of quantifying the liquefaction induced ground movement (the area was a constructed zone), signs of lateral soil movement as well as foundation settlements in some buildings were observed. Since the liquefaction assessment presented in this study was based on an average SPT profile that was considered to be representative of the area, it is expected that some locations with higher SPT profiles did not liquefy. This explains the localized nature of observed liquefaction. Namely, only the locations with low SPT values were thought to have liquefied during the earthquake. Figure 12 shows the complete collapse of residential condominiums and sand boiling that occurred near Zilan River.
