## Design and Construction of the First Worldwide Concrete Water Tank Chlorination Totally Reinforced with GFRP Bars

**Abstract:** This paper presents the design procedures, construction details, testing, and monitoring results of the world's first RC water tank chlorination totally reinforced with glass-fiber-reinforced polymer (GFRP) bars. The project is located in Thetford Mines, Quebec, Canada. The tank is considered as one of the most important components in the city's new water treatment plant. The tank's volume capacity is over 2500 m<sup>3</sup> and its walls are 4650 mm high. The foundation, vertical walls, and top slab were totally reinforced with GFRP bars. The tank was designed for satisfying the serviceability and strength criteria in CAN/CSA S806-12, ACI 440.1R-06, and ACI 350/350R-06. The tank is well instrumented at critical locations with fiber-optic sensors to collect strain data. Site inspection showed that the tank performed very well and was able to withstand applied loads without problem or leaking during the leakage test, and 8 months under the service condition.

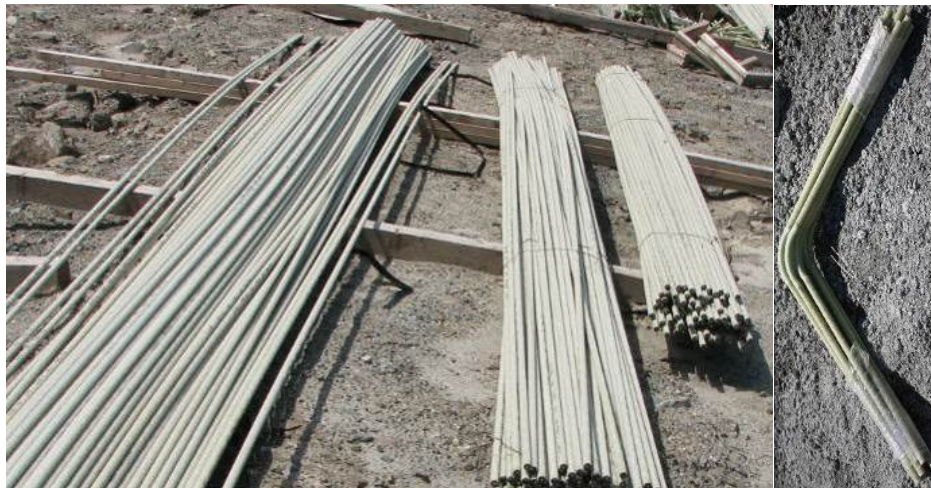
**Figure 2:** Straight and bent sand-coated GFRP-reinforcing bars as shipped to the site

Sand-coated GFRP bars were used to reinforce the three structural elements of the tank, foundation, walls, and cover slab. The bars were made of continuous E-glass impregnated in a vinylester resin using the pultrusion process as manufactured by a Canadian company [Pultrall Inc.]. The glass fibers give the bar mechanical strength, while the resin matrix (resin, additives, and fillers) provides corrosion resistance in harsh environments. The GFRP bars had a sand-coated surface to enhance bond performance between the bars and surrounding concrete, (see Figure 2). Two grades of these bars were used: Grade III and Grade II as classified in the CAN/CSA S807-10 according to Young's modulus (60 and 50 GPa, respectively). Grade III and II GFRP bars were used as the main and secondary reinforcement, respectively, in tank walls, cover slab, and foundation. Moreover, two bar diameters were used in the tank design: No. 15 and No. 19 (nominal cross-sectional area of 199 and 284 mm<sup>2</sup>, as indicated in CAN/CSA S807-10). The mechanical properties of the GFRP bars are summarized in Table 1, as provided by the manufacturer. Considerable research efforts have been deployed in the past decade to assess the suitability of FRP reinforcement in reinforced-concrete structures (Robert et al. 2009). The work of these researchers has highlighted the short- and long-term performance of FRP-reinforced-concrete structures and the durability of FRP reinforcing bars subjected to different conditions, including immersion in alkaline solution, sustained tensile stress, elevated temperature, and freeze–thaw cycles. The results of these studies have revealed that the effect of the aforementioned conditions had no significant effect on the tensile strength of the GFRP bars for a service life exceeding 100 years.

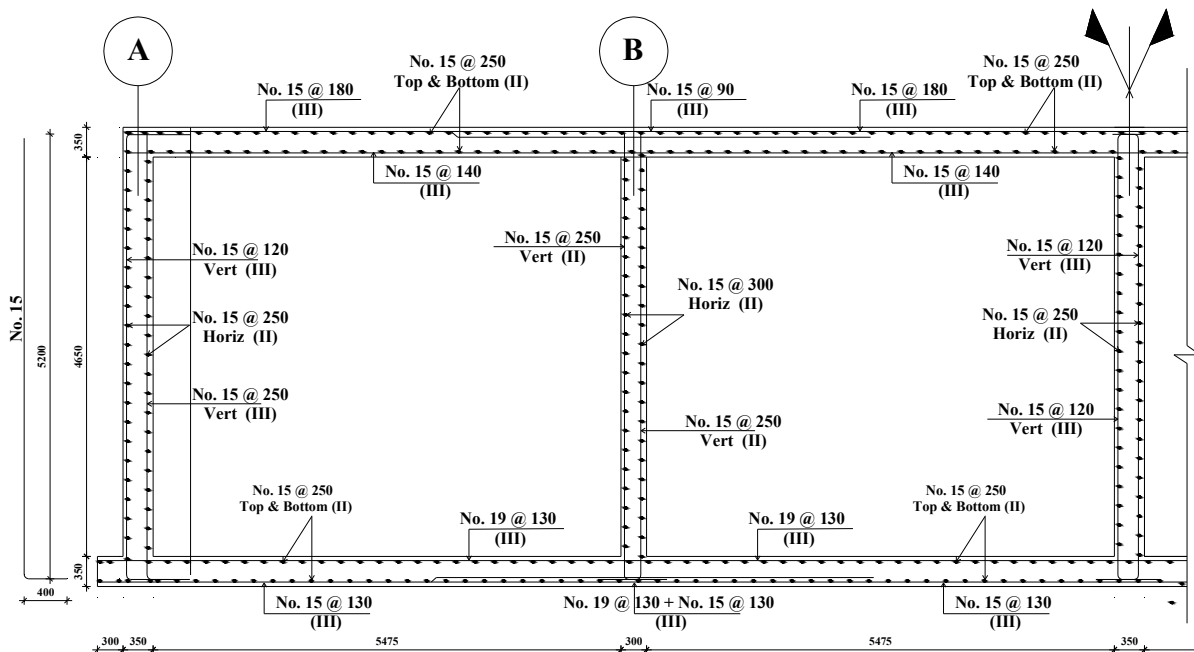
Figure 3: FRP-reinforcement details for the main vertical section in the tank.

The reinforced concrete tank is a combination of walls, foundation, and top slab. The vertical walls and foundation are rigidly connected together to form a monolithic frame. The top slab was designed based on one-way loading action in the short direction, as statically indeterminate continuous four equal-spans on a hinged support. Moreover, the loading action on the walls combined with the foundation was considered one-way in the short direction since the water pressure is resisted by vertical bending moments in the walls. Figure 3 shows a half vertical section of the outer and interior walls, foundation, and top slab with the axis-symmetric reinforcement details. The tank was designed based on serviceability and the ultimate limit state for FRP reinforcement requirements, while the thickness was determined using the working stress design, as recommended by ACI 350. The size of reinforcing FRP bars was chosen with the knowledge that cracking could be better controlled by using a larger number of small diameter bars rather than fewer larger diameter bars (ACI 350). Several bars at moderate spacing are much more effective in controlling cracking than one or two larger bars of equivalent area. For these reasons, No. 15 bars were used extensively in designing the tank, with spacing ranging from 90 mm to 180 mm. Since No. 19 bar was used only in one section in the foundation, since the maximum observed moment required a high reinforcement ratio.

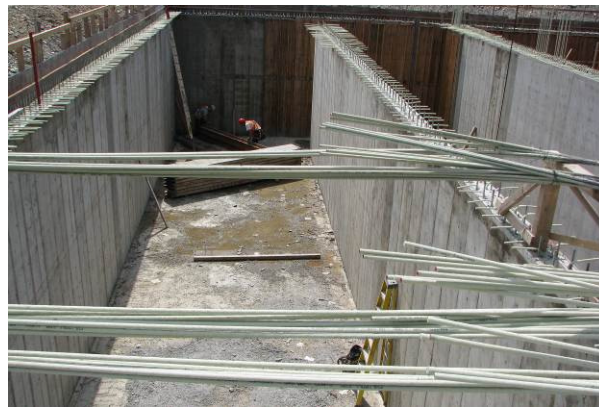
**Figure 4:** Overview of vertical walls.

Tank construction started and was completed in February and July 2012, respectively. The soil under the foundation is rock. Site excavation began in February, with soil, rock, and other materials being removed, typically with heavy earthmoving equipment such as excavators and bulldozers. The depth of excavation was around 5.5 m, to create a level, clean area to work, with the foundation being established in the excavated area. The FRP bars were delivered to the site in mid-March. The placement of GFRP reinforcement for the bottom and top foundation mat as well as concrete casting and curing were started and finished by the end of March. Continuous plastic chairs were placed in the longitudinal direction at 0.7 m intervals under the bottom reinforcement mat to support the FRP bars and maintain the required clear concrete cover. In the case of the top mat, single chairs at 0.9 m intervals in both directions were used. Through April and May, the construction was stopped in the FRP-RC tank and shifted to complete and cast the top slab of the steel-RC tank. Thereafter, wall construction started in May 27, 2012, with the installation of the interior and exterior mats of the FRP reinforcing bars (vertical and horizontal bars). After that, the formwork, casting, and curing of the walls was started and completed on June 5, 2012. Figure 4 shows the formwork, FRP-vertical and horizontal reinforcement of the vertical walls, before and after casting and during the different construction stages. The day after the wall were cast, all the formwork for the interior walls on both sides was removed, while the exterior formwork for the outer walls was maintained and used through all the construction stages of the top slab. The formwork for the top slab started directly after removing the wall formwork and was finished in mid-June. The placement of GFRP reinforcement for the bottom and top mat of the top slab and concrete casting was started and finished by June 22, 2012. In addition, continuous plastic chairs were placed in the longitudinal direction at 0.8 m intervals under the bottom of the top reinforcement mat to support the FRP bars and maintain the required clear concrete cover. After casting, the slab was cured for 10 days, with the formwork being completely removed 4 days later. Figure 5 shows the FRP-RC top slab. Following that, cleaning work and leveling of the top surface of the foundation with cement mortar inside the tank were completed in the mid-July to start filling the tank with water.

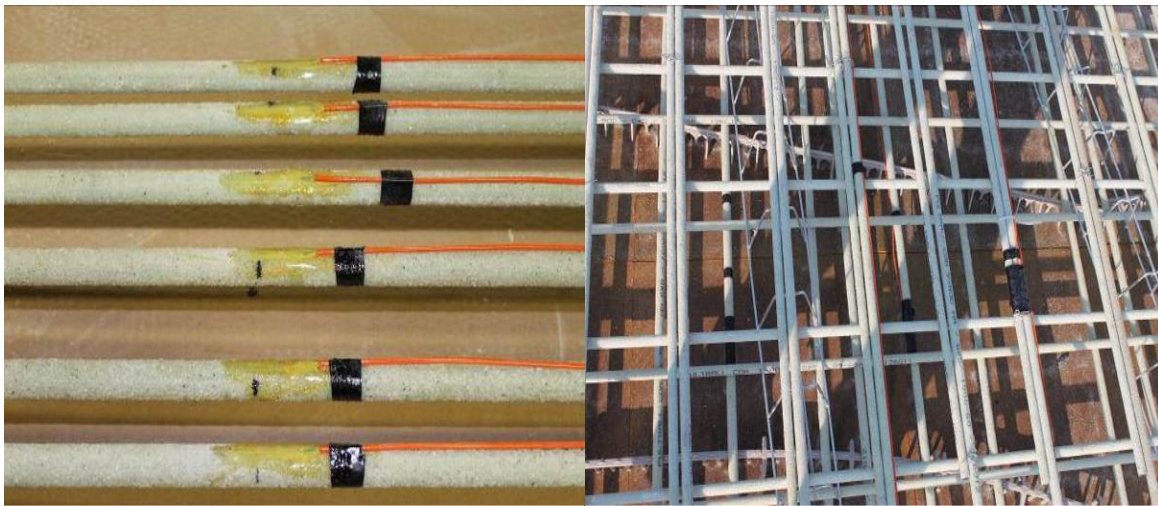
**Figure 6:** Preparation and instrumentation of GFRP bars

The FRP-RC tank was instrumented at critical locations to measure internal strain data using fiber-optic sensors (FOSs). The objective of using FOSs was to allow for the long-term monitoring of the tank. The wall and top slab were instrumented with 6 and 10 FOSs, respectively, at different locations. One of tank's exterior walls was chosen to be instrumented to collect the strain data at maximum moment location for the two loading conditions: water and earth pressure. Three FOSs were glued on three vertical GFRP reinforcing bars on each side of the wall and interior and exterior mat. The GFRP bars were instrumented at the structural laboratory of the University of Sherbrooke. Thereafter, the bars were shipped to the construction site where they were installed at the designated location during the construction stage of the wall. The interior and middle walls were not instrumented since the water pressure acts on both sides. It is of interest to mention that an FOS can measure strain data in the range of positive and negative 2500 microstrains. The benefit of this lies with collecting the tension and compression strain in the FRP bars, since, in the case of exterior wall, the moment is reversible due to the opposite effect of earth and water pressure. Figure 6(a) shows the GFRP bars instrumented with FOSs.

The ten FOSs in the top slab were distributed along the mid-span section between the walls for the positive moment (top and bottom mat) and over the wall for the negative moment (top and bottom mats). These sensors were glued on the transverse GFRP reinforcing bars at the locations of expected maximum stresses. These bars were prepared with FOSs in the site, because the bar length ranged from 9.0 to 16.0 m, and it was difficult to protect and ship these bars with FOSs from the university to the site. All the FOS wires in the wall and slab were collected and passed at one point in the top surface of the top slab. Eight-channel data-acquisition systems were used to collect FOS readings at the different stages of construction.

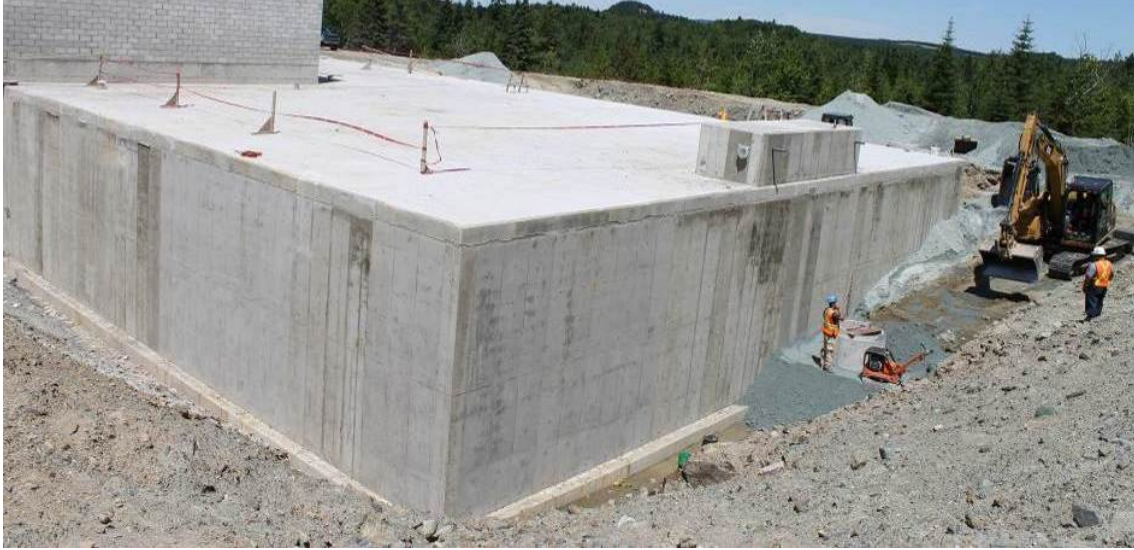
**Figure 7:** Overview of the completed tank through the leakage test and prior to backfilling

The leakage test was performed three days immediately after the formwork for the top slab was removed and before any backfilling. The steel and FRP RC tank were tested by the contractor and witnessed by the consulting engineer. As mentioned before, the tank had two cells, so each cell should be considered a single tank and tested individually. One of these cells was filled up completely with water to check for leakage; the other cell remained empty. After finishing the test on one side of the tank and checking all visible cracks, the water transferred to the other cell. Figure 7 shows the tank overview during the leakage test of one cell. The water was kept at test level for three days prior to the actual test. The exterior wall surfaces of the tank were inspected while the tank was being filled.

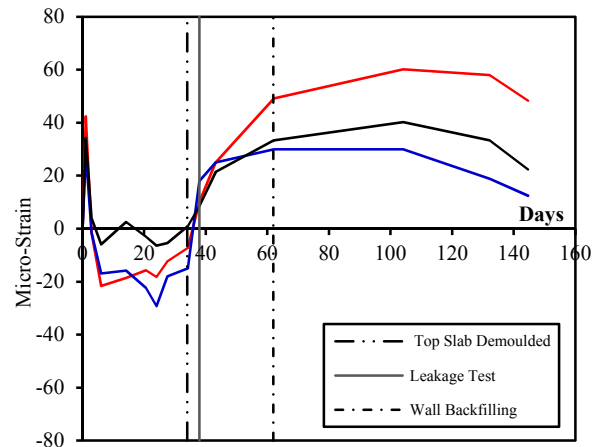
**Figure 9:** Measured strains in the FRP vertical reinforcement in the wall (W<sub>E-1</sub>).

Figure 9 shows the strain measurements from the FOSs attached to the GFRP bars for the interior and exterior vertical reinforcement. The initial strain readings were recorded a few hours before casting (zero point at the x-axis). After casting, the strain readings were recorded daily for one week. Following that, the 6 wall FOSs were monitored each week. Therefore, the reported strain values in the first 10 days represented concrete shrinkage. Moreover, the high temperature due to cement hydration at early age could be observed. Figure 9 shows the sudden variation in tension strains from compression to tension strain, as a result of the wall moment due to water pressure. The maximum tension strain ranged from 40 to 60 microstrains during the leakage test and after the backfilling was initiated. The measured values indicate that the strains in the wall were insignificant, as it represented less than 1.0 % of the ultimate strain of the GFRP bars. This can be attributed to two reasons. First, considering the straining action of these forces and determining the maximum compression and tension stresses on the wall, the results will be approximately equal to -0.8 and 0.5 MPa, respectively. These values are insignificant compared to the strength capacity of the wall cross section (350 mm). On the other hand, the cracking moment of the wall's cross section is higher than that the actual moment during the leakage test. This was confirmed from the site inspection during the leakage test, since no flexural cracks were observed. The backfilling work started immediately after the shrinkage cracks were repaired, making it possible to release the water pressure given the opposite action of the soil pressure. Yet the strain in the FRP bars of the exterior mat continued to increase up to the addition of uncompacted soil over the top slab, the tension strain decreased and stabilized as the result of the opposing action of the water and earth pressures, in addition to the weight of the soil on the top slab.
