GFRP-RC COLUMNS UNDER REVERSAL-CYCLIC LOADING

Mahmoud Ali¹ and Ehab El-Salakawy²

¹ M.Sc. Student, Dept. of Civil Eng., University of Manitoba, Winnipeg, MB, Canada

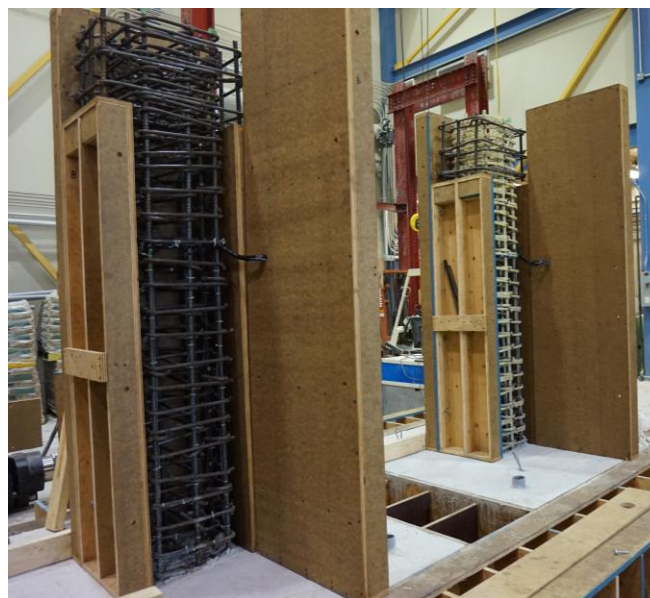
Figure 2: Construction process for the test specimens

All test specimens were constructed with normal-weight, ready-mixed concrete with a specified 28-day compressive strength of 35 MPa. The maximum nominal aggregate size was 19 mm, and the measured slump of the concrete was 120 mm. All test prototypes were cast and wet-cured in the laboratory for 7 days (Figure 2). The average concrete compressive strength was approximately 38.5 at the day of testing based on standard cylinder tests (152×305 mm). Two types of reinforcing bars were used in this study; CSA grade 400 deformed steel bars for specimen CS and sand-coated GFRP bars (Pultrall Inc. 2012) for specimen CG. The properties of the reinforcement as provided by the manufacturer are listed in Table 1.

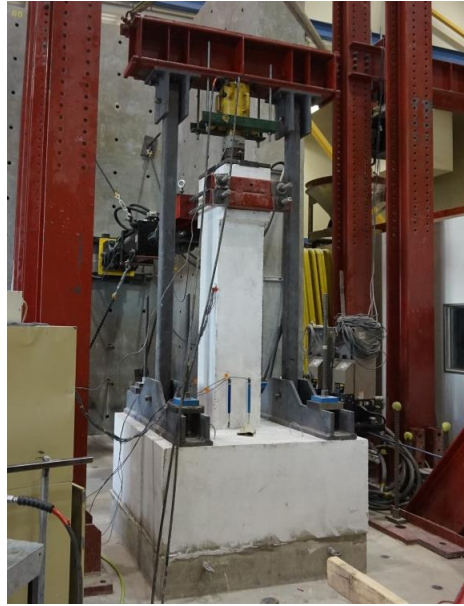
Figure 3: Test Set-up

A heavily reinforced footing was fixed to the strong floor to provide rational fixity to the column. As shown in Figure 3; the simulated seismic load was applied using a 1000-kN fully dynamic actuator of ± 250 mm stroke. In addition, a hinged-loading frame was used to transfer the axial load from a 1000-kN capacity hydraulic jack to the column specimen and to allow translating the column laterally.

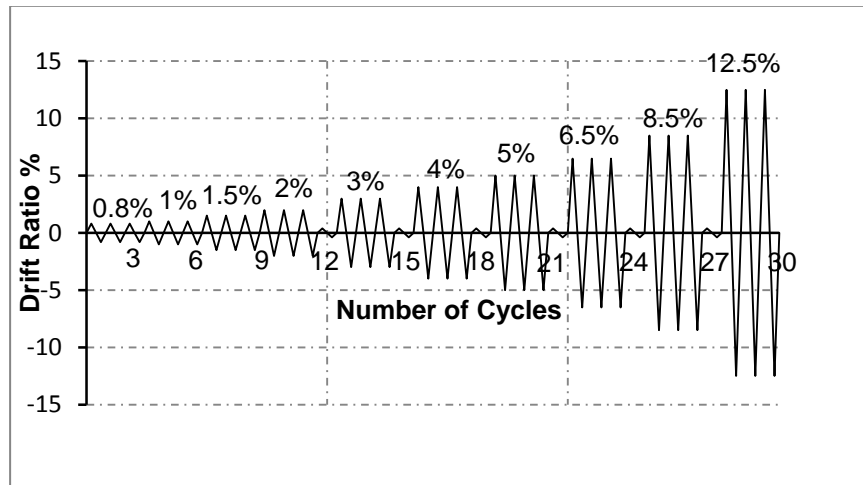
Figure 4: Seismic loading scheme

On the other hand; the displacement-controlled Phase was carried out according to the recommendation of the ACI Committee 374 Report on the acceptance criteria for moment frames based on structural testing (ACI 374.1 2005). In this phase, the load was applied at quasi-static rate of 0.01 HZ. Figure 4 shows the loading scheme, the numbers on top are the drift ratios (y-axis values), while the numbers on the X- axis are the cycle numbers.

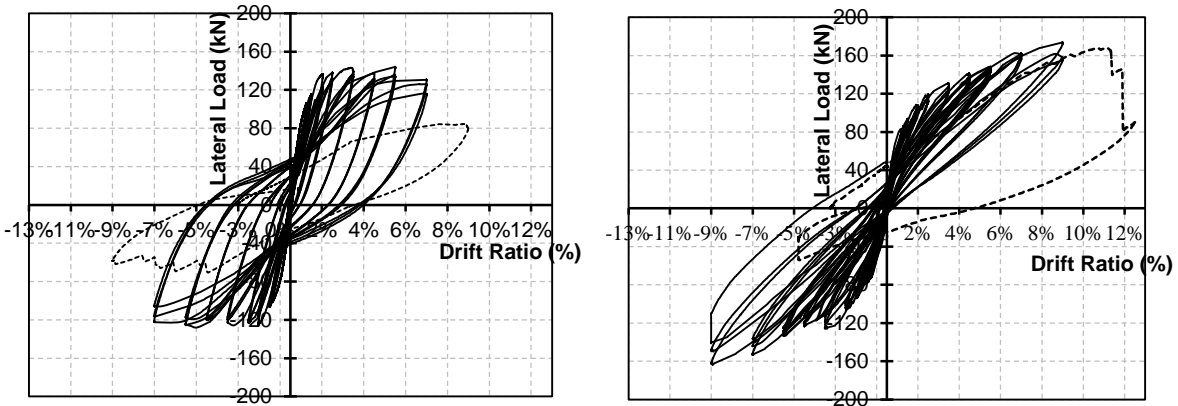
(a) Steel-RC specimen (CS)

(b) GFRP-RC specimen (CG)

Figure 6: Hysteretic load-drift ratio relationship

The hysteresis diagram represents the relationship between the applied lateral load and the drift ratio of the column tip. The drift ratio was calculated as the horizontal displacement of the column divided by the unsupported height of the column. Figure 6 indicates that the hysteresis response of specimen CS showed gradual increase in the lateral resistance at the early loading stages. At 3% drift ratio, the maximum lateral capacity (147kN) was reached with a significant pinching of the hysteresis loop. At the subsequent loading steps, there was insignificant increase in the lateral capacity up to 5% drift ratio. Following the 5% drift ratio up to failure, there was a significant degradation in strength due to the deterioration of the concrete core.

For specimen CG, the hysteresis diagram shows different behaviour compared to specimen CS due to the different characteristics of the internal reinforcement. At the early stages of loading, specimen CG showed lower lateral resistance relative to specimen CS due to the relatively low modulus of elasticity of GFRP bars compared to steel. However, after 4% drift ratio, the lateral resistance of specimen CG exceeded the lateral resistance of specimen CS. Moreover, the maximum lateral resistance was developed at 8.5% (167 kN), while failure occurred at 12.5% drift ratio which resulted in an approximately 200% increase in the deformability with only 4% degradation in strength at failure. It can be noted that the descending portion of the hysteresis curve aimed approximately at the origin of the lateral load-drift relationship; as a result there was no significant pinching of the hysteresis loop.

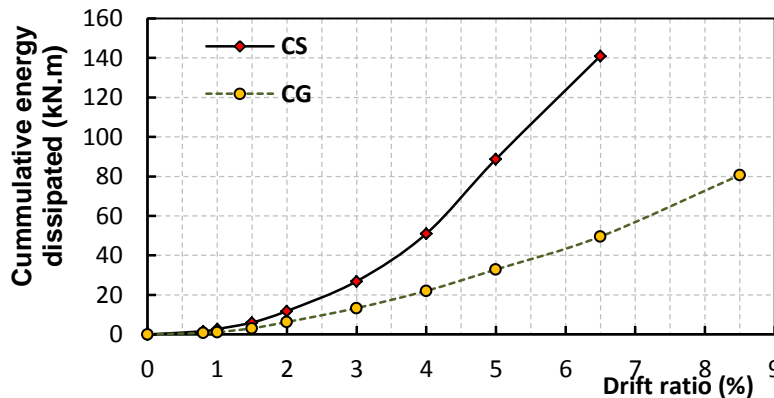
Figure 7: Cumulative energy dissipated by test specimens

Figure 7 shows the cumulative energy dissipation of specimens CS and CG. The cumulative energy dissipation can be calculated by the total area under successful hysteresis loops. As expected, Specimen CS showed higher energy dissipation than specimen CG due to the inelasticity of steel reinforcement after yielding which provides wider hysteresis loops. For example; the cumulative energy absorbed by steel reinforced specimen (CS) at 4% drift ratio was approximately 50 kN.m, while for CG it was approximately 22 kN.m.
