Vancouver, Canada

May 31 – June 3, 2017/ *Mai 31 – Juin 3, 2017*

DETERIORATION OF JOINTS IN CONCRETE PAVEMENTS: INVESTIGATION OF FIELD CORES

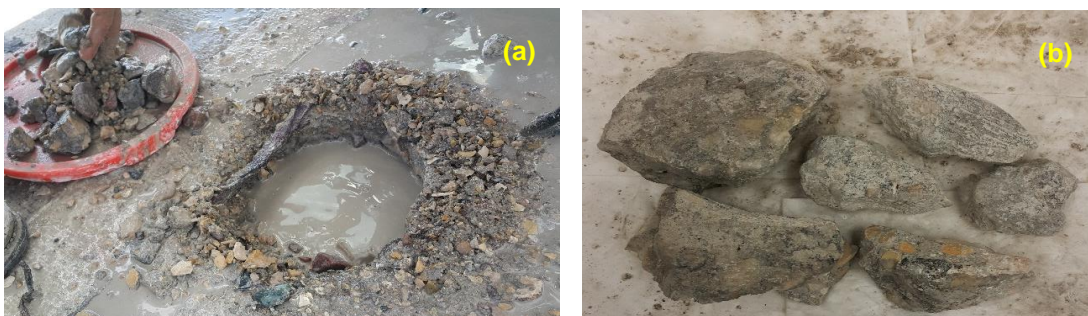
Figure 2: An example from regional roads showing: (a) damage of concrete during the coring process, and (b) fractured core.

For regional roads, most of the sites showed distinctive signs of damage (Figure 1). The visual evaluation of the condition of these sites revealed that the drainage of the joints contributed significantly to their performance. In many cases, the joints continued to entrap water (solution) long after wetting events (Figure 1a). Also, accumulation of dirt and other road debris in these joints was visible (Figure 1b). Joint sealants were mostly de-bonded from both sides of the saw-cut joints (Figure 1c). The most intensive damage occurred at the intersection of the transverse and longitudinal joints, where these areas exhibited significant loss of material. Therefore, based on the visual evaluation of the condition of these sites, the extent of damage was considered as 'medium or high' deterioration in both longitudinal and transverse joints. Due to the differences in the pavement conditions for the streets selected, the cores had been extracted from different sections at and adjacent to the joints. In many cases, the damage to the joints was extensive and the concrete crumbled during the coring process (Figure 2a); therefore, it was not possible to obtain full cores in these locations, where they ended up into several pieces, as for example shown in Figure 2b.

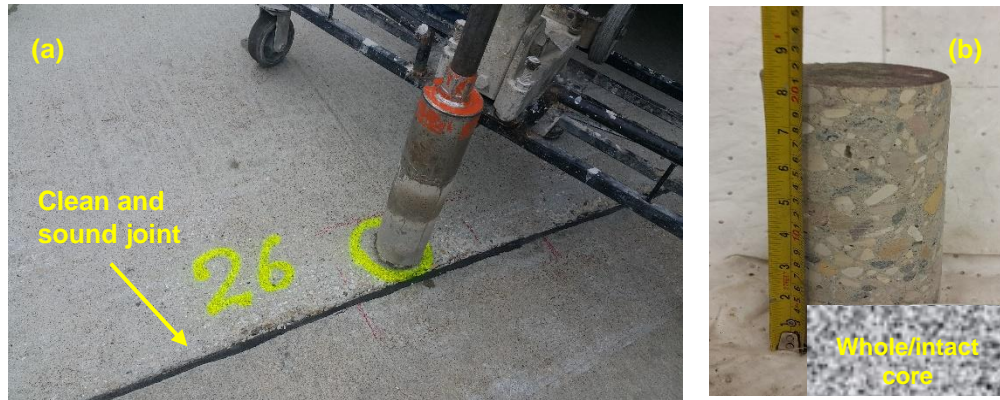
In comparison to the regional roads, the residential streets were in excellent conditions. Most of the joints were clean and sound, and there was no evidence of faulting or spalling (e.g. Figure 3a). The pavement cross slope and drainage system appeared to be effective as water continued draining after wet events as adequately as designed. During coring, it was observed that core holes drained well compared that of regional roads. Also, the cores extracted at and near joints appeared sound and intact; they were cleanly and fully drilled with excellent conditions (e.g. Figure 3b).

Figure 3: An example from a residential street showing: (a) sound joint without evidence of faulting or spalling, and (b) whole/intact core.

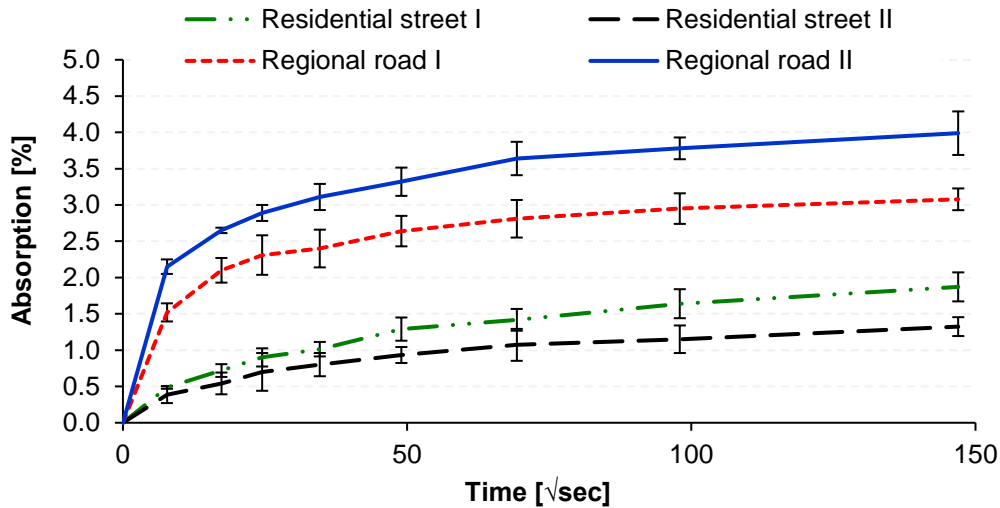
Water absorption test indicates mass transport of fluids into concrete by capillary suction [Hall, 1989]. The rate and total absorption were determined for at least six samples from each location in both regional and residential streets, as shown in Figure 4. It can be noted that the general trend of the absorption curves indicates a significant difference between the cores extracted from the regional and residential streets. For example, the initial absorption, at 1 min, for the cores extracted from the residential and regional streets gained about 25% and 55%, respectively of their total absorption after 360 min. Also, the rate and total absorption values for the cores extracted from the regional streets are significantly higher (two to three times) than that of the cores extracted from the residential streets. This was statistically supported by ANOVA for the total absorption results, as the samples extracted from the regional roads yielded F values of 90.4 which was larger than the F_{cr} value of 4.2.

Figure 4: Rate of water absorption of cores extracted from different pavement sections.

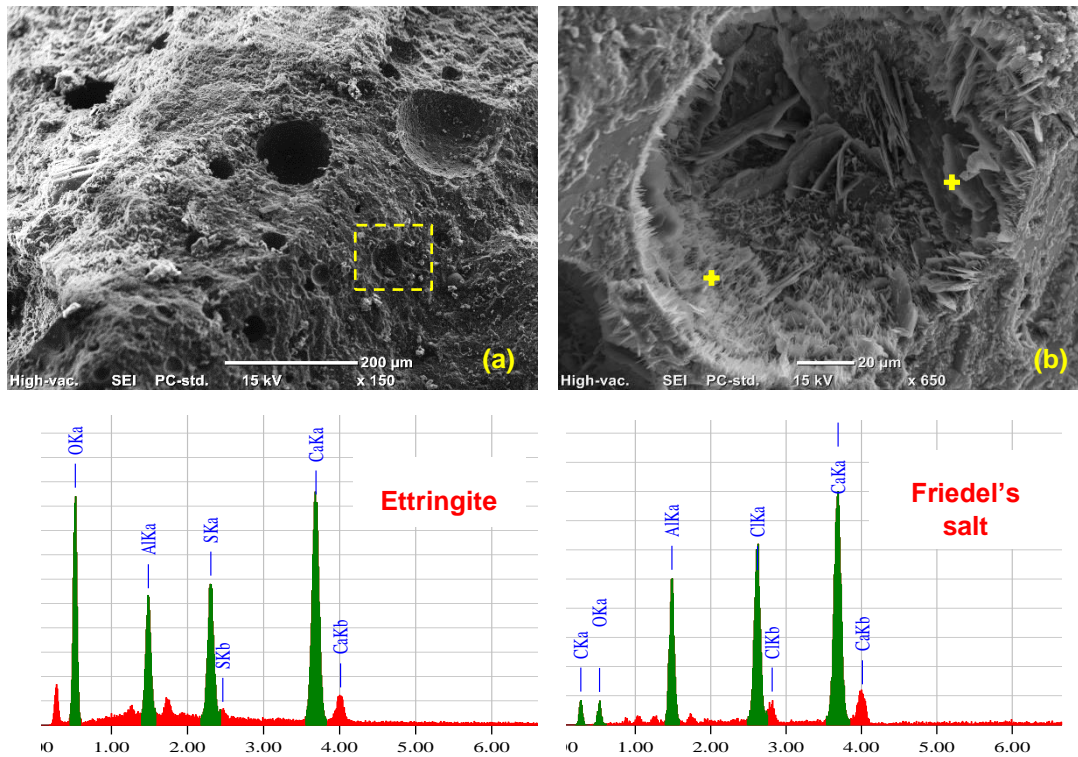
SEM analysis complied with the absorption and MIP findings. Homogenous and dense matrix was observed in various specimens extracted from the residential streets (e.g. Fig. 5a), except that Friedel's salt and ettringite crystals (e.g. Fig. 5b) infilling some voids near (within 10 mm) the exposed surface. The presence of Friedel's salt is likely a result of the substitution of sulfate ions by chloride ions (i.e. binding chloride as salts are borne by vehicles tires) in aluminate phases such as monosulfate, and unreacted tricalcium aluminate, if any; however, this phase may not be detrimental to the integrity of concrete as no marked symptoms of cracking and softening were observed.

Figure 5: Samples collected from residential street showing: (a) homogenous and dense matrix; and (b) traces of Friedel's salt and ettringite crystals precipitating in air voids with associated EDX spectra.
