## MASS HERITAGE TIMBER PERFORMANCE IN FIRE

**Abstract:** Timber heritage structures are prevalent worldwide due to the inherent ease of their construction prior to the popularization of contemporary concrete and steel buildings in the late 19<sup>th</sup> century. As material reuse or conservation becomes a more popular and sustainable option, the performance of these timber structures is being (re) examined, and their performance in a fire is not an exception to this. This is particularly important as vulnerable structures are left to decay in some instances. For this reason, there is a value in researching the fire performance of existing mass timbers members found in infrastructure. This study aims to address this need and to provide a holistic study on the resilience of heritage timber with controlled fire exposure. The research presented involves testing sections of heritage timber (defined herein as timber which has seen over 100 years in service conditions) that were reclaimed from structural members in an existing adaptive reuse project in Canada. These samples were first characterized through mechanical tests, and then tested using a Lateral Ignition and Flame spread Tes

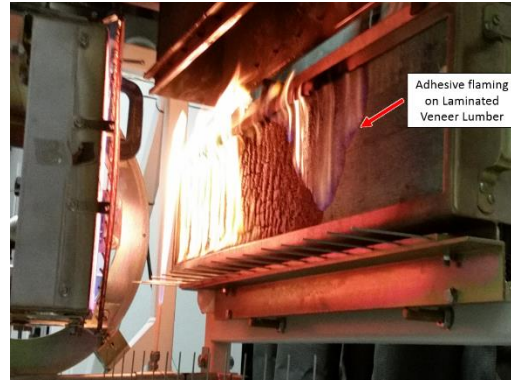
Figure 3. A contemporary flame spread test on laminated veneer lumber (LVL) conducted by the authors using a LIFT (Lateral Ignition and Flame spread Test) apparatus. In this test, adhesive flaming was observed demonstrating the complexity of modern engineered timber. The flame front of the adhesive would be quantified and a spread rating implied on the material (see Otto et al., 2017).

Our modern procedures (see Figure 3) for studying contemporary timber in fire are largely prescriptive in nature (see ASTM 2013, 2015) and very rarely are they extended to analyze heritage timber stock for the same quantifiers mainly due to the limited specimens that can be procured. For this reason, confusion can occur when asked to compare new to old heritage timber behavior in fire.

After testing Beam 3, it was cut to fabricate two specimens of size sufficient for heat testing in a LIFT (Lateral Ignition and Flame spread Test) apparatus at the Carleton University Minto Fire lab. See Figure 8 for specimen and Figure 3 for LIFT apparatus. Beam 1 was harvested for square sections which could be used in future tests in the cone calorimeter to investigate the charring of heritage timber under various controlled moisture conditions (as underway by the authors to further complete this study).

Figure 3 represents the use of a LIFT apparatus to test a laminated veneer lumber sample. This apparatus was utilized for six comparative tests as described in this section with their results.

The laminated veneer lumber tended to have the worst flame spread characteristics, and consequently the more severe char depth. As shown in Figure 3, there is evidence to suggest that the adhesive may bleed during testing for laminated veneer lumber and propagate flame spread down the member. This behavior was not exhibited in the heritage timber, seeing as there was no adhesive, and the behavior was not observed with the glulam samples either. This behavior requires future study at a later time and is not an aspect of heritage stock. The glulam timber did have one of the highest char depths, but one of the lowest flame spreads. This was unique as the flame extinguished during testing, shown in Figure 6 when the data terminates. The heritage timber also had flame extinguishment, though much farther down the sample than the glulam, but also had the smallest charring depth. This is a very interesting result because the beam was severely tested in mechanical load before it was tested in the LIFT apparatus and it could have been expected to exhibit high degrees of cracking to propagate deeper charring. The cut samples did appear to be in good condition when they were heated with no observable mechanically induced damage.

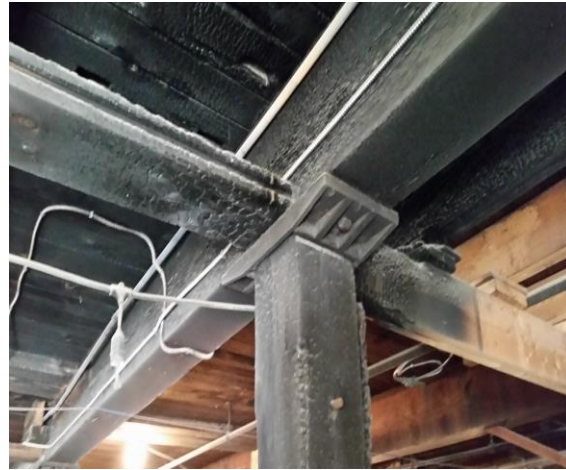
Figure 4. An arson attack on heritage timber where the smaller timber beam components had significant damage, whereas the larger column had minimal damage as the core cross-section remained (authors' photo).

Figure 4 illustrates a heritage timber beam and column of a heritage building constructed in approximately the late 1910's in Canada (the site is made anonymous for practical purposes of discussion). The structural system is similar if not identical to that shown in Figure 2. Juveniles subjected this structure to an act of arson. The fire was put out after approximately one hour and the damage was isolated to the area shown

in the authors' photo. It is of note that the connection performed well as noted in literature (see FPInnovations, 2014). This case study served as the motivation to undertake an investigation of these materials using contemporary technologies for comparison – the exact materials from this very structure would be assessed.

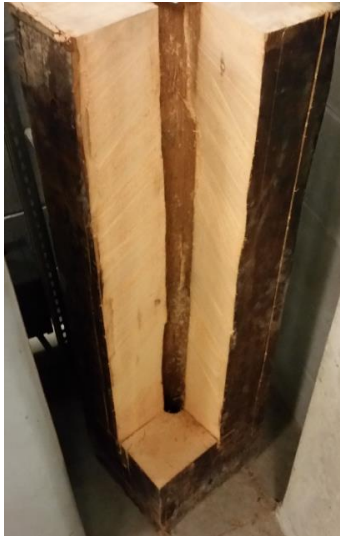
Figure 8. A heritage Beam (no. 3) after two strips were cut out to be tested under a controlled heat exposure. Note the hollowed core was traditionally added to prevent moisture accumulation.

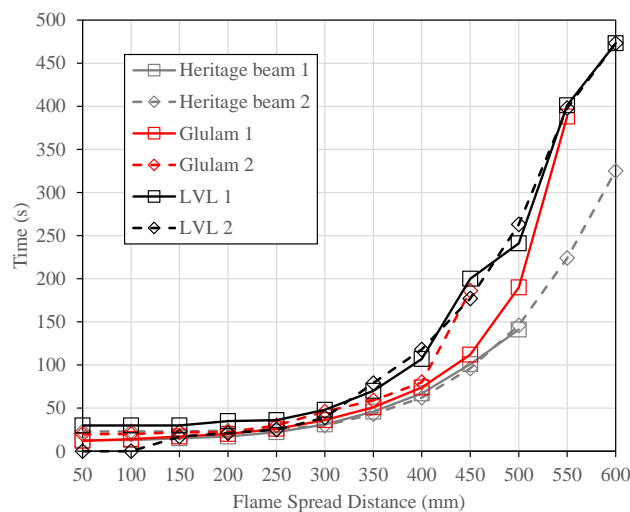
Figure 9. Flame Spread Observations.

Two samples from Beam 3 were tested in the LIFT apparatus, along with two samples of laminated veneer lumber and two samples of glulam. All samples had a moisture content of less than 6 percent at the time of testing. The flame spread measurements are quantified in Figure 9 as well as the specimens after burning visually shown in Figure 10. The quantification of char depth and overall final char front, which will exceed the flame spread measure, are tabulated in Table 1 below. In following the ASTM standard, the definition of the char front was based on a drawn centerline as it was observed to progress more rapidly at the top of the member.

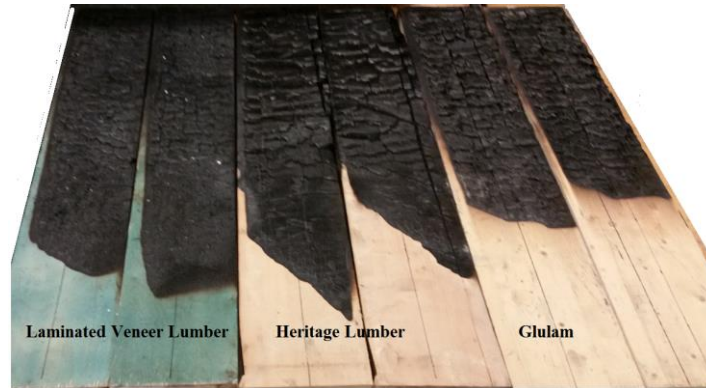
Figure 10. Timber Specimens after Heating.

Table 1. Maximum char depth and char front as taken from the centerline of the material.

Test	Maximum Char Depth (mm)	Char Front Distance from Start of Sample (mm)
Heritage 1	9	640
Heritage 2	10	560
Glulam 1	12	530
Glulam 2	14	500
LVL 1	13	650
LVL 2	14	610
