ULTIMATE LOAD TESTS ON A 40-M LONG TL-5 BRIDGE BARRIER REINFORCED WITH GFRP BARS AND SPECIAL PROFILE 180° HOOKS

Abstract: A new Canadian manufacturer recently developed high-modulus glass fibre reinforced polymer (GFRP) bar with 180° hooks. One of the application of the developed bars is Test Level 5 (TL-5) bridge barrier. To qualify the use of these barriers, a crash test was conducted on a constructed 40-m long GFRP-reinforced barrier, followed by static load tests to-collapse on barrier segments under simulated vehicle impact load. The barrier was subjected to transverse line loading at interior and exterior locations to determine its structural behavior, crack pattern and ultimate load carrying capacity. This paper reports the construction of this barrier along with the static load test setup, procedure and results. Test results showed that failure mode of the tested barrier wall was punching shear at the line load location although both flexural cracks appeared at the tapered faces of the barrier wall during loading. The experimental ultimate load carrying capacities of the barriers were observed to be far greater than the factored design load specified in the Canadian Highwa

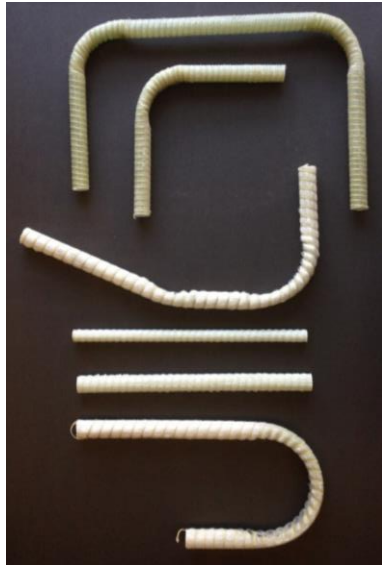
Figure 1: View of the developed GFRP bar types

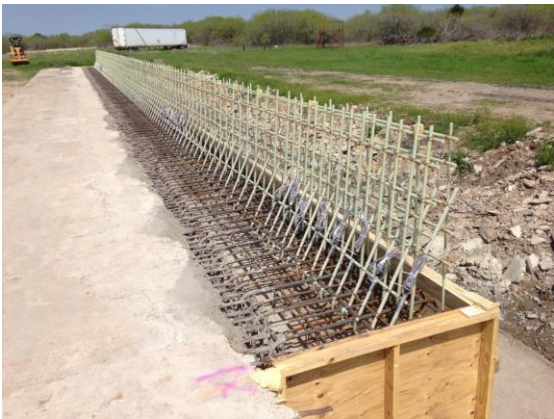
Figure 5: View of GFRP and steel bar arrangement at the beginning of the constructed barrier-deck system

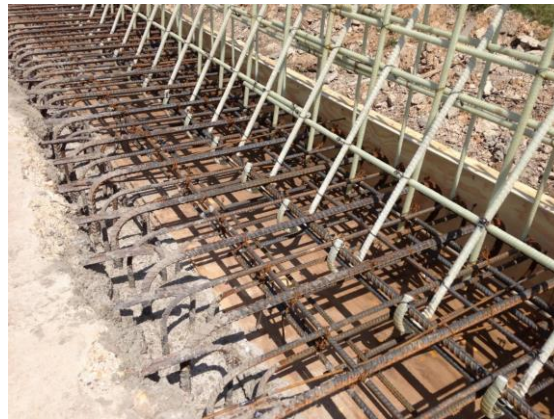
Figure 6: Close-up view of the hooked GFRP bars and deck

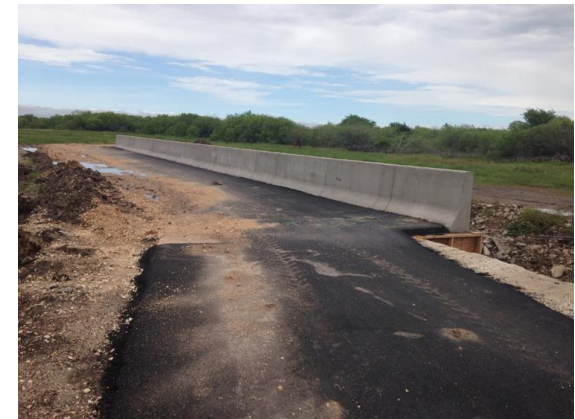
Figure 7: View of the barrier wall after removing the formwork and asphalt paving

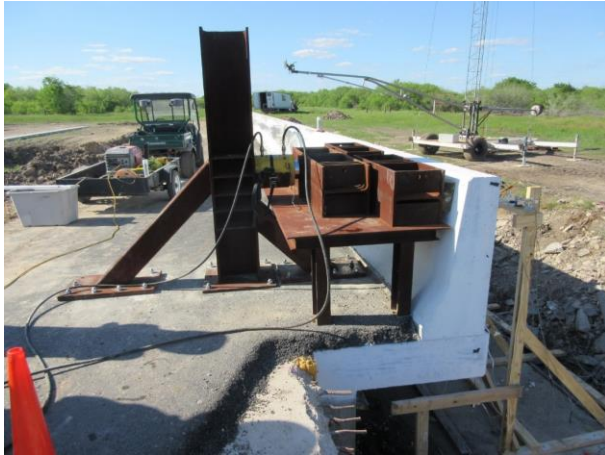
Figure 9: View of the loading setup for the static load test at exterior location of the barrier wall

To simulate the two load scenarios specified in Fig. 8, it was decided to load the barrier wall at its end with a horizontal line load at a height of 900 mm from the top surface of the asphalt and over 2400 mm length as shown in Fig. 9. As for loading the barrier internally, it was decided to load the barrier with a line load over 2400 mm length centered at the control joint as shown in Fig. 11. The interior location shown in Fig. 11 represents the barrier wall segment located in the middle of the constructed barrier wall and centered at the control joint. Six potentiometers (Pots) were placed at 990 mm from top of the deck concrete surface and oriented horizontally to measure lateral deflection of the barrier wall at the level of the applied load every 1200 mm length of the barrier wall, while three Pots were placed at the bottom of the deck to measure its vertical deflection during load application process. Views of the Pots, supported over timber frame, are shown in Figs. 10 and 12 for exterior and interior locations, respectively. The load was applied using a jacking load of 2500 kN capacity. The jacking load was applied on a steel I-beam oriented horizontally, that transferred that load to two spread beams to form a line load over 2400 mm length of the barrier wall. A trapezoidal timber wedge was inserted between the tapered face of the barrier and the spread beam to ensure that the transferred load acted horizontally on the barrier wall. This load transfer system ensured that a uniformly distributed line load was applied on the barrier wall. The hydraulic jack was rest on a steel curved plate attached to a steel column and the push steel beams were rest on a steel table on the front side of the barrier wall as shown in Figs. 9 and 11.

Each barrier location was subjected to increasing static load using the jacking system and steel frame shown in Figs. 9 and 11. At a load increment of 25 kN, the barrier wall was inspected to mark crack initiation and propagation until collapse. The barrier was considered failed when the sensors continued to record increasing deflections with no increase in applied load (i.e. the barrier could not absorb an increase in the applied load).

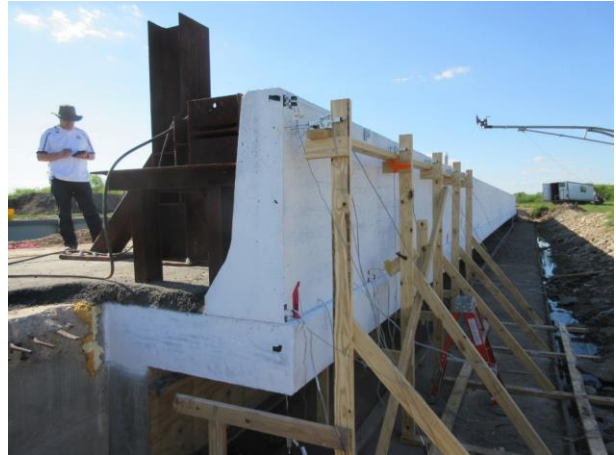
Figure 10: View of the loading setup and sensors' supporting frame at exterior location of the barrier

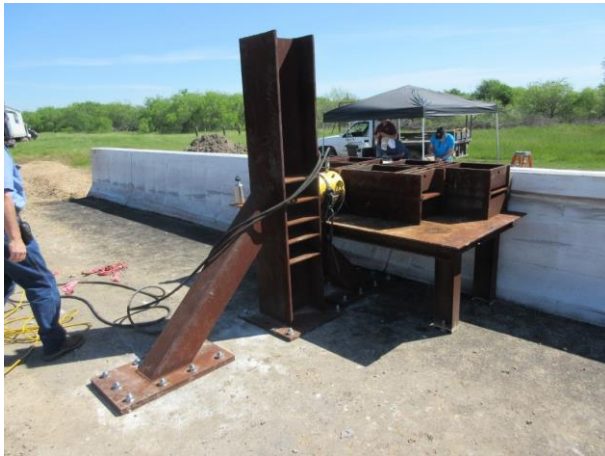
Figure 11: View of the test setup at for static load test at interior location

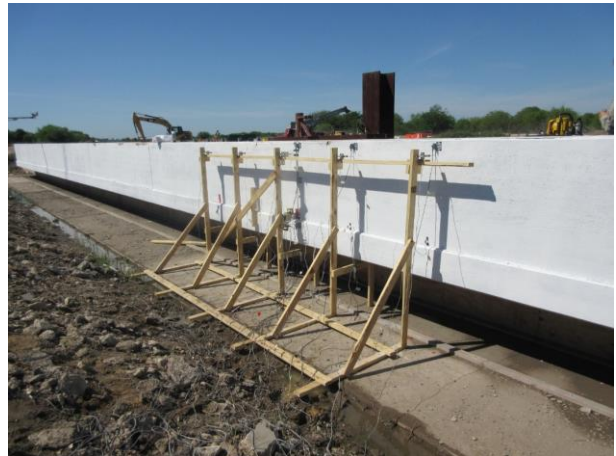
Figure 12: View of the timber frame supporting petontimeters at interior location

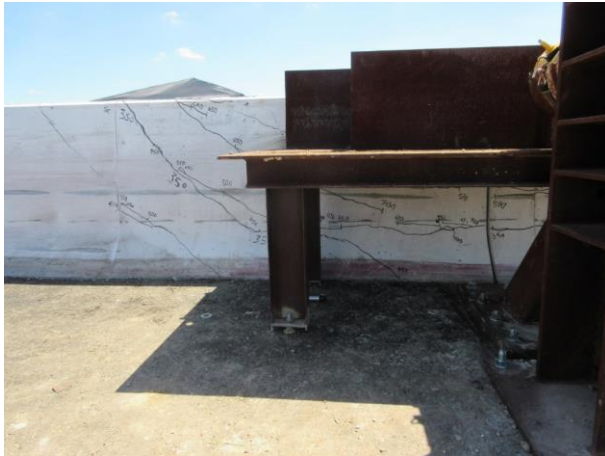
Figure 13: View of the horizontal cracks within the loaded length of the barrier, extending diagonally outside outside the right side of the loaded length

In case of loading the barrier internally at the control joint, Figs. 13 through 16 show views of the crack pattern during the test and after removing the test frame and the timber frame supporting sensors. It was observed that with increase in load, horizontal crack appeared at the front side of the barrier wall-deck slab junction at a load of 312 kN as depicted from deflection readings. Other horizontal flexural cracks appeared at the intersection of the two tapered parts of the front side of the barrier wall at a load of 327 kN. These cracks appeared within the 2400 mm length of the line load, extending diagonally outside the loading region and reaching the top surface of the barrier wall at the same load level. These cracks showed that the barrier wall behaved as a cantilever wall within the 2400 mm length of the line load, while the two-way slab action

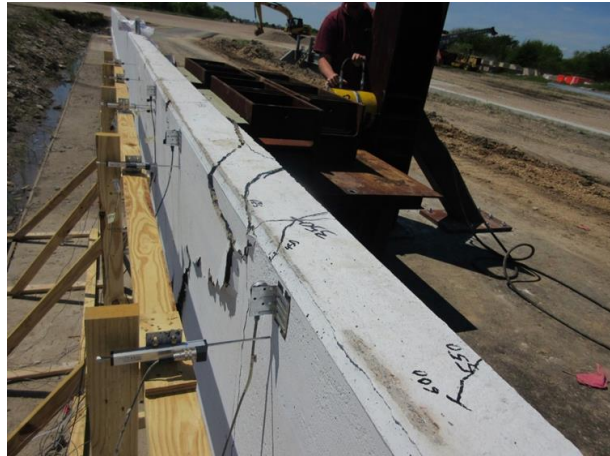
Figure 14: View of the punching shear crack at the top of the barrier wall, extending to the back of the wall at failure

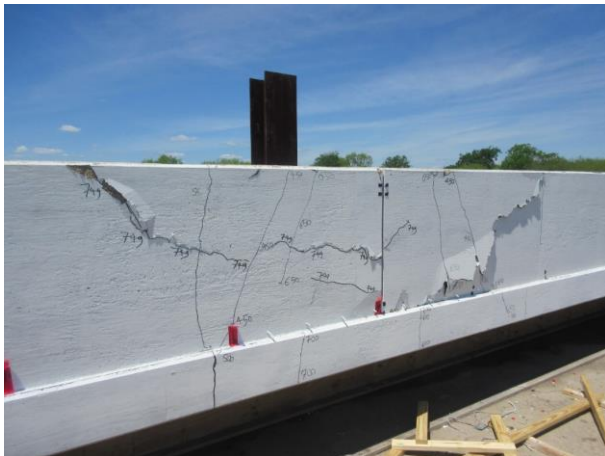
Figure 15: View of the punching shear failure at the back face of the barrier wall after removing the timber frame

appeared outside this region (on the left and right sides of the line load) in the form of diagonal cracks extending to the top surface. However, punching shear crack appeared on the left side of the line load at a load greater than 608 kN and propagated through the barrier thickness and to the other side of the line load at an ultimate load of 702.75 kN. The sudden punching shear failure at the line load location may be attributed to the GFRP bar low stiffness, bond characteristics, elastic response till failure, low strength under compression and shear stresses. Diagonal cracks appeared at the back face of the barrier wall at a load of 608 kN as depicted in Fig. 15.

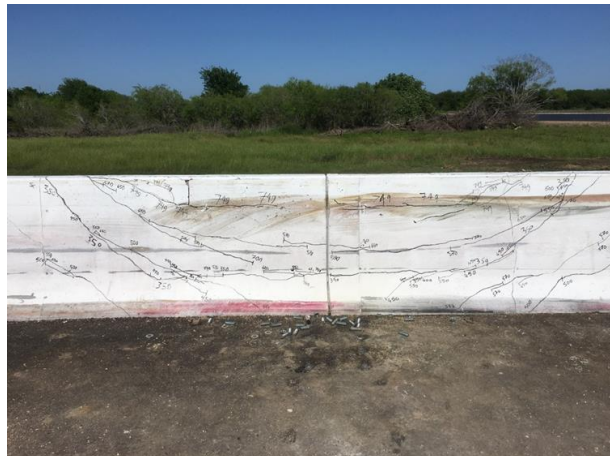
Figure 16: Front view of the flexural crack pattern and punching shear failure of the barrier interior location

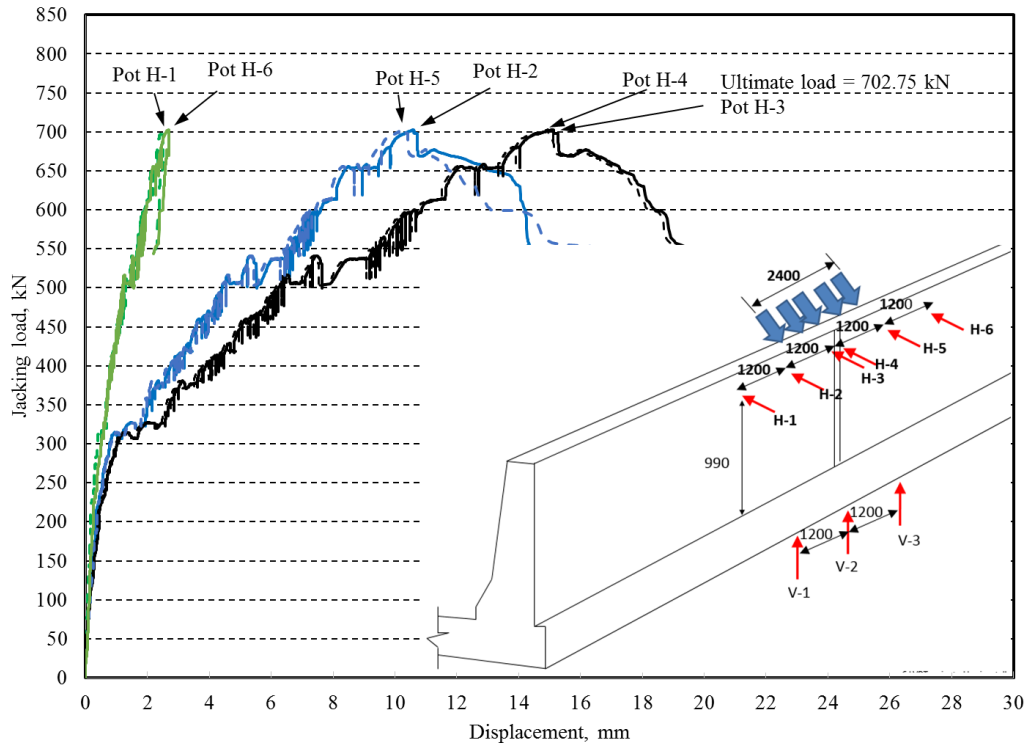
Figure 17: Load-horizontal deflection relationship of the barrier wall at interior location

Figures 17 and 18 depict the load-deflection history of the barrier wall and deck slab, respectively. It can be observed that barrier wall has a maximum lateral deflection of 15.12 mm. Also, it can be observed that the maximum deflection of the deck cantilever at failure was 1.54 mm which is very small indicating the deck slab cantilever was insignificantly affected by the maximum load reached experimentally. Failure of barrier at the interior location due to punching shear of the wall at 702.75 kN transverse loading compared to 357-kN CHBDC factored design transverse loading. This leads to a factor of safety in design as 1.97. With the inclusion of 0.75 durability factor for GFRP bars specified in CHBDC Chapter 16, the safety factor becomes 1.48. As such, the proposed barrier details shown in Fig. 2 are considered adequate to resist equivalent vehicle impact loading at interior locations.

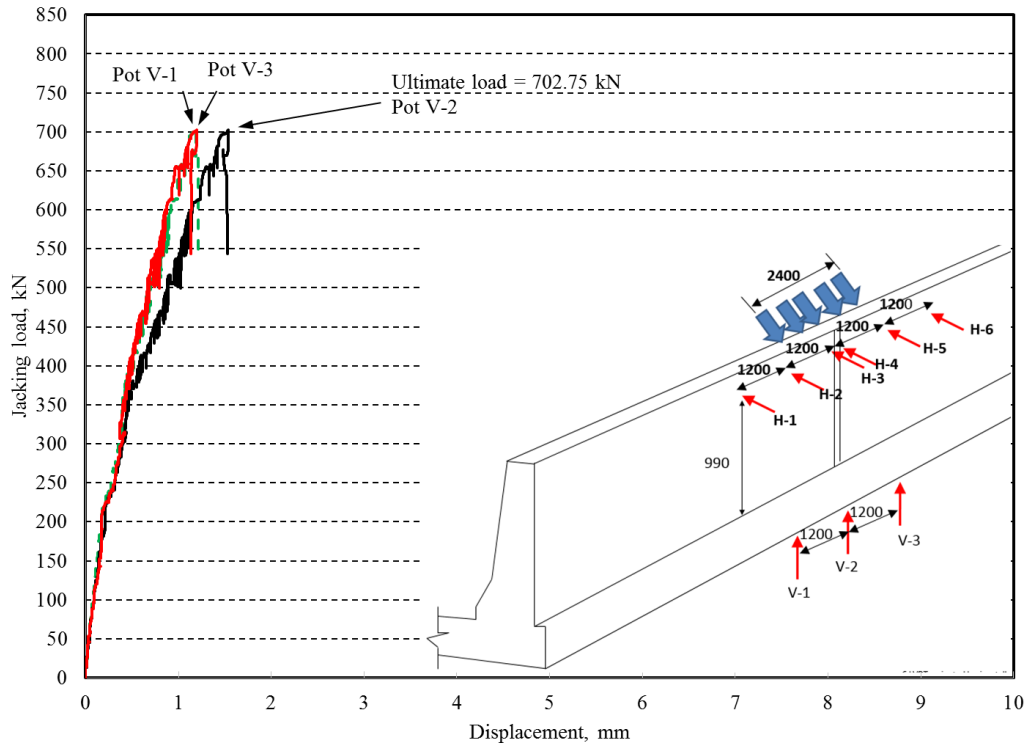
Figure 18: Load-vertical deflection relationship of the barrier wall at interior location

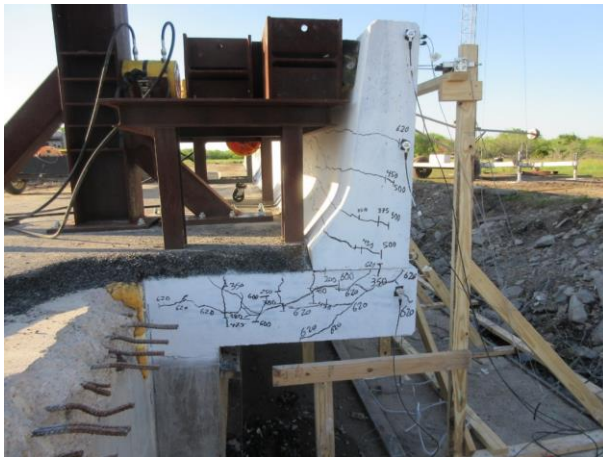
Figure 19: View of the crack pattern at the side of the barrier wall and slab cantilever at failure

In the static test at exterior location, Figs. 19 through 22 show views of the crack pattern after removing the testing frame and the timber frame supporting sensors. It was observed that with increase in applied load, horizontal crack appeared at the front side of the barrier wall-deck slab junction at a load of 321 kN as depicted from deflection readings. Other horizontal flexural cracks appeared at the intersection of the two tapered parts of the front side of the barrier wall at a load of 327 kN. These cracks appeared within the 2400 mm length of the line load, extending diagonally outside the loading region and reaching the top surface of the barrier wall at the same load level. These cracks showed that the barrier wall behaved as a cantilever wall within the 2400 mm length of the line load, while the two-way slab action appeared outside this region in the form of diagonal cracks extending to the top surface. However, punching shear crack appeared on the left side of the line load at a load greater than 580 kN and propagated through the barrier thickness and to the other side of the line load at an ultimate load of 589.77 kN. The sudden punching shear failure at the line load location may be attributed to the GFRP bar low stiffness, bond characteristics, elastic response till failure, low strength under compression and shear stresses. Diagonal cracks appeared at the back face of the barrier wall at a load of 580 kN as shown in Fig. 21. Also, extensive horizontal flexural cracks appeared within the loaded length of the front face of the barrier wall at loads between 327 and 468 kN, extending diagonally outside the loaded area towards the top surface of the barrier wall at higher loads as depicted in Fig. 20. Figure 19 shows extensive cracks in the deck slab cantilever under the barrier. Flexural cracks in the deck slab between the barrier and the concrete foundation appeared at jacking load between 234 and 327 kN. However, diagonal tension crack appeared in the deck slab cantilever just under the barrier wall at 580-kN jacking load.

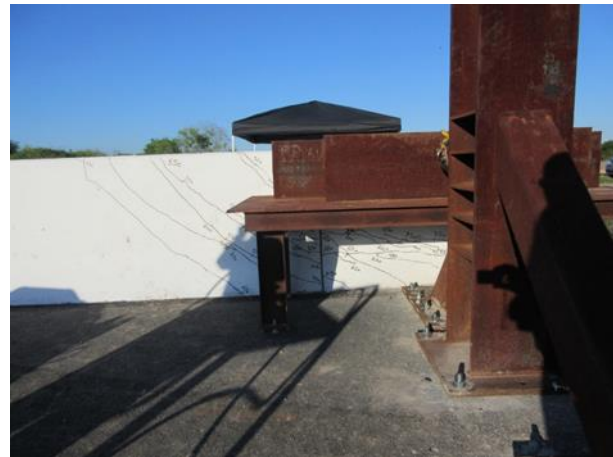
Figure 20: View of the horizontal flexural cracks within the loaded length, extending diagonally beyond the loaded length

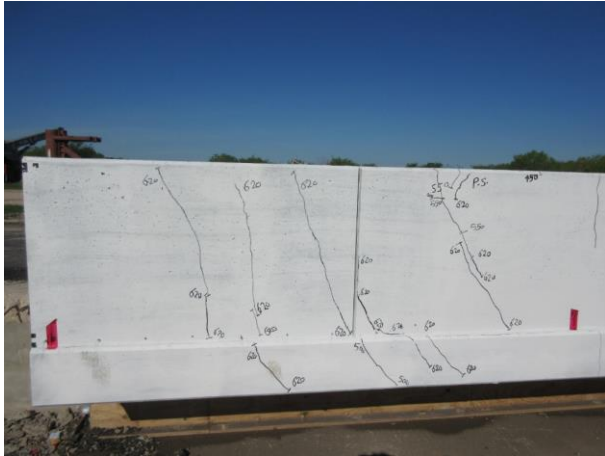
Figure 21: View of diagonal cracks at the back face of the barrier wall

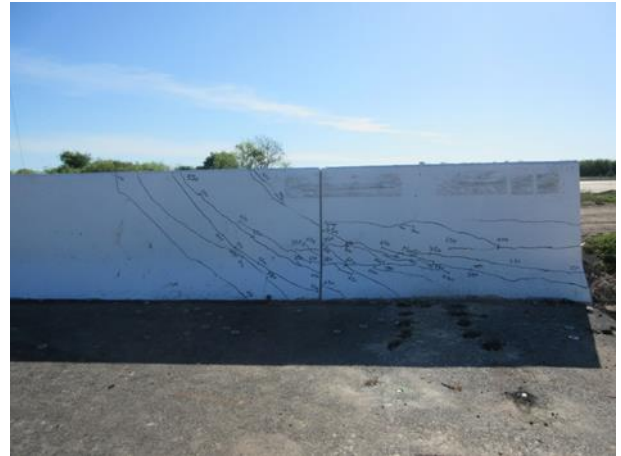
Figure 22: View of the crack pattern at the front face of the barrier wall at exterior location

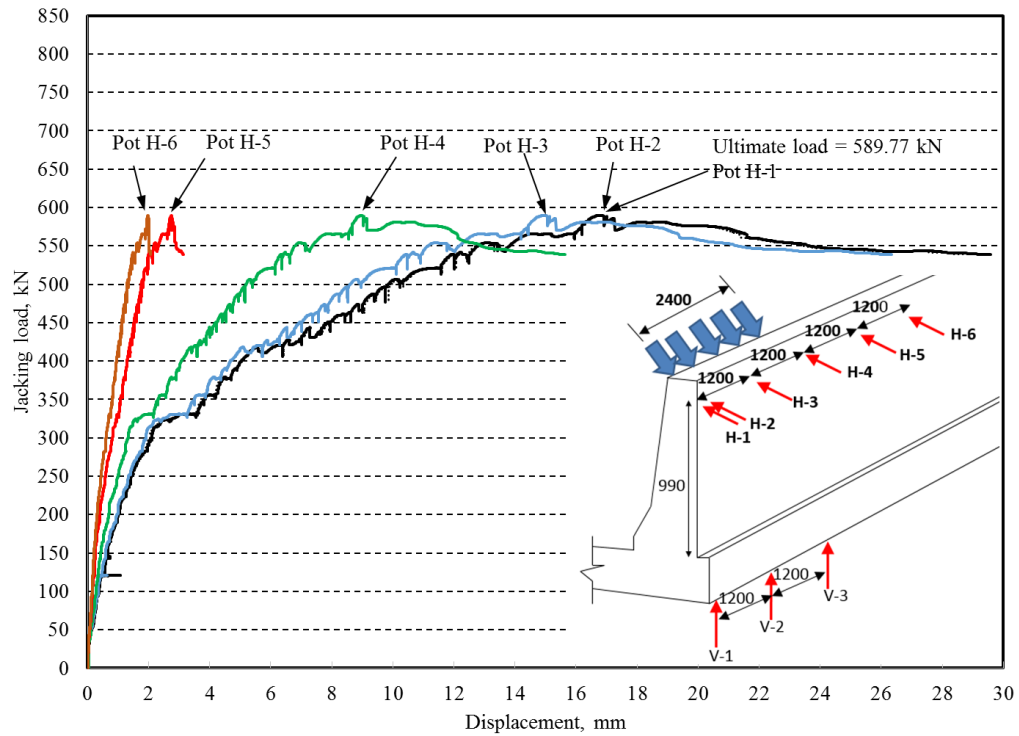
Figure 23: Load-horizontal deflection relationship of the barrier wall at exterior location

Figures 23 and 24 depict the load-deflection history of the barrier wall and deck slab, respectively. It can be observed that barrier wall has a maximum lateral deflection of 16.79 mm. Also, it can be observed that the maximum deflection of the deck cantilever at failure was 6.57 mm. Failure of barrier at the interior location due to punching shear of the wall at 589.77-kN transverse loading compared to 357-kN CHBDC factored design transverse loading. This leads to a factor of safety in design as 1.65. With the inclusion of 0.75 durability factor for GFRP bars specified in CHBDC Chapter 16, the safety factor becomes 1.24. As such, the proposed barrier details shown in Fig. 2 are considered adequate to resist equivalent vehicle impact loading at exterior locations.

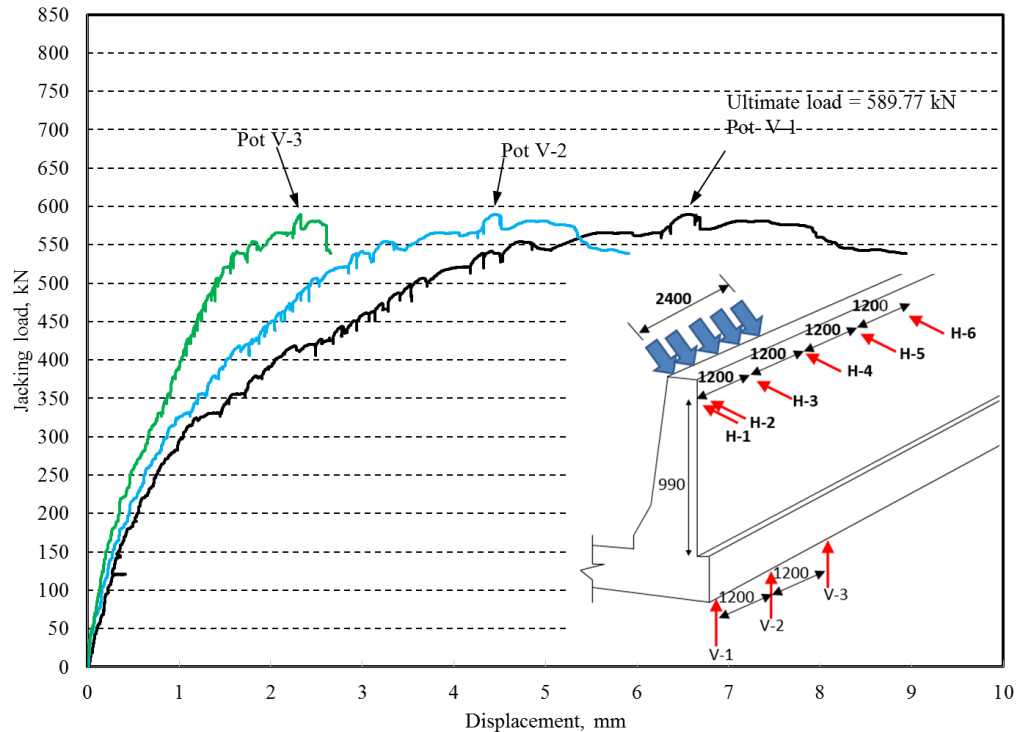
Figure 24: Load-vertical deflection relationship of the barrier wall at exterior location
