## **ANCHORAGE CAPACITY OF TL-5 CONCRETE BRIDGE BARRIER-DECK JUNCTION REINFORCED WITH GFRP BARS AND NEWLY-DEVELOPED 180° HOOKS**

**Abstract:** The paper presents Glass Fibre Reinforced Polymer (GFRP) bars as an alternative solution to the conventional steel reinforcement in TL-5 concrete bridge barriers due to their corrosion resistance, long-term durability properties and exceptional high tensile strength. To qualify the GFRP-reinforced barrier-deck slab system for use in bridges, the barrier should be designed for vehicle impact to (i) determine the amount of vertical and horizontal reinforcement in the barrier wall and (ii) to determine the bar anchorage details at the barrier-deck slab junction. GFRP bar detailing incorporated the recently-developed high-modulus bars with 180° hook. The goal of this research was to exam the structural qualification of the GFRP bars with 180° hooks for anchorage at the barrier/ deck slab junction. The experimental program consisted of 5 full scale barrier walls with two anchorage profiles to ensure that the resistance of the anchorage at the barrier-deck junction is greater than or equal the factored design load specified in the Canadian Highwa

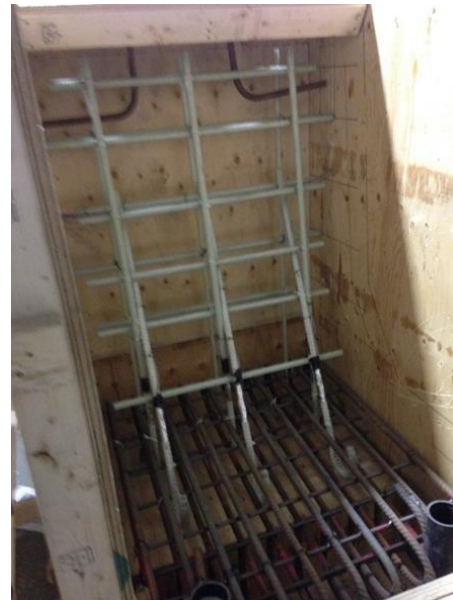
Figure 6: View of internal reinforcement in tested barrier specimen B-2

mm spacing while the vertical reinforcement at the back face of the barrier was kept as M13 at 300 mm spacing. Figure 6 shows a photo of the arrangement of GFRP bars in specimen B-2 before casting concrete.

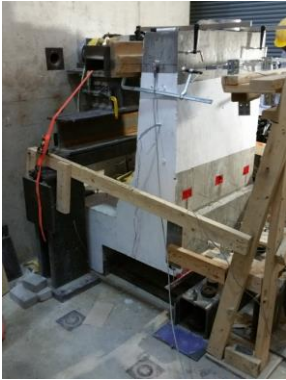
Figure 7: Test setup for specimen B-1

The characteristic compressive strength of concrete was 50.73 MPa. Figure 9 shows view of the test setup for specimen B-1. Each barrier specimen was supported over the structures laboratory floor, then, tied down to the floor using 50-mm diameter steel threaded rods. Each rod was placed @ 600 mm c-c and tightened by applying a specified torque to control the slab uplift during testing. A hydraulic jack was used to apply horizontal load to the barrier wall. Each specimen was tested under increasing monotonic load up-to-collapse. During the test, jacking load was applied in increments. At each load increment, the load was maintained for a few minutes to observe crack initiation and propagation as well as change in barrier

Figure 7 shows the test setup of specimens B-1 before testing. While Fig. 8 shows view of the crack pattern of the tested barrier specimen. In this specimen, the first visible flexural crack was observed at the intersection of the tapered portions of the front side of the barrier wall as well as at the barrier-deck junction and at the deck slab fixed end at 40 kN jacking load. These flexural cracks penetrated further at a higher load, along with other flexural cracks in the deck slab. Although flexural cracks appeared in the barrier wall and the deck slab portion, a sudden diagonal tension crack appeared in the deck slab at a jacking load of 120 kN on the right and left sides of the barrier. These cracks propagated further till the barrier could not take a jacking load beyond 150.5 kN. Given the width of the barrier of 900 mm and the height of the applied load over the top surface of the deck slab of 990 mm, the experimental resisting moment is calculated as 165.56 kN.m/m. This experimental resisting moment at the barrier deck junction is greater than the CHBDC design value of 83 kN.m/m at the barrier-deck slab junction per Table 1 in this report. This leads to a factor of safety of 1.99 in the design of the proposed barrier at interior location as listed in Table 1. Figure 9 depicts the applied load-displacement relationship for specimen B-1. It can be observed that the average deck slab uplift and the horizontal movement at failure were generally equal to 1.95 and 9.71 mm, respectively. These values are considered acceptable and do not significantly affect the structural response of the barrier wall. It can be observed that the maximum lateral deflection of the barrier wall at failure is 46.78 mm, while the barrier vertical deflection is 18.54 mm. Figure 10 depicts the tensile strains in the diagonal GFRP bars at front face of the barrier. Strain gauges were located at 35 mm above the top surface of the deck cantilever as shown in the schematic diagram inserted in the figure. It can be observed that the average strain in the hooked GFRP bars and the adjacent middle GFRP bars at failure were 3892 and 2114  $\mu\epsilon$  while the ultimate strain of the GFRP bars per the manufacturer's certification sheet is 26,600  $\mu\epsilon$ .

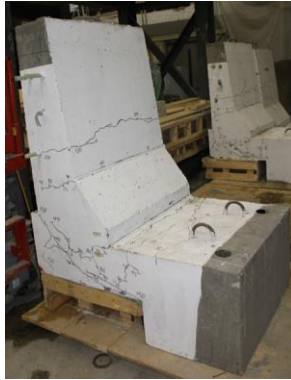
Figure 8: Crack pattern on the left side of B-1

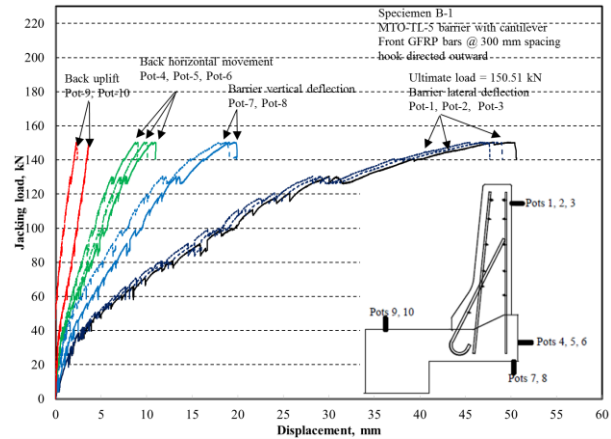
Figure 9: Load-displacement curves for B-1

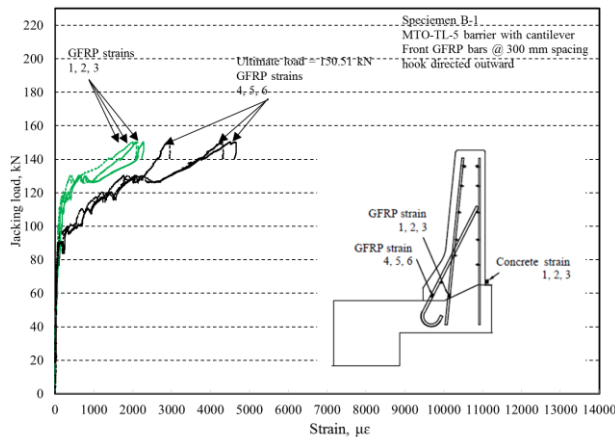
Figure 10: Load-GFRP bar strain curves for B-1

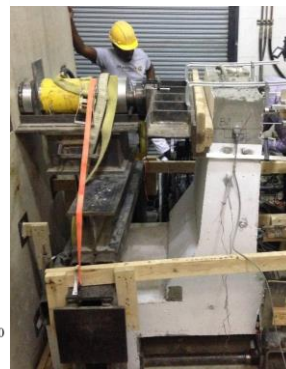
Figure 11: Test setup B-2

Specimen B-2 is identical to B-1 except that the hook of the diagonal bar at the lower tapered portion at the front face of the barrier wall was oriented to towards the roadway over the deck. Figure 11 shows view of the barrier setup before testing while Fig. 12 shows view of the crack pattern of the tested barrier specimen. In this specimen, the first visible flexural crack was observed in the front side of the barrier wall at barrier-deck junction at 40 kN jacking load. Also, flexural crack appeared at the intersection of the tapered portion of the front side of the barrier wall at a jacking load of 50 kN. Flexural cracks were observed in the deck slab at higher loading. These flexural crack penetrated further into the concrete thickness at a higher load.

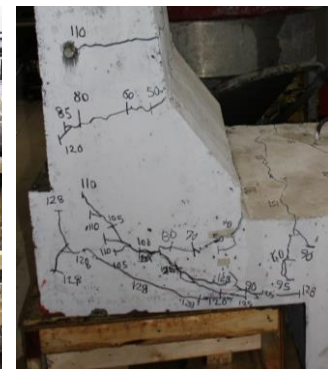
Figure 12: Crack pattern in the left side of B-2

However, a sudden diagonal tension crack appeared in the deck slab under the barrier wall at a load of 120 kN. The recorded data in the data acquisition system showed that the barrier could not carry a jacking load beyond 129.92 kN. Given the width of the barrier of 900 mm and the height of the applied load over the top surface of the deck slab of 990 mm, the experimental resisting moment is calculated as 142.91 kN.m/m. This experimental resisting moment at the barrier deck junction is greater than the CHBDC design value of 83 kN.m/m at the barrier-deck slab junction per Table 1 in this report. This leads to a factor of safety of 1.72 in the design of the proposed barrier at interior location as listed in Table 1. One may conclude that orienting the 180° hook towards the outer face of the barrier rather than the traffic direction increased the barrier-deck anchorage capacity by 16%. Figure 13 depicts load-displacement relationship for B-2. It can be observed that the average slab uplift and the horizontal movement at failure were 2.89 and 9.76 mm, respectively. It can be observed that the maximum lateral deflection of the barrier wall at failure is 45.51 mm, while the barrier vertical deflection is 16.93 mm.

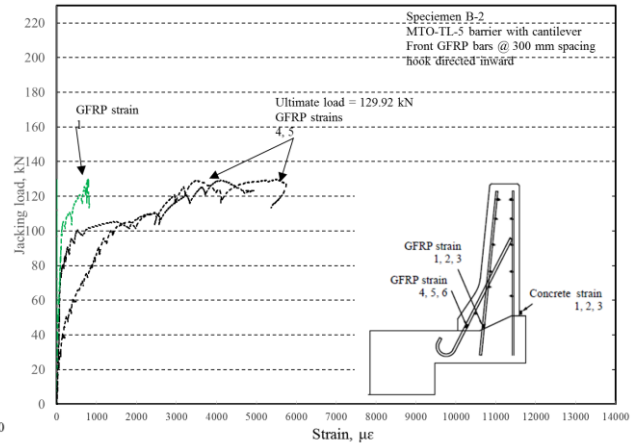
Figure 14: Load-GFRP bar strain curves for B-2

Figure 14 depicts tensile strains in the diagonal GFRP bars at the front face of the barrier. Strain gauges were located at 35 mm above the top surface of the deck cantilever. It can be observed that the average strain in the hooked GFRP bars and the adjacent middle GFRP bars at failure were 4842 and 791 µε while the ultimate strain of the GFRP bars per the manufacturer's certification sheet is 26,600 µε. The low GFRP

and concrete strain values are attributed to the fact that the failure of the barrier-deck junction is due to diagonal tension in the deck slab cantilever just under the barrier wall.

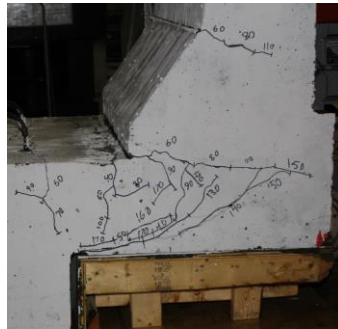
Figure 16: Crack on right side of B-3

Specimen B-3 is identical to B-2 except that the vertical bars at the front face of the barrier wall are doubled to represent the exterior location of the barrier wall. Figures 15 and 16 show different views of the crack pattern of the tested specimen. In this specimen, the first visible flexural crack was observed in the front side of the barrier wall at barrier-deck junction at 40 kN jacking load and at the intersection of the tapered portions at 50 kN jacking load. Flexural cracks were observed in the deck slab at jacking load of 50 kN with other flexural cracks appeared at higher loads. These flexural crack penetrated further into the concrete thickness at a higher load. However, a sudden diagonal tension crack appeared in the deck slab under the barrier wall at a load of 140 kN. The recorded data in the data acquisition system showed that the barrier could not carry a jacking load beyond 170.33 kN. Given the width of the barrier of 900 mm and the height of the applied load over the top surface of the deck slab of 990 mm, the experimental resisting moment is calculated as 187.36 kN.m/m. This experimental resisting moment at the barrier deck junction is greater than the CHBDC design value of 102 kN.m/m at the barrier-deck slab junction per Table 1 in this report. This leads to a factor of safety of 1.84 in the design of the proposed barrier at exterior location as listed in Table 1. Figure 17 depicts the applied load-displacement relationship for specimen B-3. It can be observed that the average deck slab uplift and the horizontal movement at failure were 3.66 and 8.98 mm, respectively. These values are considered acceptable and do not significantly affect the structural response

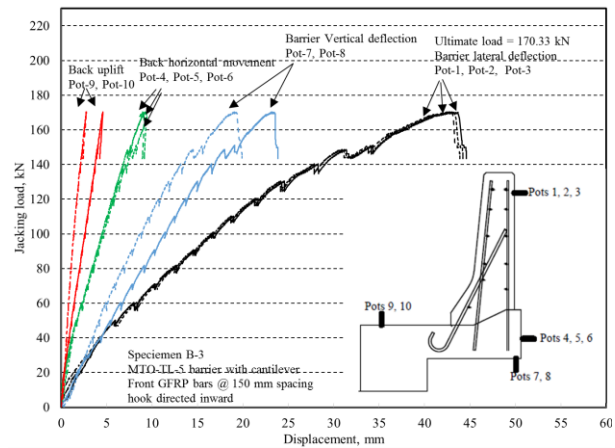
Figure 17: Load-displacement curves for B-3

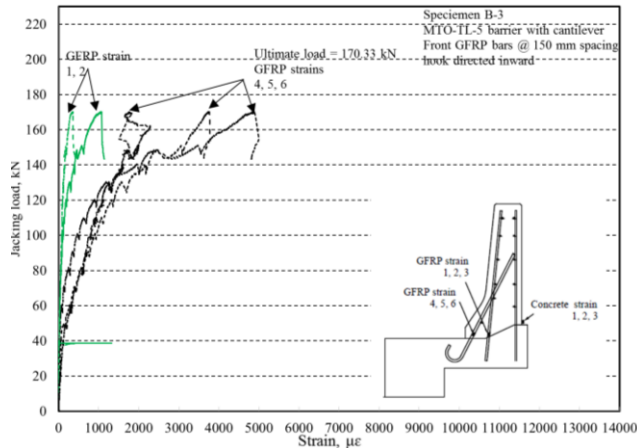
Figure 18: Load-GFRP bar strain curves for B-3

of the barrier wall. It can be observed that the maximum lateral deflection of the barrier wall at failure is 42.5 mm, while the barrier vertical deflection is 21.04 mm. Figure 18 depicts the tensile strains in the diagonal GFRP bars at the front face of the barrier. The strain gauges were located at 35 mm above the top surface of the deck cantilever as shown in the schematic diagram inserted in the figure. It can be observed that the average strain in the hooked GFRP bars and the adjacent middle GFRP bars at failure were 3445 and 686  $\mu\epsilon$  while the ultimate strain of the GFRP bars per the manufacturer's certification sheet is 26,600  $\mu\epsilon$ .

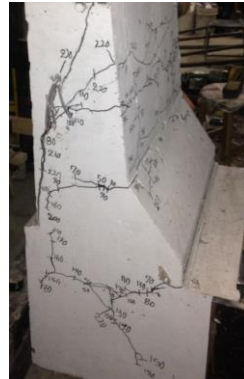
Figure 19: Cracks on left side of B-4

Specimen B-4 represents a barrier wall connected to non-deformable concrete slab. The amount of vertical reinforcement at the front face represents the case of interior segment of the barrier wall. Figure 19 shows view of the crack pattern after failure. The first flexural crack appeared in the front side of the barrier wall at barrier-deck junction at 30 kN jacking load. Other flexural crack appeared at the intersection of the tapered portions of the front side of the barrier wall at a jacking load of 50 kN. Other extensive flexural cracks appeared in the tapered portion of the barrier at higher loads. Although flexural cracks at the barrier-deck junction penetrated further into the barrier thickness at a higher load giving the signed of flexural failure, sudden concrete shear failure appeared in the top tapered portion of the barrier wall, starting from the applied load location, at a jacking load of 220.54 kN in each side of the barrier wall. Given the width of the barrier of 900 mm and the height of the applied load over the top surface of the deck slab of 990 mm, the experimental resisting moment is calculated as 242.59 kN.m/m. This experimental resisting moment at the barrier deck junction is greater than the CHBDC design value of 83 kN.m/m at the barrier-deck slab junction

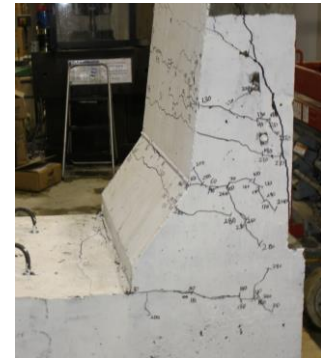
Figure 20: Cracks on right side of B-5

Specimen B-5 represents a barrier wall connected to non-deformable concrete slab. The amount of vertical reinforcement at the front face represents the case of exterior segment of the barrier wall. Figure 20 shows different views of the crack pattern of the tested barrier specimen. The first flexural crack appeared in the front side of the barrier wall at barrier-deck junction at 30 kN jacking load. Other flexural crack appeared at the intersection of the tapered portions of the front side of the barrier wall at a jacking load of 60 kN. Other extensive flexural cracks appeared in the tapered portion of the barrier at higher loads. Although flexural cracks at the barrier-deck junction penetrated further into the barrier thickness at a higher load giving the sign of flexural failure, sudden concrete shear failure appeared in the top tapered portion of the barrier wall, starting from the applied load location, at a jacking load of 328.79 kN in each side of the barrier. Given the width of the barrier of 900 mm and the height of the applied load over the top surface of the deck slab of 990 mm, the experimental resisting moment is calculated as 361.67 kN.m/m. This experimental resisting moment at the barrier-deck junction is greater than the CHBDC design value of 83 kN.m/m. This leads to a factor of safety of 3.55 in the design of the proposed barrier at interior location when it is rigidly connected to non-deformable concrete deck slab. Figure 22 depicts the applied load-displacement relationship for specimen B-5. It can be observed that both the average deck slab uplift and the horizontal movement at failure were 1.97 and 6.46 mm, respectively. These values are considered acceptable and do not significantly affect the structural response of the barrier. It can be observed that the maximum lateral deflection of the barrier is 22.5 mm which is considered small given the presence of non-deformable slab.

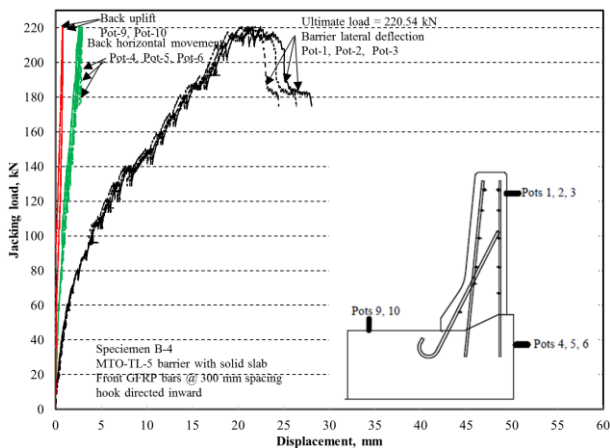
Figure 21: Load-displacement curves for B-4

per Table 1 in this report. This leads to a factor of safety of 2.92 in the design of the proposed barrier at interior location when it is rigidly connected to non-deformable concrete deck slab as listed in Table 1. Figure 21 depicts the applied load-displacement relationship for specimen B-4. It can be observed that both the average deck slab uplift and the horizontal movement at failure were 0.80 and 2.78 mm, respectively. These values are considered acceptable and do not significantly affect the structural response of the barrier wall. It can be observed that the maximum lateral deflection of the barrier wall at failure is 21.84 mm which is considered small given the presence of non-deformable deck slab.

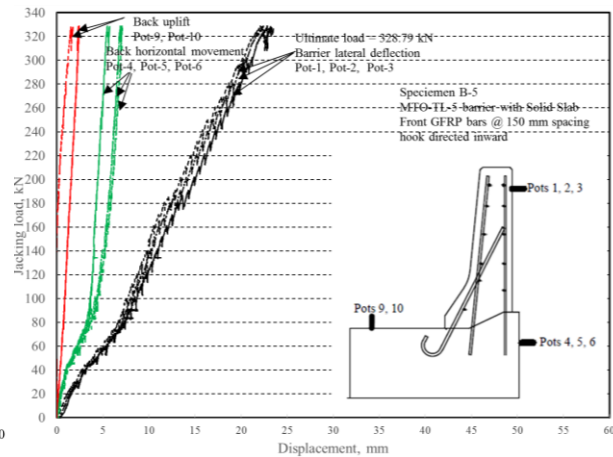
Figure 22: Load-displacement curves for B-5

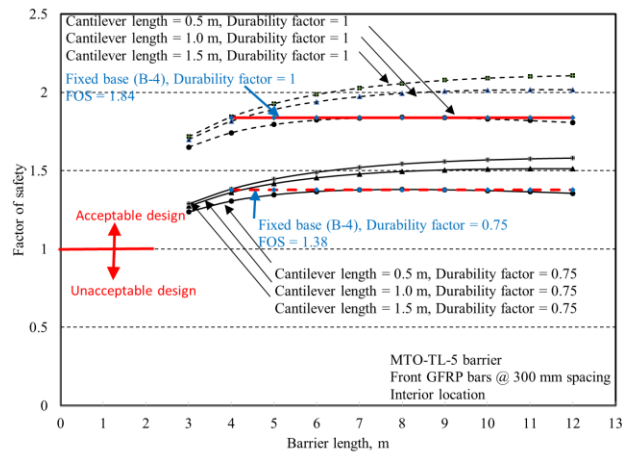
Figure 23: Factors of safety in design at interior location of specimen B-2 with cantilever slab and specimen B-4 for solid slab

Figure 23 presents correlation between experimental findings and FEA results at the TL-5 barrier's interior location for specimen B-2 with cantilever deck slab and specimen B-4 with thick deck slab.. It can be observed that the FOS for the proposed pre-installed barrier over non-deformable base (specimen B-4) is 1.84 compared to 2.92 obtained based on CHBDC-specified factored applied moment shown in Table 1. As such, it can be concluded that the vertical embedment length of 195 mm for the GFRP bars in the deck slab is adequate to maintain the required barrier-deck anchorage capacity. It can be observed that the FOS for the proposed barrier wall installed over deck slab cantilever increases with increase in deck slab cantilever length, for a given barrier length. Also, it can be observed that the FOS increases with increase of barrier length up to about 6 m, beyond which the increase in FOS is insignificant. It should be noted that for barrier lengths equal of greater than 6 m, the FOS ranges from 1.65 to 2.11 with increase in barrier length up to 12 m, compared to a FOS of 1.72 for specimen B-2 shown in Table 1 based on the available CHBDC design factored moment. Given the barrier length should be long enough to promote two-way action of truck impact load distribution, it is recommended to use the proposed GFRP-reinforced barrier resting over deck slab cantilever, shown in Fig. 3 for barrier length greater than or equal 6 m.

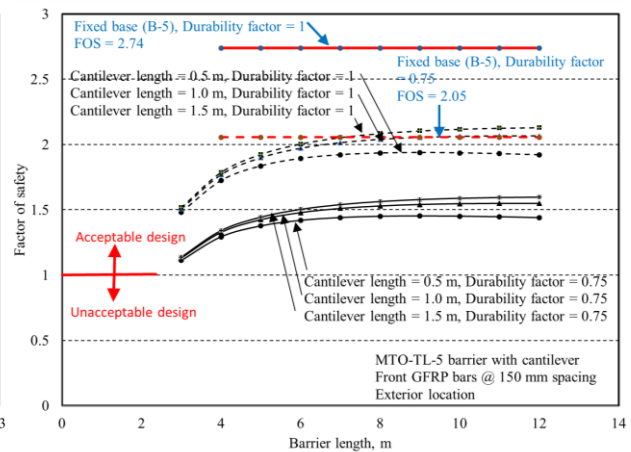
Figure 24: Factors of safety in design at exterior location of specimen B-3 with cantilever slab and specimen B-5 for solid slab

For exterior load location, Figure 24 shows that the FOS for the proposed barrier wall installed over deck slab cantilever increases with increase in deck slab cantilever length, for a given barrier length. Also, it can be observed that the FOS increases with increase of barrier length up to about 6 m, beyond which the increase in FOS is insignificant. It should be noted that for barrier lengths equal of greater than 6 m, the FOS ranges from 1.48 to 2.13 with increase in barrier length up to 12 m, compared to a FOS of 1.84 for specimen B-3 shown in Table 1 based on the available CHBDC design factored moment. Given the barrier length should be long enough to promote two-way action of truck impact load distribution, it is recommended to use the proposed GFRP-reinforced barrier resting over deck slab cantilever for barrier length greater than or equal 6 m. It can be observed that the FOS for the proposed pre-installed barrier over non-deformable base (specimen B-5) is 2.74 compared to 3.55 obtained based on CHBDC-specified factored
