IMPACT LOAD EFFECTS ON CORRODED REINFORCED CONCRETE BEAMS

Abstract: Bridges and road infrastructure in North America and around the world where deicing salts are used is suffering deterioration due to corrosion of steel reinforcement. A lot of research in the past several decades has targeted reduction of corrosion rates or replacement of the corrosion-prone steel in bridge structures with varying level of success. Bridge guardrails are particularly susceptible to steel reinforcement structural steel corrosion and deterioration, however little to no research is dedicated to their behaviour under severe impact loading. The research reported in this paper is from a preliminary program designed to investigate the effect of impact loading on corroded reinforced concrete elements. Small-scale reinforced concrete beams were subjected to accelerated current-impressed corrosion in the laboratory and then tested under impact loading in a drop-mass test frame. Two different degrees of corrosion were investigated: 2.67% and 5.11%. A control beam with no corrosion was also tested for comparison. The impact test results show that, in general, there is not a marked effect of the degree of corro

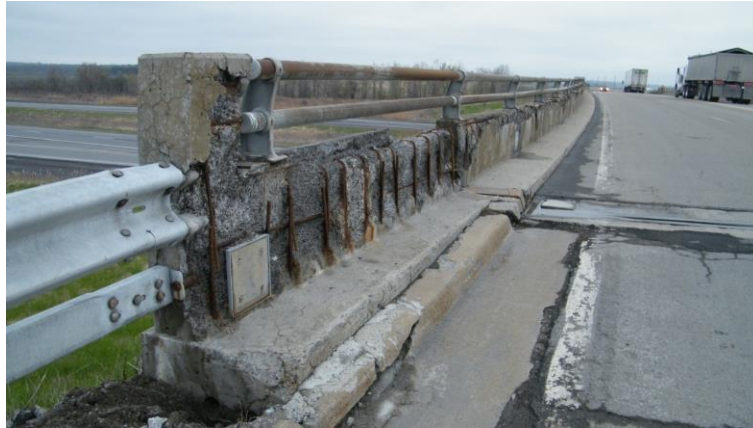
Figure 1: Corrosion of steel reinforcement in bridge guardrails

Guardrails are designed to resist impact loads from vehicles on bridges and parking garages. Corrosion of steel in structural steel and reinforced concrete guardrails such as shown in Figure 1 could compromise their strength. There are lots of research works done on uncorroded reinforced concrete structures subjected to impulse load. However, as discussed previously, little research exists in the literature on corroded reinforced concrete structures subjected to impact load. During dynamic events, a large amount of energy is imparted to the structure over a very short time. If the structure fails to absorb this energy, a sudden and catastrophic failure may occur (14). In order to prevent the failure of guardrails, the behaviour of corroded reinforced concrete structures under impact loading must be investigated and understood.

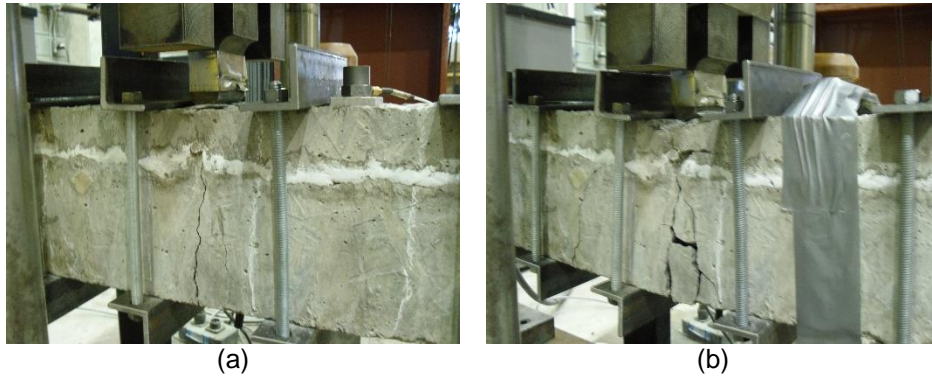
Figure 5 presents the post-test photographs of Beam 1 showing flexural cracking after each drop test. One primary crack is observed from the bottom of the beam at mid-span with the root of the crack in the upper third of the beam (Figure 5(a)). After the 200-mm drop test, the cracks in the bottom coalesced and increased in width and propagated to the load point (Figure 5(b)).

Figure 5: Post-test photos of Beam 1 (Control): (a) post 175-mm (b) post 200-mm drop

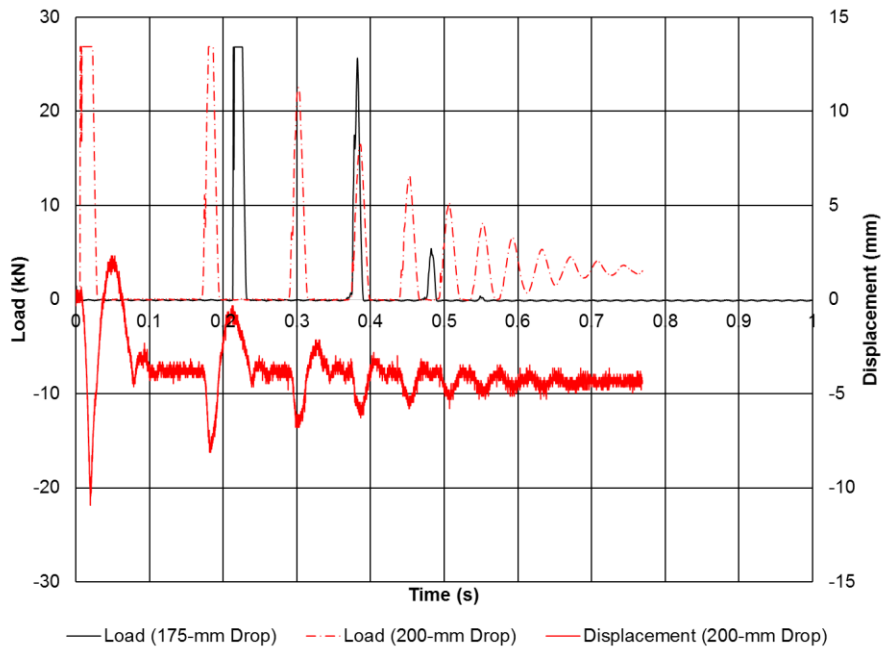
Figure 6 presents the load-time plot for Beam 2 (DOC 2.67%). It can be observed that, once again, the peak impact load was cut-off at 26.9 kN. Also, due to equipment malfunction no displacement data was recorded for the 175-mm drop test. The maximum mid-span displacement for the 200-mm drop test was 10.9 mm.

Figure 6: Load and mid-span displacement vs time graph of Beam 2 (DOC 2.67%)

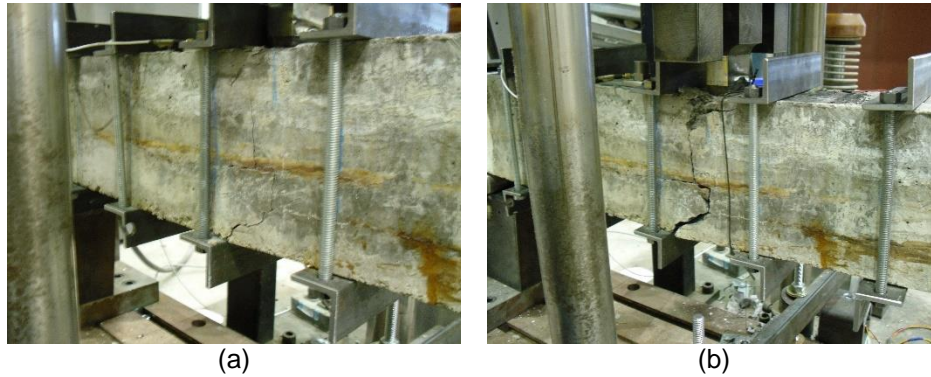
From the post-test photographs presented in Figure 7, however, the level of damage from the 200-mm drop test is observed to be substantially more than for the 175-mm drop test. An initial crack at the mid-span after the 175-mm drop test opened up after the 200-mm drop test and propagated to the load point on the top of the beam (Figure 7(b)).

Figure 7: Post-test photos of Beam 2 (DOC 2.67%): (a) post 175-mm (b) post 200-mm
