SUSTAINABLE REHABILITATION AND UPGRADE TO UNDERGROUND TELECOMMUNICATION STRUCTURES

Shamon, Wamid^{1,3} and Kornblum, Dan²

^{1,2} Telecon Design, Canada

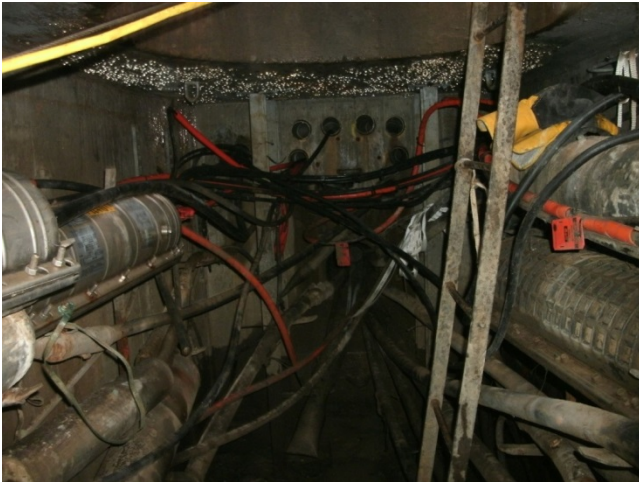
Figure 1: Underground telecom manhole

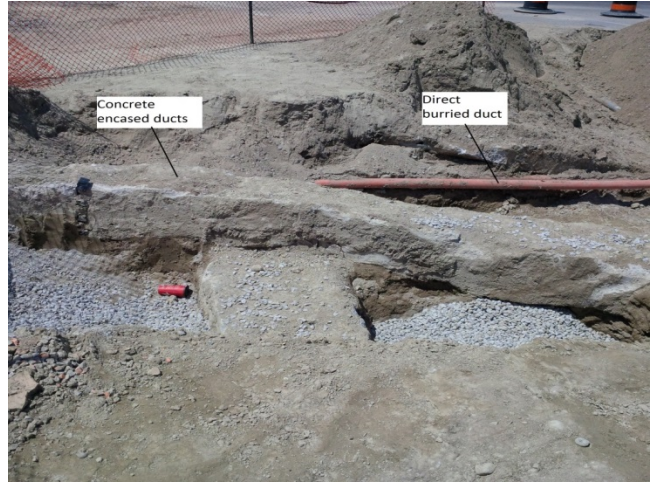
Figure 2: Underground structures

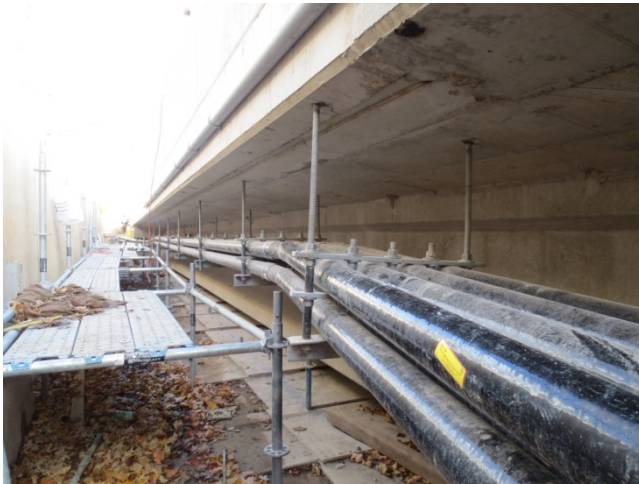
Figure 3: FRE Ducts on hanger system attached to bridge structure

Is the ability to recover the functionality of an infrastructure system, subject to an extreme event of any kind, in a fast and efficient manner. The rehabilitation design for existing UTS should take into account the importance of the resiliency factor. In the face of a changing climate, the increasing frequency and severity of extreme events, it is important to ensure that existing infrastructures including UTS could survive such events. Solutions would include increasing the depth of cover for structures under canals and rivers, or alternatively providing adequate protection, and utilizing FRE ducts for exterior application such as structure attached to a bridge instead of PVC conduits.

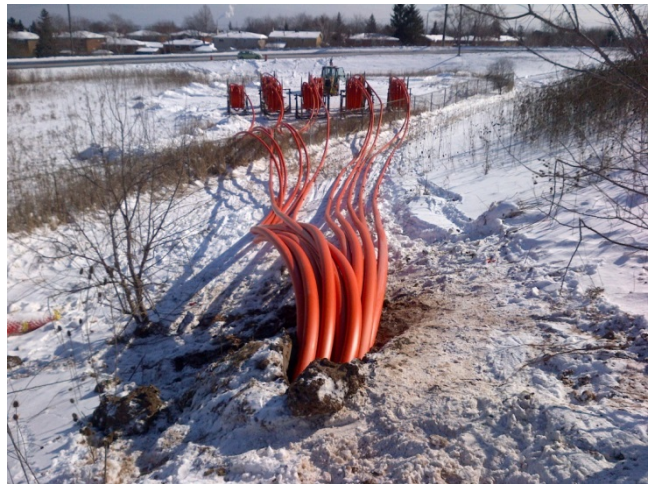
Figure 4: Horizontal Directional Drilling-HDPE ducts

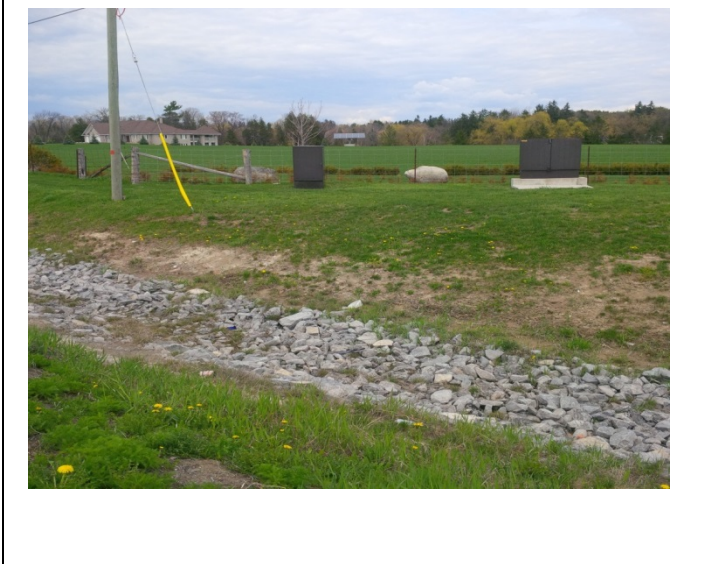
Figure 5: OPI & CPS equipment on concrete foundation

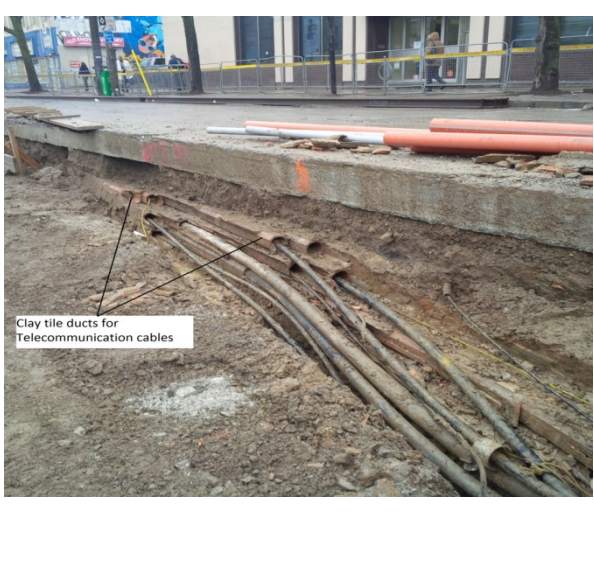
Figure 6: Clay tile ducts structure
