EVALUATION OF A LOW-COST DRONE FOR MONITORING RESTORATION OF WELL PADS

Abstract: Oil and gas development activities disturb the land surface at well pads. These sites must be restored upon decommissioning, and this process takes several years to accomplish. Using drones to assess restoration of well pads can be more efficient and provide better data compared to manual inspection at the ground surface. Fieldwork was conducted in 2017 to evaluate the use of a small, low-cost drone for measuring and assessing reclamation at four well pads on crown land near Hudson's Hope, BC. These sites had an "abandoned" status for one year, were under the same operator, and had not yet received a Certificate of Restoration. This paper presents the results of the investigation and discusses the advantages and limitations of using drones for reclamation assessment purposes.

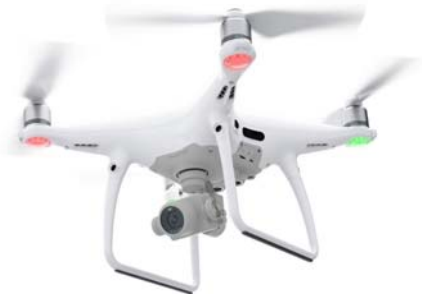
Figure 1: DJI Phantom 4 Pro drone (DJI 2017)

A small, low-cost drone was used to acquire the aerial images. A DJI Phantom 4 Pro drone (Figure 1) was selected because it can be easily carried to the site and rapidly deployed. Furthermore, this drone model carries a relatively good camera with a mechanical shutter. At the time of its purchase in the summer of 2017, this drone cost \$2100 plus taxes. An extra battery and larger capacity microSD card were also purchased for another \$300 plus taxes. The selected drone has a practical flight time limit of 20 minutes. One well pad of a size limited to about 6 ha could be safely flown using a single fully charged drone battery.

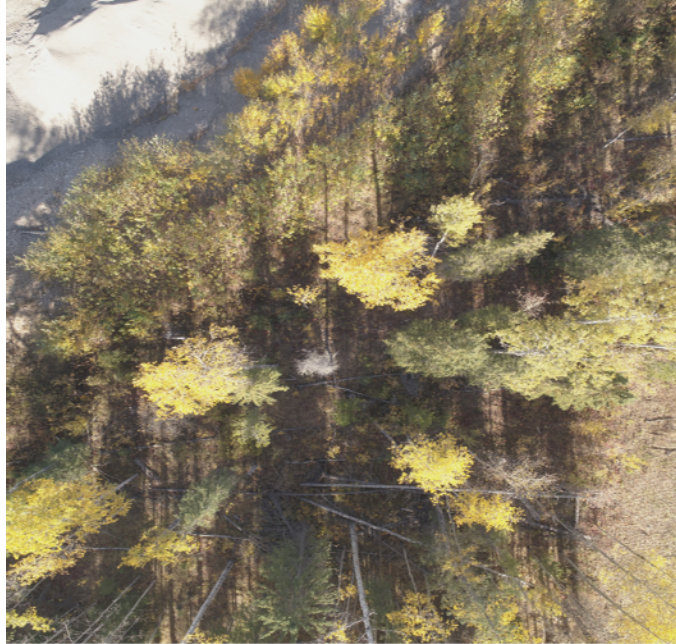
Approximately 40 m northwest of the well pad 2 there is a large gravel quarry. This quarry is not shown in GoogleEarth where a 2012 image was obtained, but it was detected in the aerial images taken while flying the drone over the well pad. The northwest edge of the well pad and the southeast edge of the gravel quarry are both captured in the aerial image shown in Figure 3. Some fallen trees can also be seen.

Figure 3: Aerial photograph showing edge of a gravel quarry 40 m northwest of well pad 2

Because of the trees between the well pad and the gravel quarry, this quarry is not easily seen at the ground level, and it is not shown in GoogleEarth. The quarry does not seem to affect the drainage of the well pad area. However, it is worth noting the close proximity of the quarry to the well pad. The presence of the open quarry might have contributed to blow-down of trees on the northwest side of the well pad.

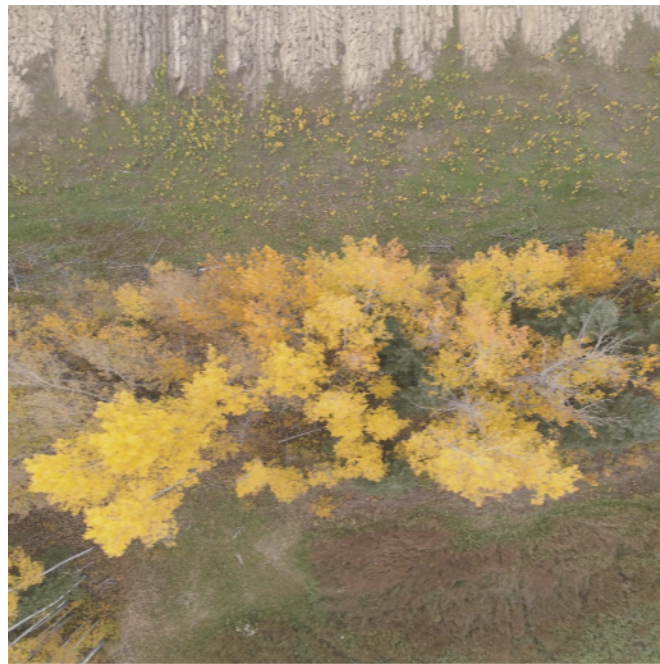
Adjacent land use activities can be seen in aerial images taken by the drone over well pad 4. Approximately 25 m north of the well pad, the land is being used for farming as shown in Figure 4. The well pad is separated from the farming field by a strip of trees.

Figure 4: Strip of trees and agricultural land north of well pad 4 captured by the drone

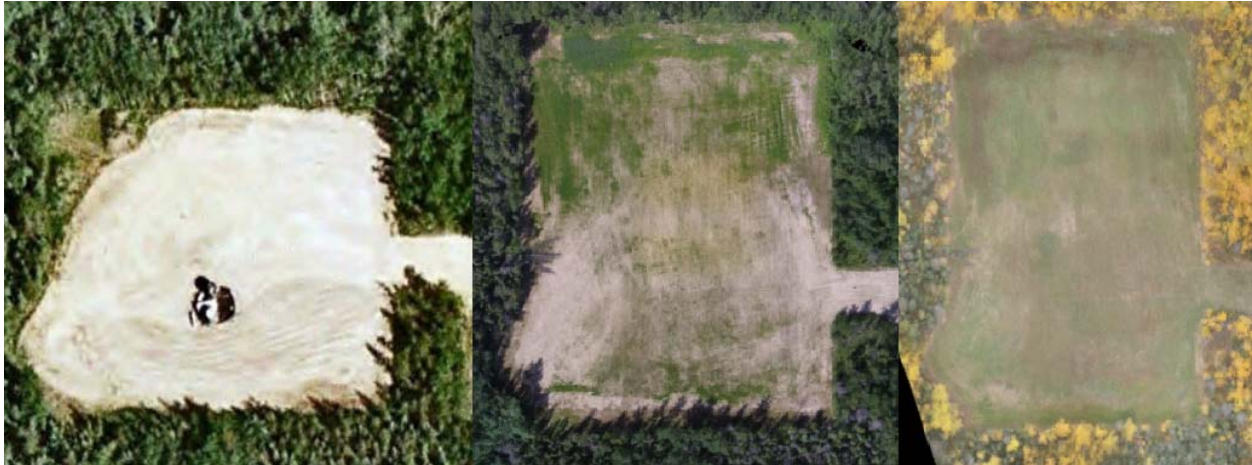
Well pad 4 had an approximate surface area of 1.8 hectares in July 2017. The area of this well pad was significantly smaller in 2012 as seen in a comparison between images taken 2012 (Google Earth) and 2017 as shown in Figure 5. This well pad was expanded, likely because additional wells were drilled from the same pad.

The contrast in vegetation coverage on this well pad was significant over a two-month period. The aerial images from July and September in Figure 5 show that large areas that were sparsely vegetated in mid-summer had become better vegetated by the fall. Note that 2017 was the first summer after the well pad had been seeded.

Figure 5: Restoration progress of well pad 4: 2012 (Google Earth), July 2017, and September 2017

For the four well pads flown in both July and September of 2017, the contrast in vegetation coverage over this two-month period is significant. In September, the well pads had fewer bare areas and more uniform vegetation as emphasized in the orthophotographs. Photographs taken at ground level can supplement the aerial images regarding what specific plant species are present. Knowing the composition of the seed mixtures planted on these well pads for reclamation purposes would be useful in determining whether the intended plant community is growing and if undesirable plant species are present.

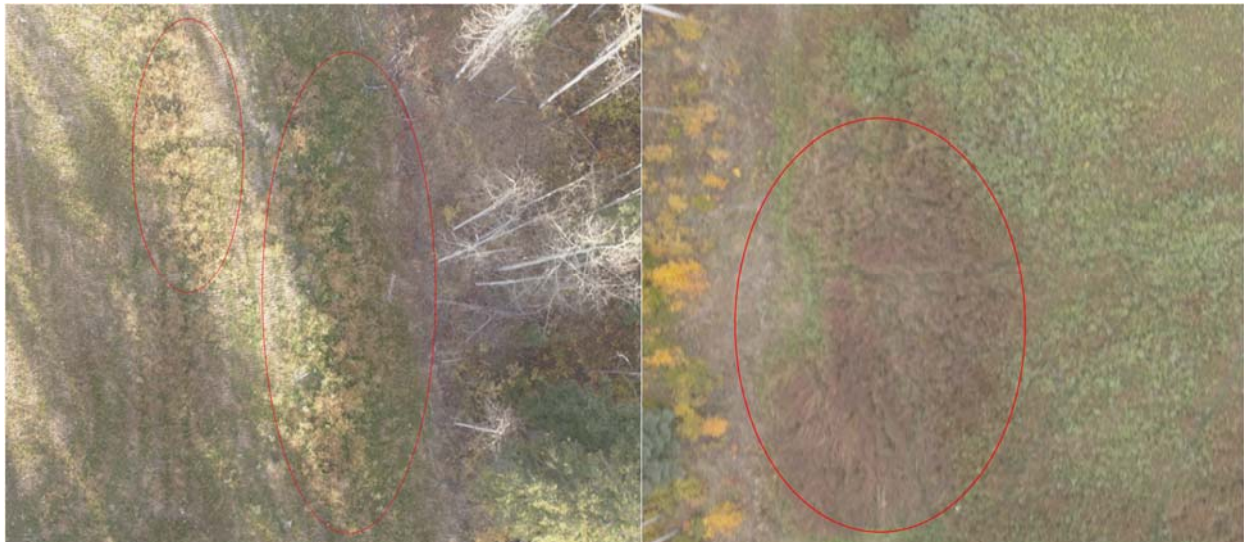
While plant species growing on well pads are difficult to discern from aerial images taken by a drone, it is easy to spot areas where vegetation density or height differs. Some vegetation differences in aerial images taken over well pads 3 and 4 are shown in Figure 6. The aerial images taken by the drone over some of the well pads clearly showed evidence of fallen trees and woody debris.

Figure 6: Vegetation differences shown in aerial images over well pads 3 (left) and 4 (right)

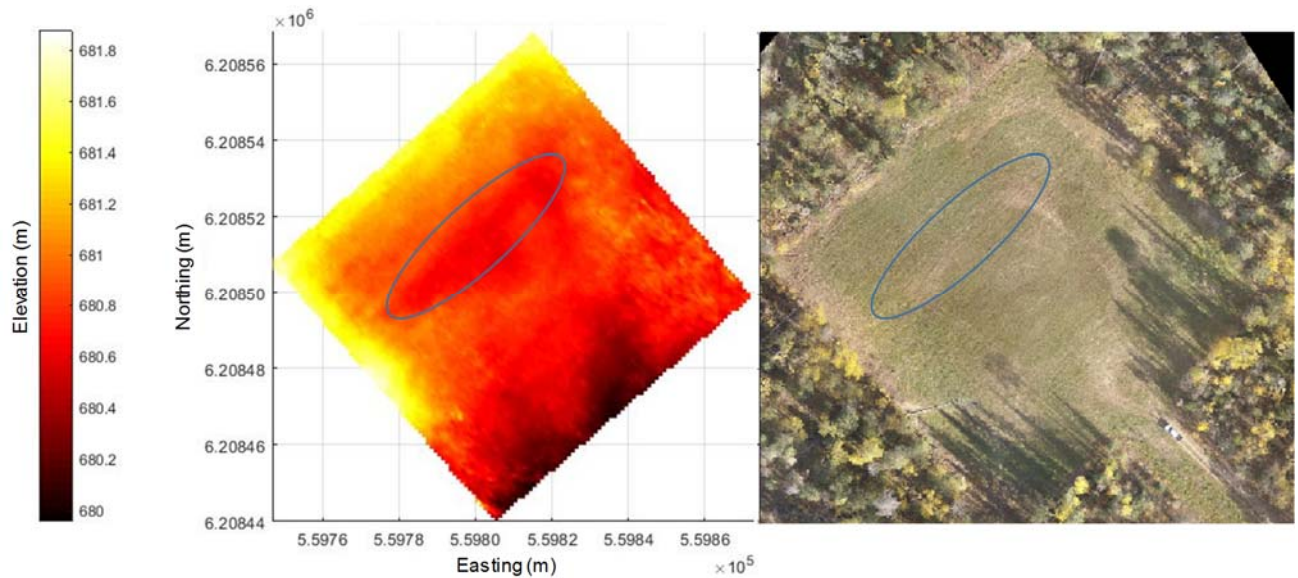
The 2D digital surface model generated using point cloud data from well pad 2 shows that water could pond in a slight depression near the centre of the well pad. The area of potential ponding corresponds to an area with slightly impeded vegetation growth as seen in Figure 7. Lack of drainage from the low area may be affecting the vegetation since there is no apparent link to heavily compacted soil or any other cause. A similar trend can be found in the southwest corner of well pad 4, as shown in Figure 8.

Figure 7: Slight depression and impeded vegetation growth near the centre of well pad 2

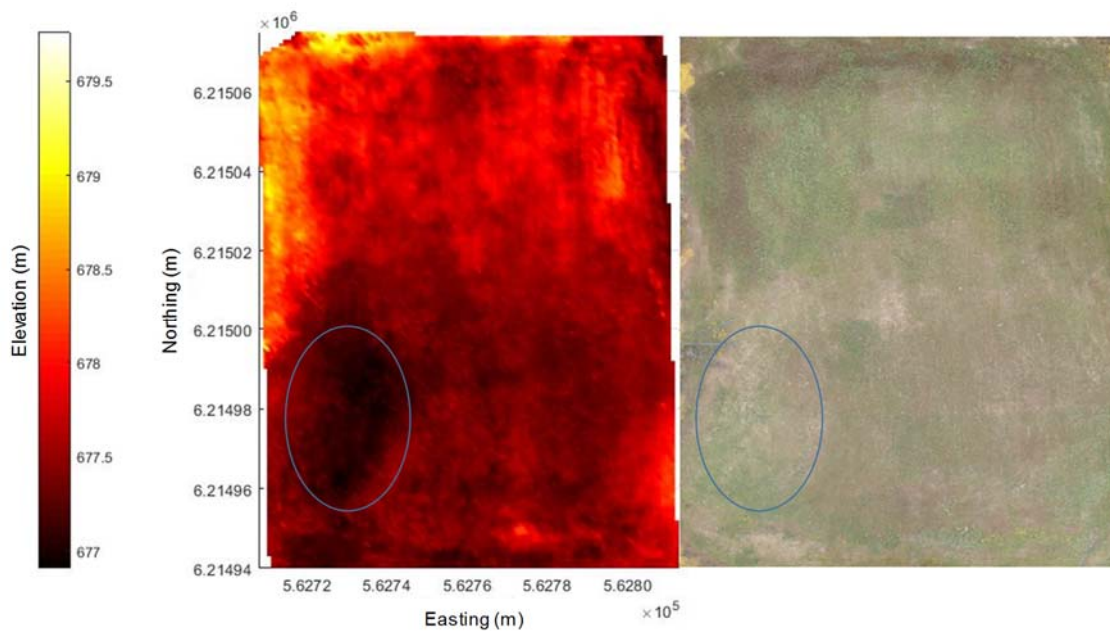
Figure 8: Potential ponding may impede growth on well pad 4

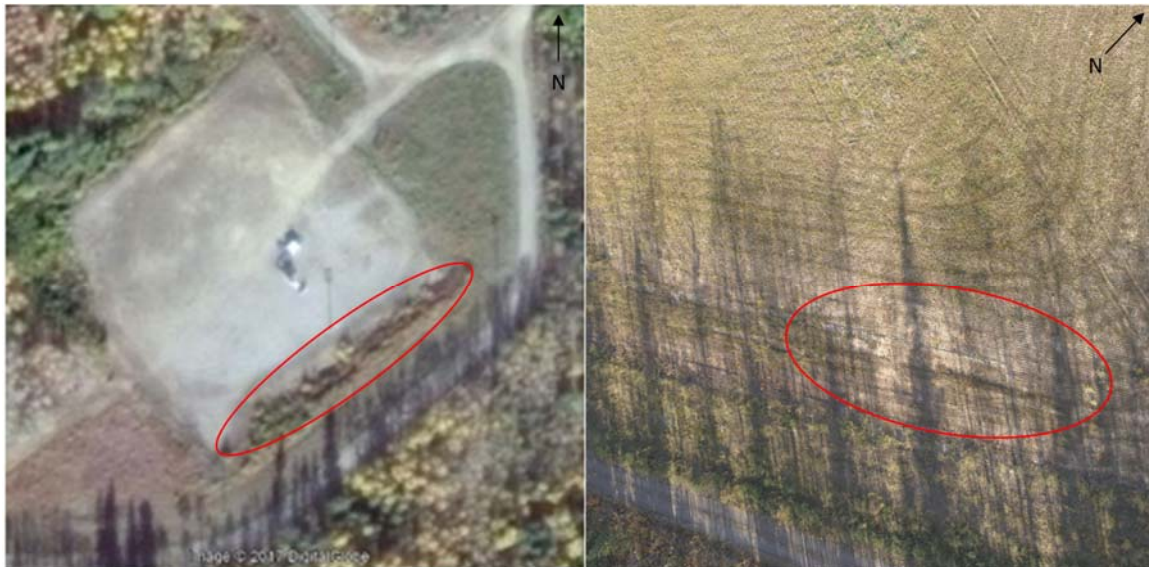
Compaction of the soil beneath a salvaged soil stockpile that once sat on well pad 4 may be a possible explanation for the reduced vegetation along the southeast side of the well pad as seen in Figure 9. The soil pile is no longer present as it was likely redistributed across the well pad as required.

Figure 9: Reduced vegetation density where salvaged soil pile was located on well pad 1

There does not seem to be a direct correlation between where various equipment or the wells were located on the well pad and vegetation growth. However, vegetation growth does appear to be affected where salvaged soil was piled on the well pad. It can be inferred that the salvaged soil was redistributed over the well pads as soil piles are no longer present. However, the soil compacted from being beneath the piles of salvaged soil may not have been fully de-compacted, and soil compaction does impede vegetation growth.

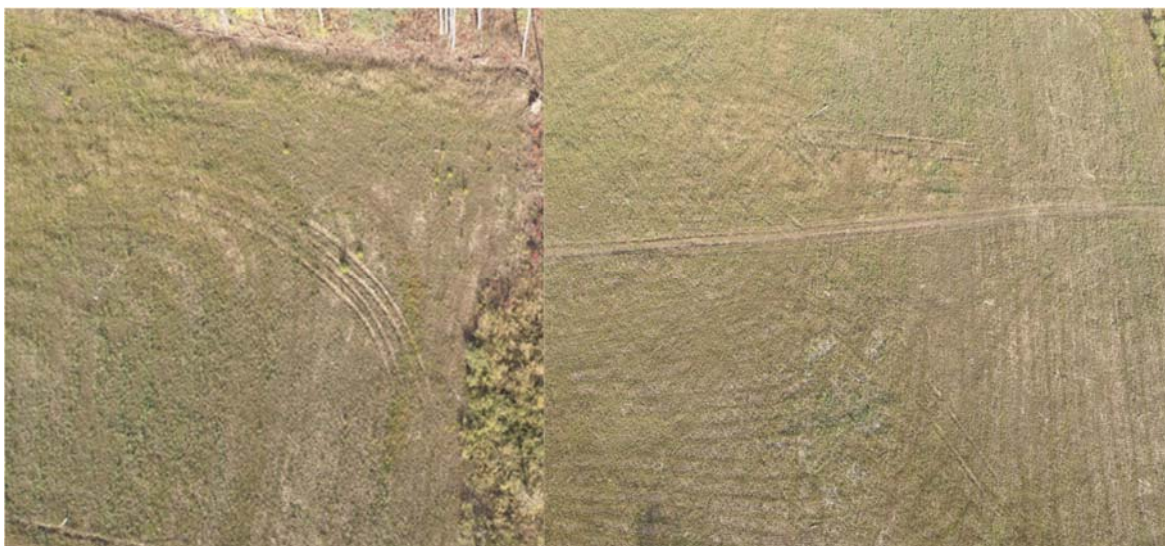
Tire tracks were noted where vehicles have driven over the well pads after the ground surface had been prepared and seeded. There is noticeably less dense vegetation growth in these tire tracks. Soil compaction under the vehicle tires and direct damage to the vegetation is likely reducing the vegetation growth in these tracks. This is shown over well pad 1 in Figure 10. The well pads have nothing around them to restrict vehicle entry, and the access road had not been decommissioned.

Figure 10: Reduced vegetation on soil compacted by vehicle traffic on well pad 1
