EXPERIMENTAL DETERMINATION OF PULL- OUT STRENGTH OF THREADED STEEL RODS MECHANICALLY FASTENED INTO GLULAM BEAM SECTIONS

Hubbard, Cory¹, and Salem, Osama^{2,3}

Abstract: Threaded steel rods have been increasingly used as concealed connecting components in glued-laminated timber (glulam) frame connections. Embedding the rods in glulam beam ends has primarily been done with the use of adhesives. Connections for timber structures using concealed bonded-in steel rods offer a practical solution in the development of more efficient joining methods. However, the influence of adhesive type, specifically its properties and strength, are not yet fully understood and as such well-developed design criteria are lacking. For the research presented in this paper, instead of using adhesively-bonded rods, mechanically-fastened threaded steel rods were employed. The beam connection parameters investigated were rod embedment length and washer bearing area. A tensile force was applied to the steel rod, and linearly increased until the embedded connection failed. The strong steel rod in the connection resulted in the wood section failing every time, so a relationship between the embedment length and w

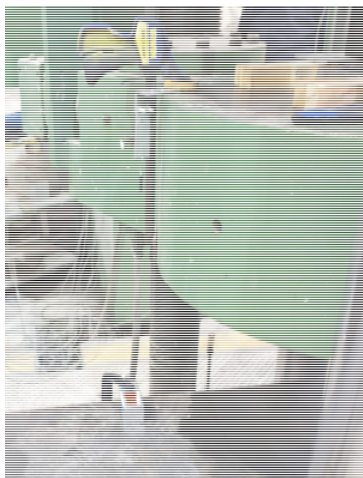
(a) Draw-wire displacement transducer

One draw-wire displacement transducer was attached to the cylinder head block and the stationary block to measure the displacement of the entire system; including the slippage in both sets of jaws, as shown in Figure 3a. Two LVDTs were attached at the top end of the beam section, as shown in Figure 3b. One was attached to a metal pole next to the small plate to measure the displacement between the pole and the small plate, while the other was attached to the side of the glulam section to measure the displacement between the beam section and the cylinder head block. Both were measuring the displacement between the beam section and the cylinder head block; therefore, their results should be the same. The two LVDTs measured the displacements of the beam section and the potential slippage of the top jaws. Once the displacement measuring instruments were in place and zeroed, the initially applied load was recorded, then the test assembly was loaded at a rate of about 8.0 kN per minute. The test was terminated when the glulam beam section achieved rod pull-out failure. A full test setup of a general assembly is shown in Figure 3c.

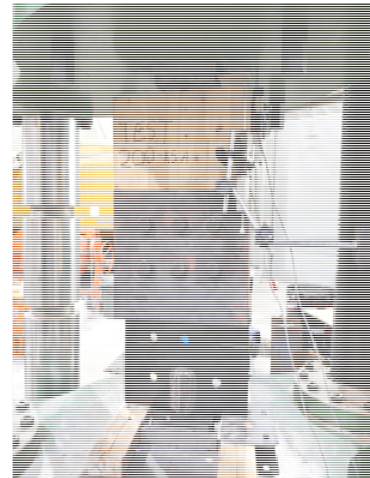
(c) Test setup of a general assembly

Figure 3: Full test setup of a general test assembly

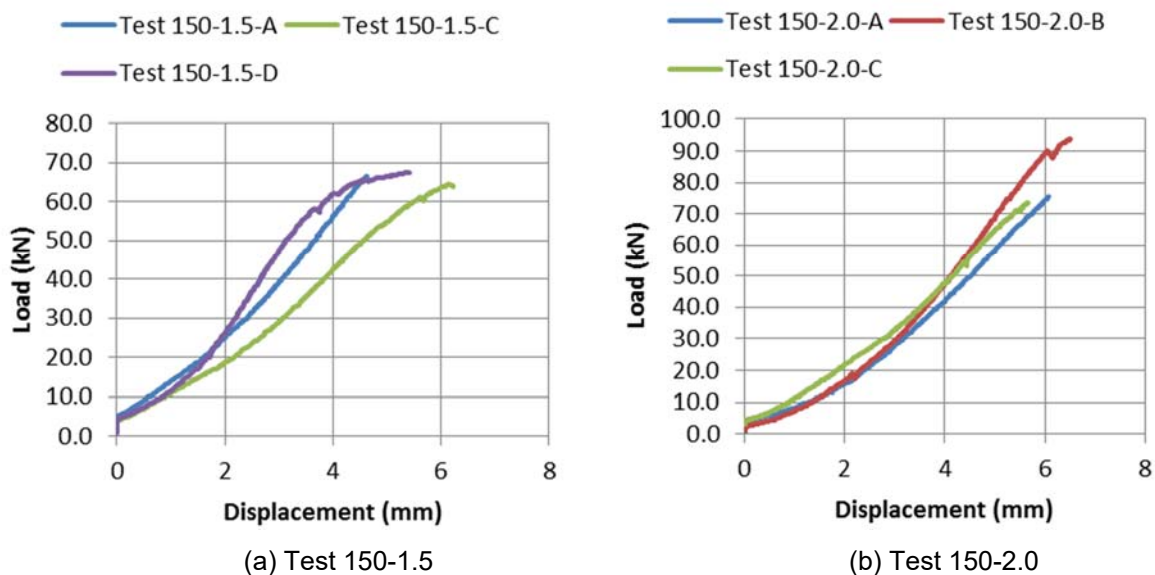
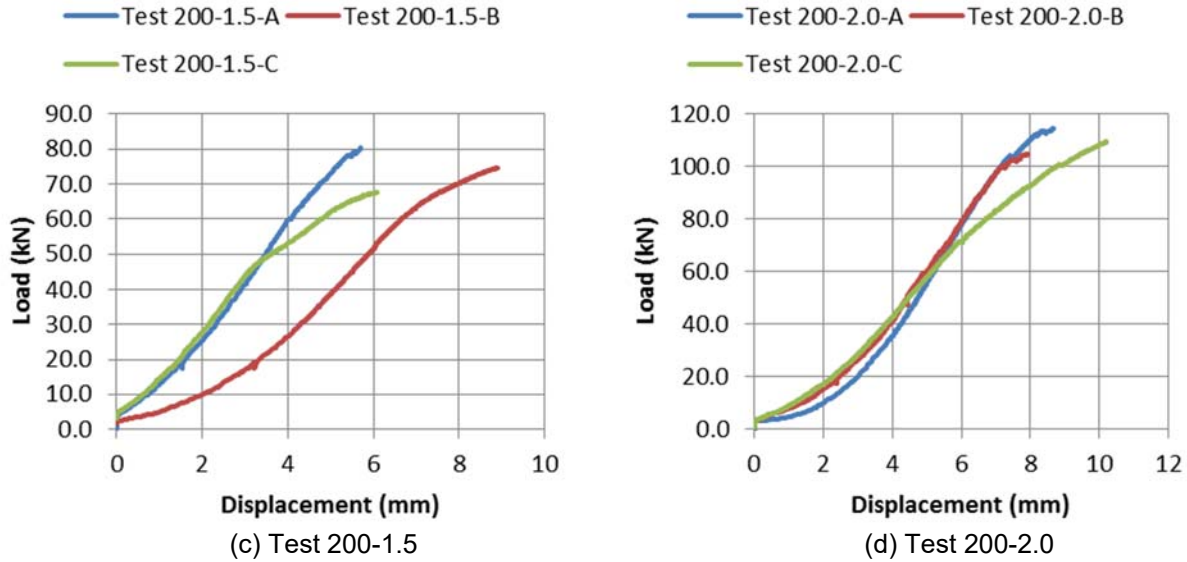
Figure 4: Load versus displacement curves for the four tested configurations

Figures 4a through 4d show the load versus displacement curves for all test configurations. The displacements used in the development of these curves were the measurements of the LDVT attached to the metal pole. The displacement measurements of the LVDT attached to the glulam section were very similar to the measurements of the other LVDT, except for the end when the glulam failed under rod pull-out. The sudden jerk of the rod pull-out would slightly turn the installed LVDT and give a greater displacement value than what the actual value should be. The curves in Figures 4(a) through (d) were cut off at a point when a noticeable drop happened in the load, or a large displacement happened with minimal load gained. In some tests, the load would achieve a higher value afterwards; however, this was not allowed for safety reasons.

In Figures 4b and 4d, the curves are nearly identical as they are on top of one another. The consistency in these two figures is mostly because these test assemblies had larger bearing areas from the 50.8 mm (2 inches) washer to spread out the effects of imperfections, such as knots, in the wood. In Figures 4a and 4c, some parts of the curves are nearly identical in the beginning, but then certain curves experienced larger displacements at similar loads. The inconsistencies in these curves is most probably because these test assemblies had smaller bearing areas from the 38.1 mm (1.5 inches) washer to not spread out the effects of imperfections in the wood, unlike the configurations with larger washers. For Test 150-1.5 connection configuration, the three experiments used were A, C, and D, while test 150-1.5-B used the offcut beam section measuring 350 mm split down the middle, when tested, giving a much lower result compared to other similar tests. Therefore, this test was deemed unsatisfactory and given a null result.

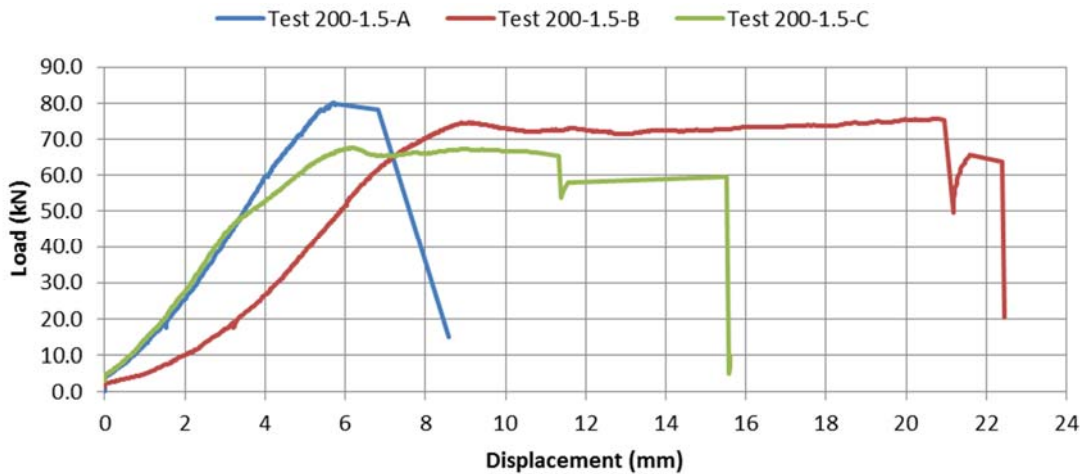
Figure 5: Test 200-1.5 load versus displacement (full curve)

Test 200-1.5 connection configuration had a different shape at the end of the curves as shown in Figure 5. While the other test configurations achieved rod pull-out failure almost immediately after their maximum load values were obtained, Test 200-1.5 connection configuration had the wood under the washer crushed before achieving rod pull-out failure. The wood crushing failure in this connection configuration was due to the smaller bearing area from the 38.1 mm (1.5 inches) washer, as well as the longer embedment length of 200 mm. In this configuration, the wood under the washer behaved like a short column and crushed before experiencing a large enough load to experience rod pull-out failure.

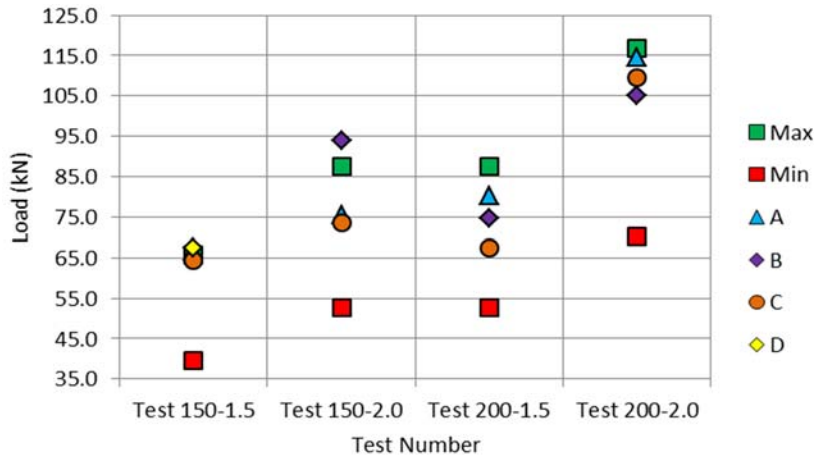
Figure 6: Maximum loads for the four configurations vs. their maximum and minimum predicted values

Shown in Figure 6 are the expected minimum, expected maximum, and the actual maximum loads of the tests for each of the four threaded-rod-in-glulam-beam connection configurations. All test results are either within the expected range or slightly above the expected maximum value; therefore, the range purposed by Equation 1, with and without the resistance factor, is plausible considering the number of test replicates for each connection configuration. The first connection configuration, Test 150-1.5 results have an excellent grouping that was around the maximum expected value of 65.7 kN. The last connection configuration's, Test 200-2.0, results have a good grouping as well that is close to the maximum expected value of 116.8 kN. While, the second and third test configurations' results are closer to the middle of their expected ranges and have their groupings more spread out. The larger spread of these two groupings is due to their

embedment length and bearing area combination that added more stresses on the imperfections in the glulam sections causing them to fail before they can reach their maximum predicted pull-out capacities. Test 150-1.5 connection configuration had both, the smallest bearing area and the shortest embedment length, so the magnitude of force that stressed on the imperfections does not affect the overall strength of the glulam section. While Test 200-2.0 connection configuration had both, the largest bearing area and the longest embedment length, so the force developed until failure was much greater than that developed in Test 150-1.5; however, the stress put on the imperfections was still not as large to affect the strength significantly. Test 150-2.0 connection configuration had load-displacement curves directly on top of one another, but the spread of the maximum load is the largest which contradicts the expected predictability of this connection configuration. While Test 150-1.5 had a wide spread of load-displacement curves, but the closest spread of maximum load suggests that slippage of the top jaws could be affecting these results.

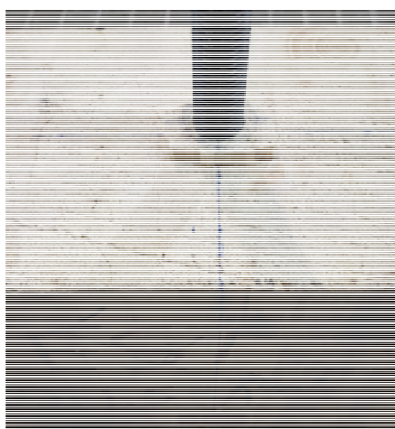
(a) Rod pull-out shearing along the washer edges

The test connection configurations with the 38.1 mm (1.5 inches) washer size experienced two main failure modes, as shown in Figures 7a and 7b. In Figure 7a, the connection failure was due to rod pull-out taking out a wood cross-sectional area that is similar to the size of the washer. In Figure 7b, the failure was similar to that shown in Figure 7a, except that instead of shearing along the fourth side of the washer closest to the small side hole (used to insert the nut) it sheared along the three walls of the small hole that was chiselled out. As shown in Figure 7c, Test 150-2.0 configuration had a similar failure mode as that shown in Figure 7b, except that one or two 45-degree cracks also formed at the end of the beam section, at approximately where the washer corners were.

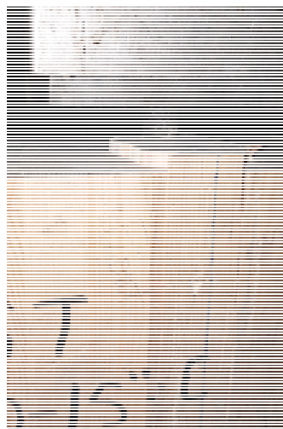
(b) Rod pull-out shearing along carved out hole edge

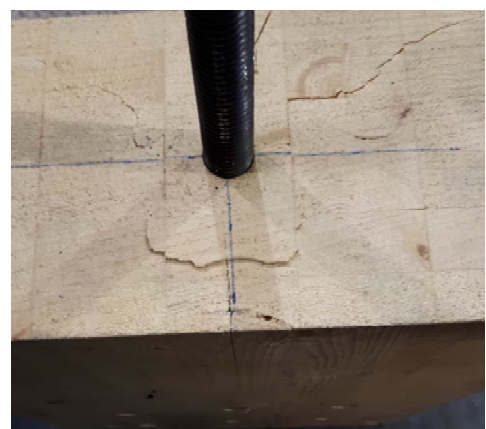
(c) Rod pull-out shearing along carved out hole edges with 45 degree cracks

As shown in Figure 8a, Test 200-2.0 configuration had a more explosive failure, where a rod pull-out failure occurred like that shown in Figure 7b, as well as the 45-degree cracks formed similar to that shown in Figure 7c. In addition, the beam section in Test 200-2.0 had a clear split down the middle on the back side of the small hole, which did not form until the end, during around the last 5 kN before rod pull-out failure. The test configuration in this instance was much stronger than all other configurations, and caused the washer to yield slightly, as shown in Figure 8b. Since most of the yielding occurred at the corners of the washer; therefore, it can be assumed that more stresses happened at the corners to cause the 45-degree cracks to form at the end of the beam section.

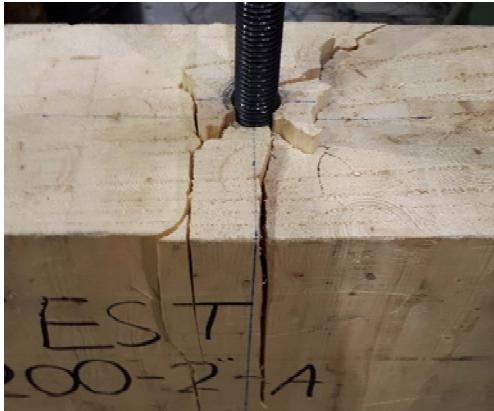
(a) Rod pull-out shearing along carved out hole with 45-degree cracks and beam splitting

Figure 8: Failure mode of Test 200-2.0

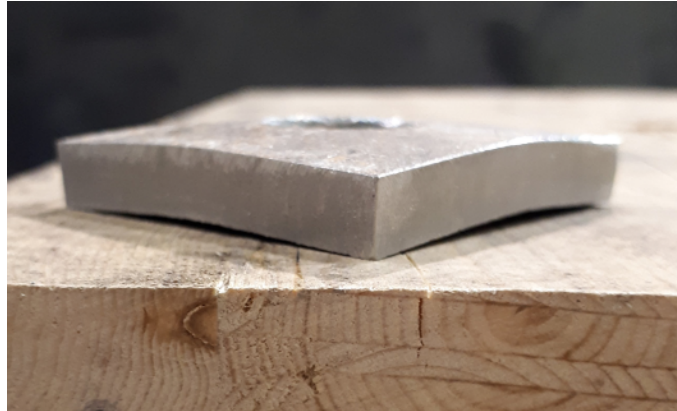
(b) yielded washer

guarantee no slippage to occur in the rod and that the displacement values will be more accurate. Second, more embedment lengths and washer sizes are to be tested, as this will help in confirming the validity of the developed formula, as per Equation 1. The final recommendation is to increase the washer thickness so that yielding in the washer does not happen for the tests with higher load capacities.
