Laval (Greater Montreal)

June 12 - 15, 2019

EXPERIMENTAL EVALUATION OF THE MECHANICAL PARAMETERS FOR SEISMIC ASSESSMENT OF TRADITIONAL BRICK AND STONE MASONRY BUILDINGS IN EASTERN CANADA

Nollet, M.-J.¹, Guizani, L.¹, Abo El Ezz, A.², Touraille, J.³, Boldireff, É.³, Moretti, P.³

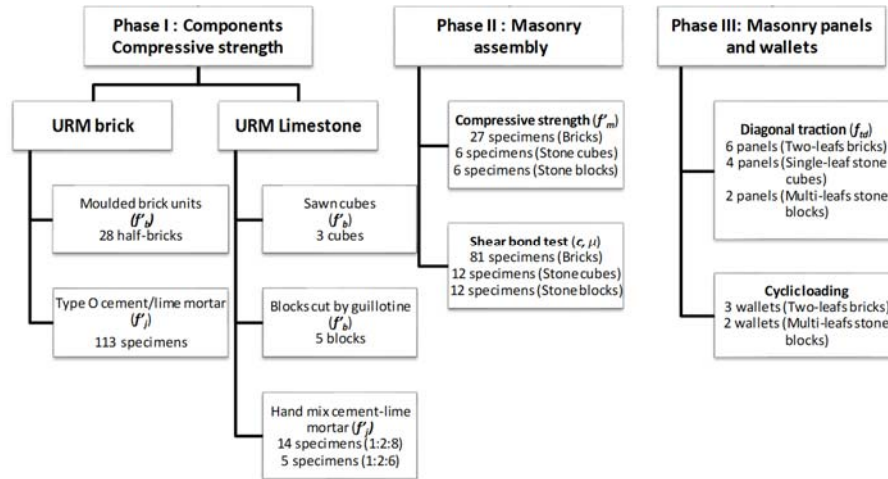
Figure 2: Experimental testing programme

Figure 2 illustrates these three phases testing programme and indicates the number of specimens considered for each type of URM: brick masonry, masonry made of sawn stone cubes and masonry made of stone blocks cut by guillotine.

The first phase of the testing programme aims at characterizing the compressive strength of the masonry constituent materials: brick (f'_b), stone units (f'_b) and mortar (f'_j). The second phase evaluates the mechanical parameters of small masonry assemblies: compressive strength (f'_m), cohesion c and coefficient of friction μ from shear bond test. The third phase focuses on the evaluation of the lateral behaviour panels and wallets. First two-leaf panels made of bricks, single-leaf panels made of stone cubes diagonal and multi-leaf panels, made of stone blocks cut by guillotine, were tested for diagonal tension (f'_{td}). Then, the lateral force-deformation behaviour of representative brick and stone wallets was assessed under cyclic loading tests. Specimens using stone blocks cut by guillotine were constructed to reproduce traditional stone masonry. The multi-leaf panels and wallets had two leafs of stone units separated by a layer of mortar and pieces of stones randomly placed.

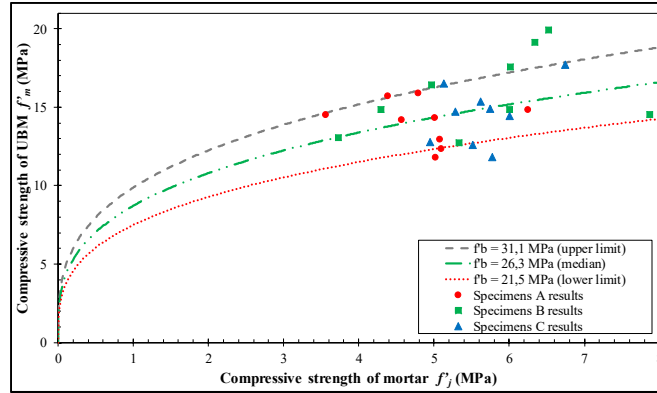
Figure 5: Relation between the masonry compressive strength f'_m , and the mortar compressive strength f'_j , for median, lower and upper values of the brick compressive strength f'_b .

Figure 5 shows three curves drawn from Eq. 1 for the median, lower and upper values of the brick compressive strength f_b according to the standard deviation given from the tests on brick samples. Values for parameters in Eq. 1 were taken from Eurocode 8 (CEN 2005), that is: $K = 0.75$; $\theta = 0.75$; $\lambda = 0.31$. Most results are included between the upper and the lower limits of the model, and 68.2% of the bricks have a compressive stress between 21.5 MPa and 31.1 MPa as in a normal distribution.

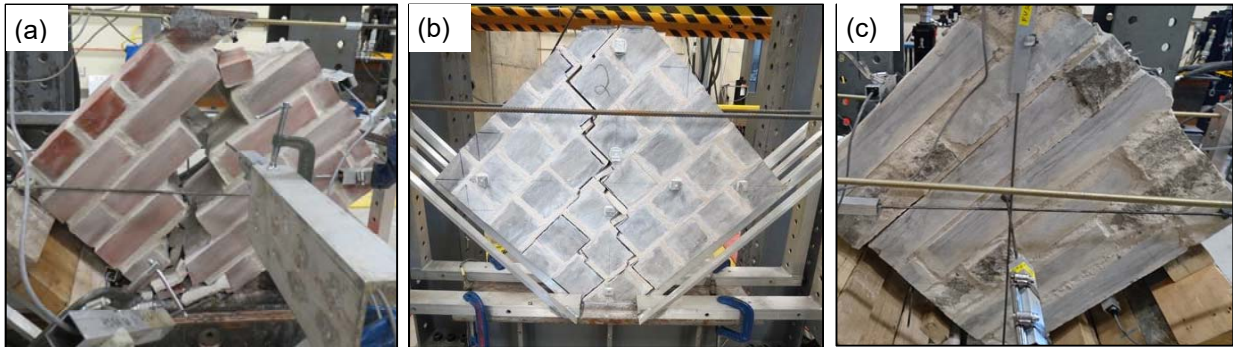
Figure 7: Diagonal tension failure of panels: (a) Brick panel A, (b) Sawn stone cubes, and (c) Guillotine stone blocks

Diagonal tensile strength f'_{td} is calculated according to the assumption of pure shear state of stress in the centre of the specimen (ASTM 2015). The shear modulus G_m of the panels is defined as the slope on the linear part of the shear stress-strain curve using the method of least squares between $0.05 \tau_{max}$ and $0.70 \tau_{max}$. The respective coefficients of variation for f'_{td} and G_m are 4.1% and 15%, which is within the expected values considering the heterogeneity of material studied. Size of the panels does not seem to influence the results. The failure pattern of all six panels was characterized by stair-stepped cracking along the mortar joint, with some cracks going through the bricks (see Figure 7a).

Diagonal tension tests were completed successfully for sawn cubes panels with a typical tension rupture on the diagonal as shown in Figure 7a. However, panels made with stone blocks cut by guillotine rupture along a horizontal joint as shown in Figure 7b. This is mainly due to the size of the unit blocks relative to

the size of the panels (limited by the testing installation). Computed diagonal tension strength for the guillotine stone blocks is therefore a lower bound value that did not even reach the theoretical 10% of the mortar strength (0.53 MPa). This illustrates the complexity of measuring diagonal tension strength for multi-leaf masonry made of irregular large units. Diagonal tensile strength f'_{td} for the sawn cube panels is calculated according to the assumption of pure shear in the centre of the specimen (ASTM 2015). It is slightly higher than 10% of the mortar strength (0.33 MPa) and in the upper range of experimental values (0.06 and 0.37 MPa) as reported by Mazzon (2010). The shear modulus G_m is defined as the slope on the linear part of the shear stress-strain curve at 33% of f'_{td} . Shear modulus of 487 MPa is about 17 % of Young modulus E_m (2 823 MPa) and within the range of experimental values (79 and 837 MPa) (Mazzon 2010).

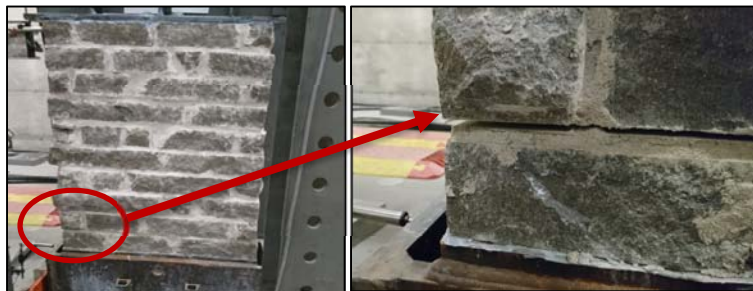
Figure 8: Rocking failure rupture of stone wallets

Two multi-leaf URM stone wallets made of blocks cut by guillotine were tested under static-cyclic loading under two different compression stress conditions. Both wallets failed in a rocking failure mode characterized by the occurrence of a horizontal crack along the lower mortar joint due to a tension failure between mortar and brick (see Figure 8). Hysteresis curves for each wallet are shown in Figure 9a. They exhibit typical characteristics of a rocking failure: narrow pinched loops typical of fragile behaviour and low energy dissipation by deformation, and large displacements without a loss of lateral strength. For Wallet 1 tested under a vertical stress of 0.2 MPa, the idealized lateral strength V_e and drift δ_e are 19.3 kN and 0.075%, respectively, and the equivalent stiffness K_{eq} is 29 kN/mm. For Wallet 2 tested under vertical stress of 0.5 MPa the corresponding values are 43.3 kN, 0.084% and 61 kN/mm, respectively. Idealized yield (elastic limit) drifts are similar for both wallets for an average of 0.08% in the lower range (0.06% to 0.13%) of reported values for first damage state to URM stone walls (Abo El Ezz 2013). Equation from ASCE-41 predicted a rocking failure with a lateral resistance of 21.7 kN and 51.4 kN, overestimating the experimental resistance by 12% and 19%.

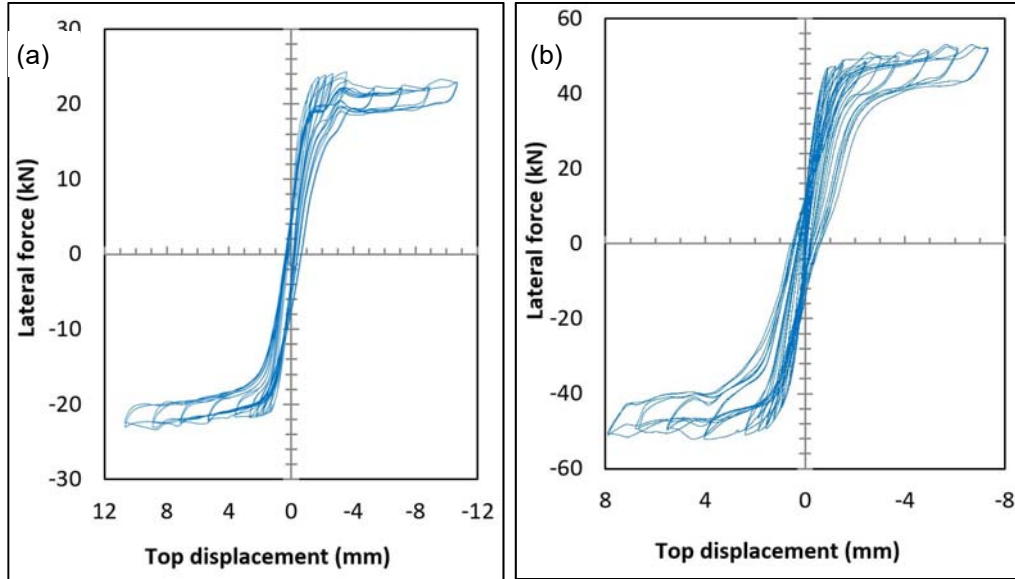
Figure 9: Cyclic hysteretic behaviour of URM stone block wallets: (a) Wallet 1 ($\sigma_v=0.2$ MPa), and (b) Wallet 2 ($\sigma_v=0.5$ MPa).
