Laval (Greater Montreal)

June 12 - 15, 2019

## **BEHAVIOUR OF 27-YEAR OLD PRESTRESSED CONCRETE BRIDGE GIRDERS**

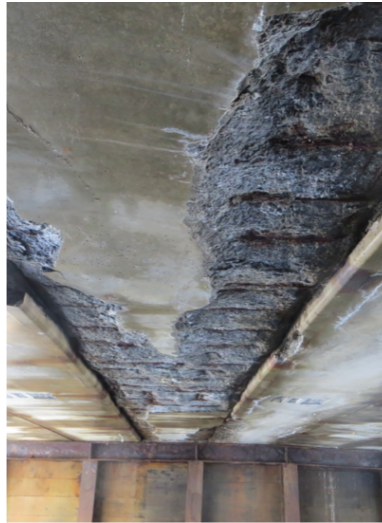
Figure 1. The Deterioration of the Case Study Bridge

1, the cover of the bridge had fallen off leaving steel reinforcement exposed, which led to serious corrosion. This bridge, built in 1991, is consisted of 9 girders where 7 are box girders and 2 are barrier girders. One of the issues of these bridge girders are the designs are unclear: the steel reinforcement design is vague and hard to identify; the actual density and strength of concrete of the girder is also unclear. Unfortunately, there are many bridges with a similar design in Alberta, it is important to figure out the cause for the deteriorations in order to know how to maintain and repair other bridges with similar damages. In this paper, a single interior box girder taken from is discussed.

In this paper, a case study bridge located on Highway 763 near Barrhead, Alberta (~150 km northwest of Edmonton) is examined. The bridge is a single span structure with a length of 11 m; is comprised of 510 mm deep prestressed hollow core box girders without a topping. This bridge was closed to traffic and then removed due to serious deteriorations discovered in an inspection in late 2017. As shown in Figure

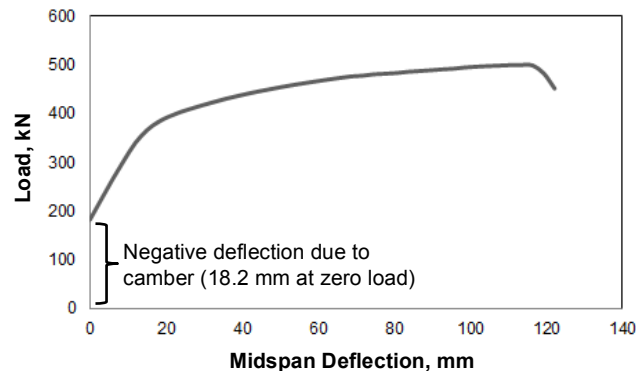
Figure 5. Load versus displacement model predictions for the 11m Long Girder under four point bending.

The results calculated with VecTor 2 are summarized in Figure 5. The expected additional (i.e. in addition to self-weight) load that the girder can handle is 500 kN at a midspan deflection of 113.4 mm. The camber calculated by VecTor 2 is around 18.2mm before loading. The magnified displacement and crack pattern figure from the model is shown in Figure 6; deep flexure and shear cracks can be seen in the loading region. This corresponding failure mode of the girder and the capacity curve indicate that the girder fails in flexure with concrete crushing after steel yields.

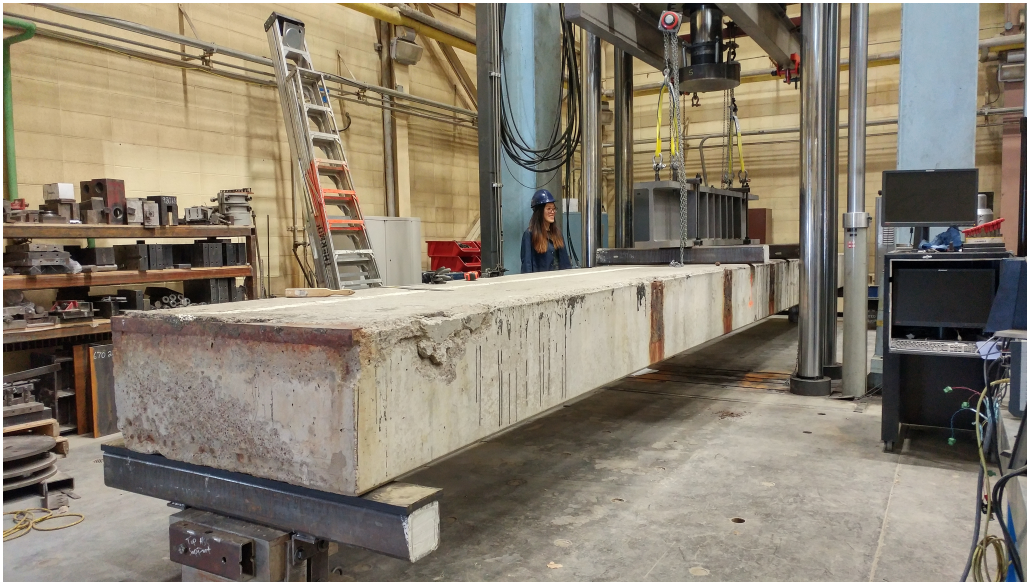
Figure 7. The Experimental Setup of the Girder

The first 11m long girder was delivered and set up in the I.F. Morrison Structural Lab at the University of Alberta; however, due to the schedule of the lab, the experimental test has not been completed at the time of writing, but it is scheduled for early March 2019. This second stage of the project will give experimental data related to the effect of environmental and load-induced deterioration on the bridge girder after 27 years of service.
