Laval (Greater Montreal)

June 12 - 15, 2019

## **GUIDELINES FOR IDENTIFICATION OF TOP-DOWN CRACKS (TDC) IN IN-SERVICE FLEXIBLE PAVEMENT**

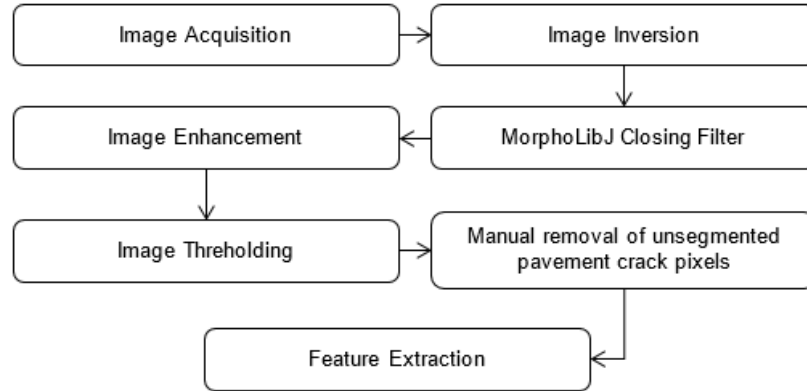
Figure 1: Image analysis technique

The pavement images obtained from the LaDOTD Pavement Management System (PMS) were processed to gather significant information related to the longitudinal top-down cracks. The image analysis technique involved three major steps namely image acquisition, image processing, and features extraction as illustrated in Figure 1. Figure 2 presents a sample image of pavement surface used in image processing analysis. In this study, gray-scale images of flexible pavement were analyzed using the ImageJ software. The description of the steps in the image analysis is presented in this section.

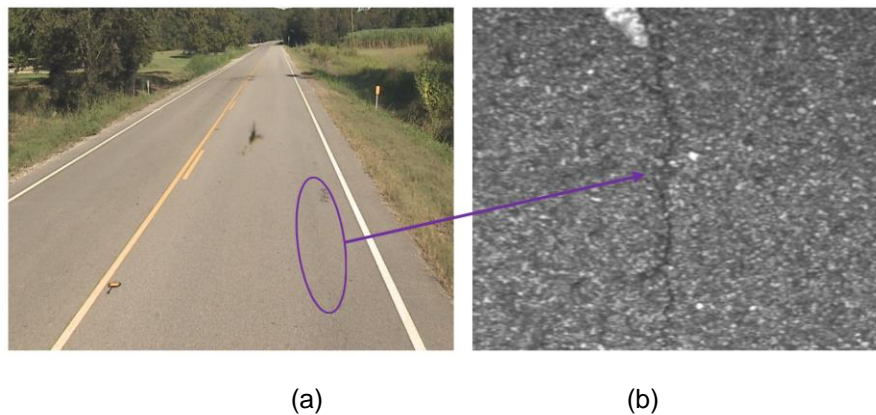
Figure 2: Sample of pavement image: (a) lane-scale (b) surface-scale

The Otsu method may result in significant error if the sharp valley of the image histogram is degraded by excessive pavement noises. In this study, the image filtering was followed by image enhancement, which involves the adjustment of the filtered image in terms of brightness and contrast so that the Otsu method of thresholding can be efficiently applied. The binarization resulted in segmentation of pavement images into crack and non-crack pixels. It was noticed that the pavement surfaces with the pixels similar to crack pixels still existed after image thresholding. These pavement background pixels were later manually removed to obtain ground-truth image.

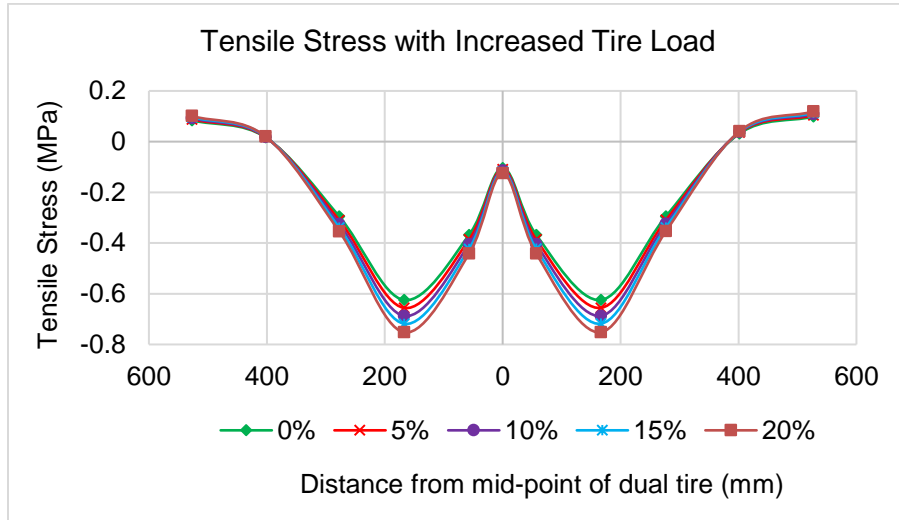
Figure 4: Horizontal tensile stress at pavement surface

The longitudinal top-down cracking in pavement wheel path is typically due to the vehicle load causing high horizontal tensile stress. A three dimensional pavement model with dimensions 1900mm\*1304mm that simulated a pavement design for medium volume traffic was constructed to study the stress distribution on pavement surface. A dual-tire assembly was considered to simulate the vehicle loading and the movement of tire was achieved by assuming quasi static approach, where the loading area and amplitude are gradually shifted over fine mesh of the loading track. The details of the developed model can be found elsewhere (Dhakal and Elseifi 2017).

The tensile stress distribution was studied by increasing the tire pressures on each tire tread by 5%, 10%, 15%, and 20%. The horizontal stress distribution with increasing tire pressure is presented in Figure 4. The tensile stresses were obtained at mid-point of the dual tire assembly, center of each tires, edges of the tires, and at distance of 125mm and 250mm away from the tires. As shown in figure, the highest tensile stress occurs underneath the center of each tires, which is argued to be the cause of longitudinal top-down cracking in wheel path.

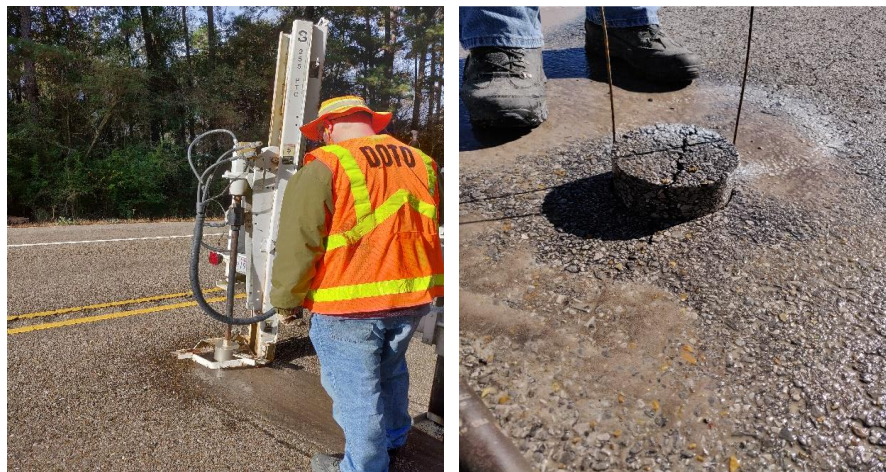
Figure 5: Acquisition of field cores

To validate the proposed top-down cracking identification protocol, field cores were obtained along the wheel path of pavement. The coordinates of the coring locations were extracted from the project maps in PMS such that these locations correspond to the pavement images locations obtained from PMS for image analysis. Figure 5 presents the acquisition of field cores. The cores were extracted at the tip of longitudinal crack in wheel path to verify the top-down orientation of the cracks.

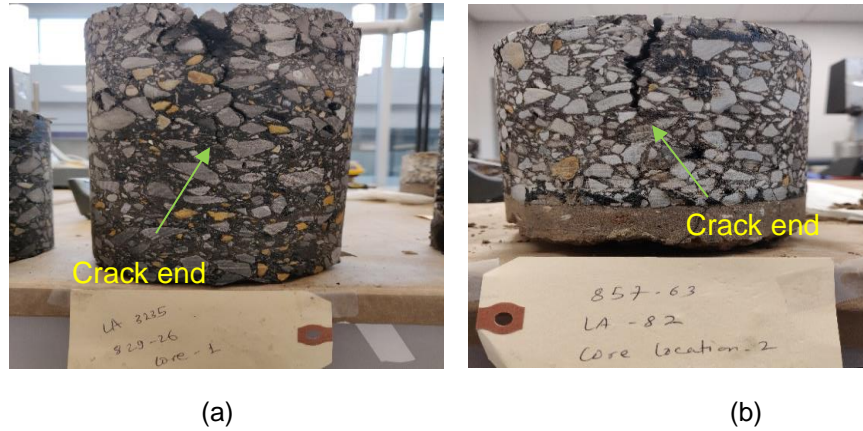
Figure 6: Cores showing longitudinal top-down cracks for control sections (a) 829-26 (b) 857-63

Field cores with longitudinal top-down cracking for two pavement sections are presented in Figure 6. It is evident from the field cores that the crack started at the top of the asphalt layer. Table 2 summarizes the cores obtained at 6 pavement sections. Based on field cores observation, the cracks were observed to extend up to a depth of 25 to 100 mm from the surface.
