Laval (Greater Montreal)

June 12 - 15, 2019

## **RISK TRANSFER IN P3 INFRASTRUCTURE PROJECTS DUE TO CONSTRUCTION DEFICIENCIES**

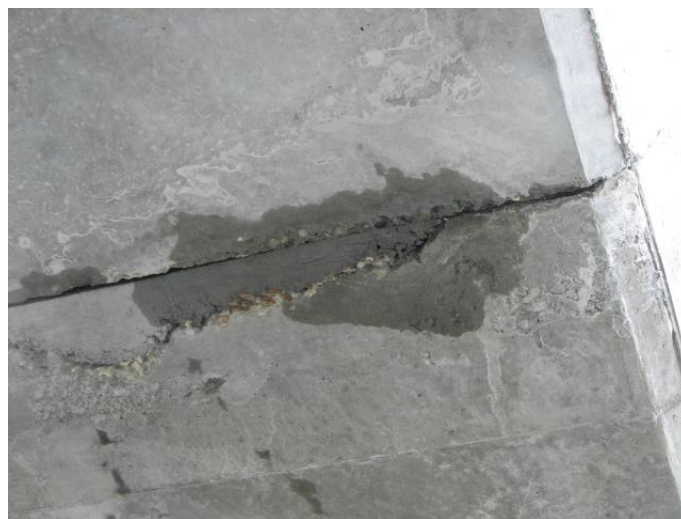
Figure 1: Improper Repair of Concrete Spall

Surface imperfections in concrete, such as spalls have minor impact on the design requirements and are non-conformities due to contractual obligations and performance requirements. However, inappropriate repair methods that lack proper bonding between repair material and the concrete surface would increase the frequency of repairs, albeit minor in their scope. Figure 1 shows an example of repair performed to address a concrete spall. As the repair was performed without proper preparation of the concrete surface to increase the bonding between the repair material (grout) and native concrete, the repair resulted in a spall again. Figure 2 shows the spall at the location of the repair, where the lack of bonding between the native concrete surface and repair grout can be clearly seen at the located pointed out.

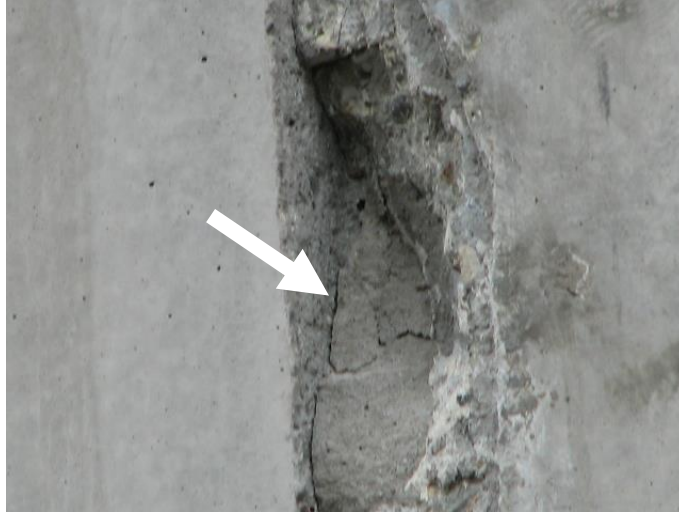
Figure 2: Spall at the Repair Location due to Incorrect Repair Method and Lack of Bonding as Pointed

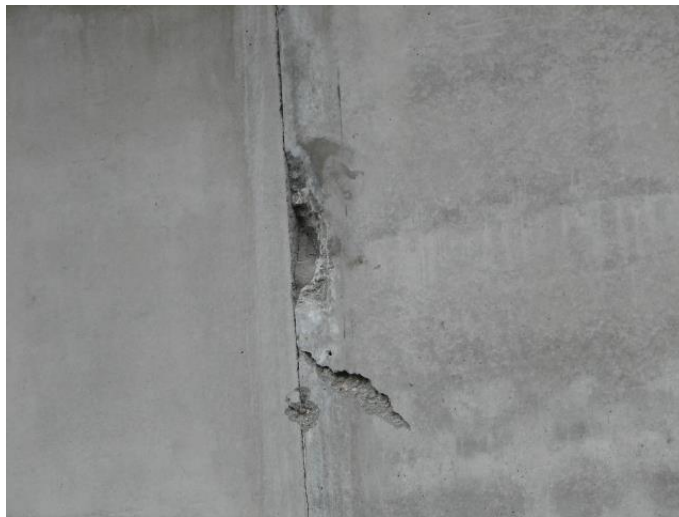
In addition to the failure of repair at the initial spall, concrete spall has extended during the repair spall, as seen in Figure 3. Incorrect matching between the repair grout and native concrete could increase the local stresses on the concrete surface leading to the extension of the initial concrete spall.

Figure 3: Spall Extension due to Incorrect Repair

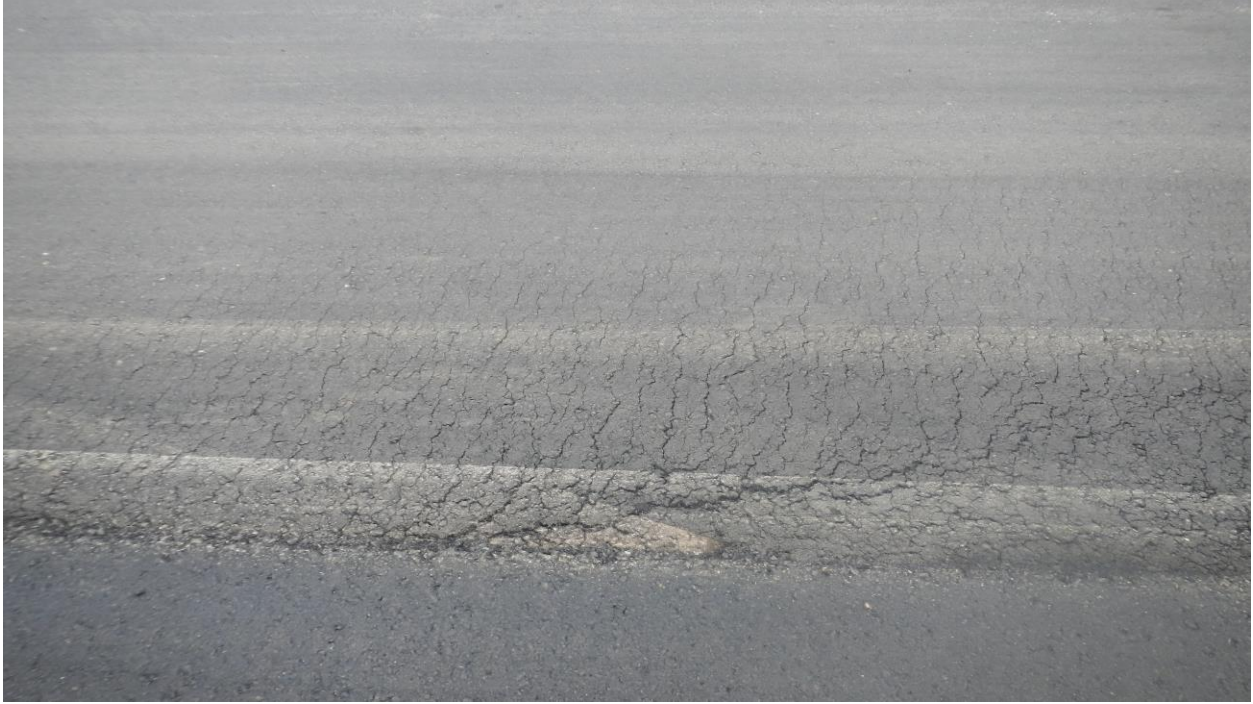
Figure 4: Surface Cracking and Differential Settlement on a Roadway

Figure 4 shows the differential settlement on a roadway that lead to extensive cracking of the pavement. Since asphalt pavement is known to develop cracks that lead to potholes in cold weather regions, it is common to include the re-surfacing of the pavement in the scheduled maintenance works. Figure 5 shows the failure of newly resurfaced pavement, which indicates that the pavement settlement is due to the deficiencies in the sub-grade compaction or materials. At this stage, as the extent of sub-grade deficiencies are unknown, the scope and cost of schedule maintenance work increases significantly from resurfacing with asphalt to removing and replacing the pavement sub-grade.

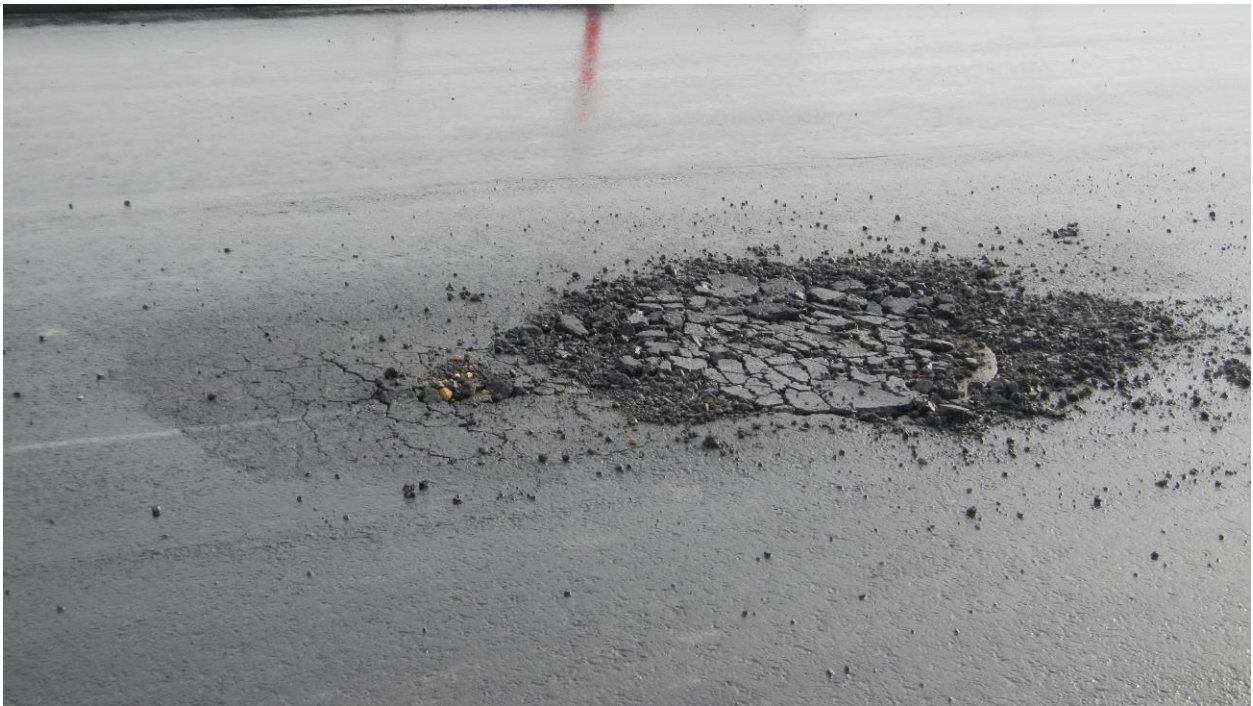
Figure 5: Failure of a Newly Resurfaced Pavement

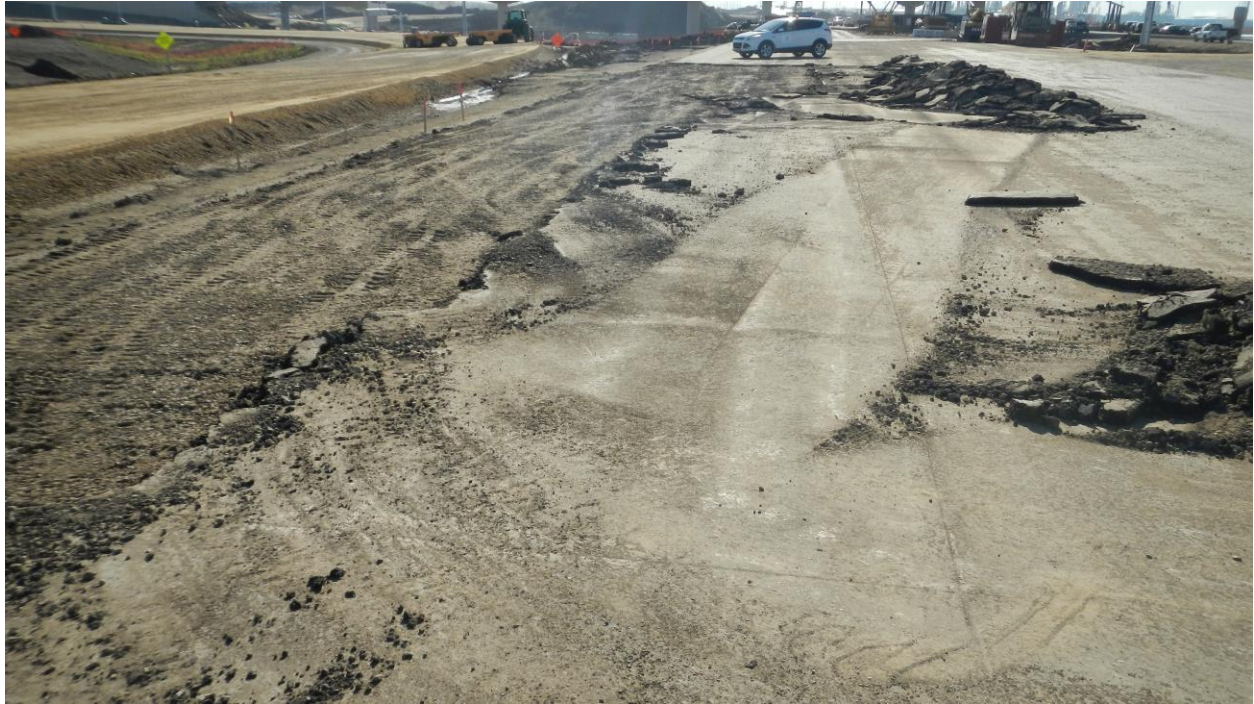
Figure 6 shows the extent of repair needed to maintain the road surface performance according to the project requirements. Such unanticipated increase in the scope and cost of the maintenance work results in a hidden risk transfer between construction and maintenance phases.

Figure 6: Extent of Repair Works Due to Deficiencies in Subgrade Compaction

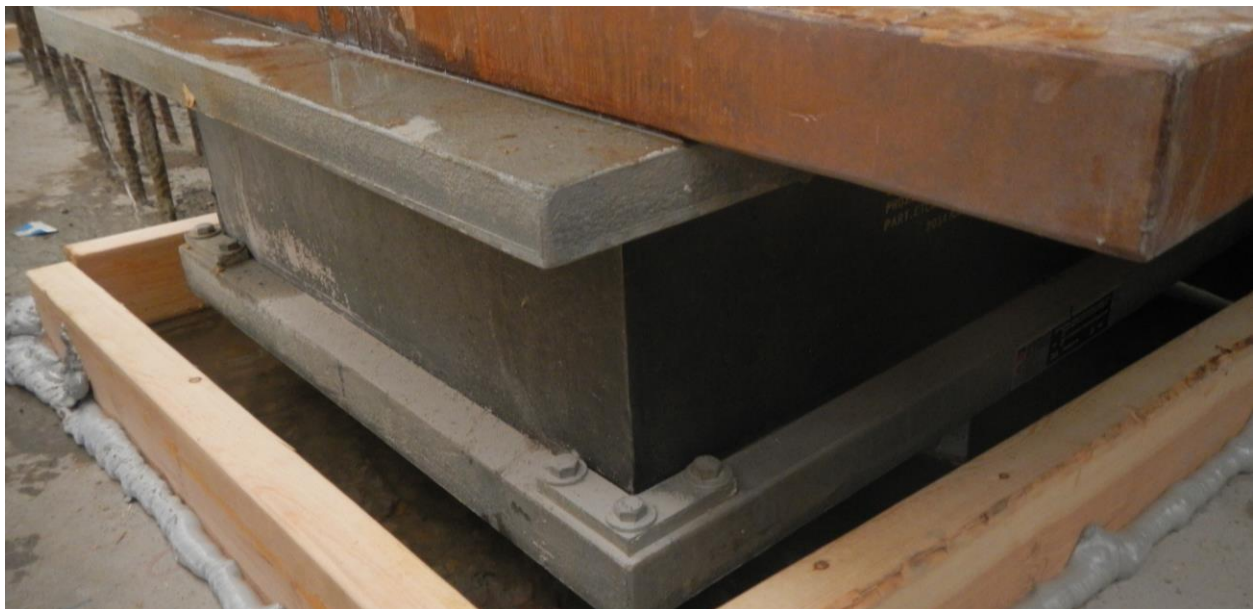
Figure 7 shows an example of a newly placed bridge bearing with the elastomeric padding designed to meet the project requirements.

Figure 7: Elastomeric Bearing Pad in a Bridge Bearing

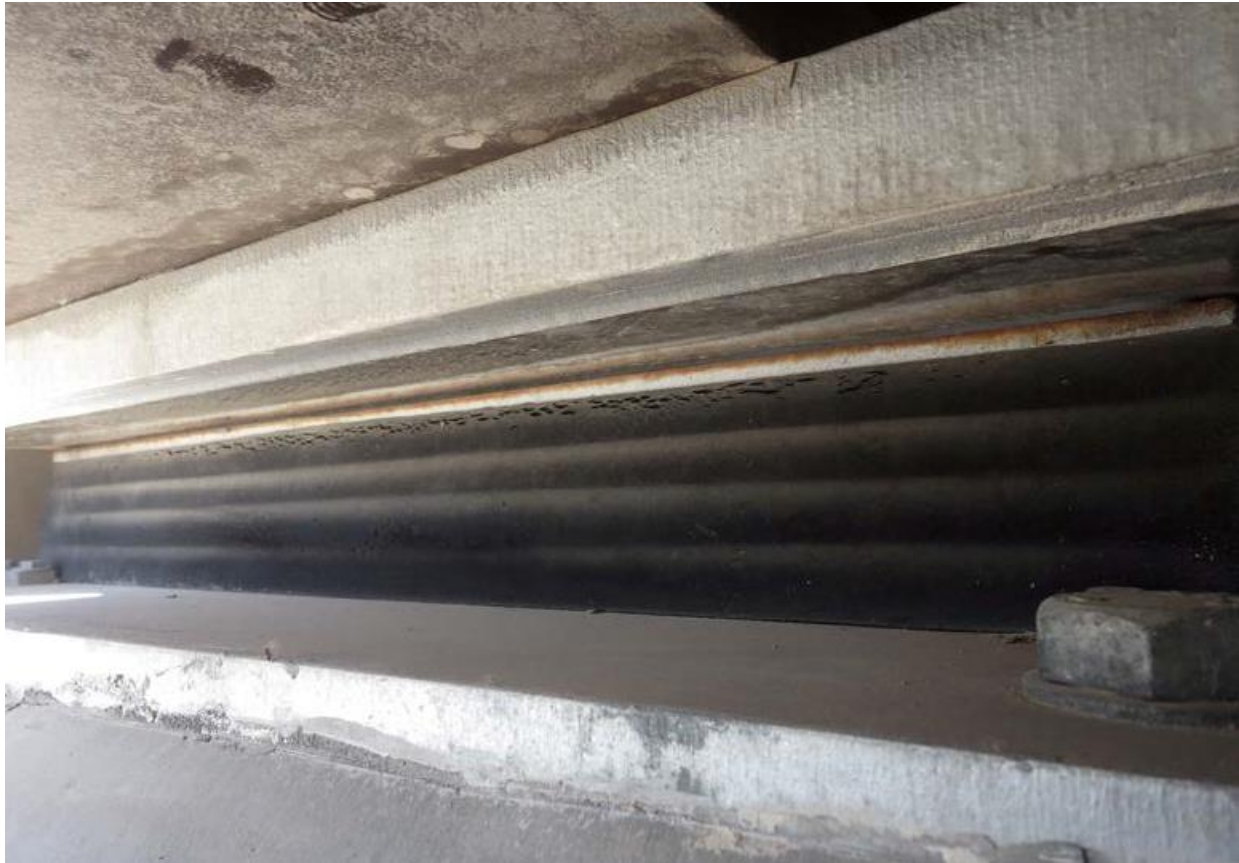
Figure 8 shows an example of elastomeric bearing pad failure through bulging and cracking before the end of its design service life. Inadequate material testing and quality control, and improper placement procedures could lead to the bearing pad failures before the anticipated design service life. However, in

order to meet the performance standards during the handback of infrastructure from the P3 concessionaire to owner, these bearing pads will need to be replaced. The unanticipated bearing pad failures could lead to extensive replacement costs well after the completion of construction, resulting in a hidden risk transfer between the design-build and operations -maintenance works.

Figure 8: Failure of Elastomeric Bearing Pad with Bulging and Cracking before the End of Service Life
