Laval (Greater Montreal)
June 12 – June 15, 2019

SUPPLEMENTING DETAILED VISUAL INSPECTIONS WITH UAV

Schmelzle, C.^{1,2} and Paulsen, M.^{1,3}

¹Associated Engineering, Edmonton, AB, Canada

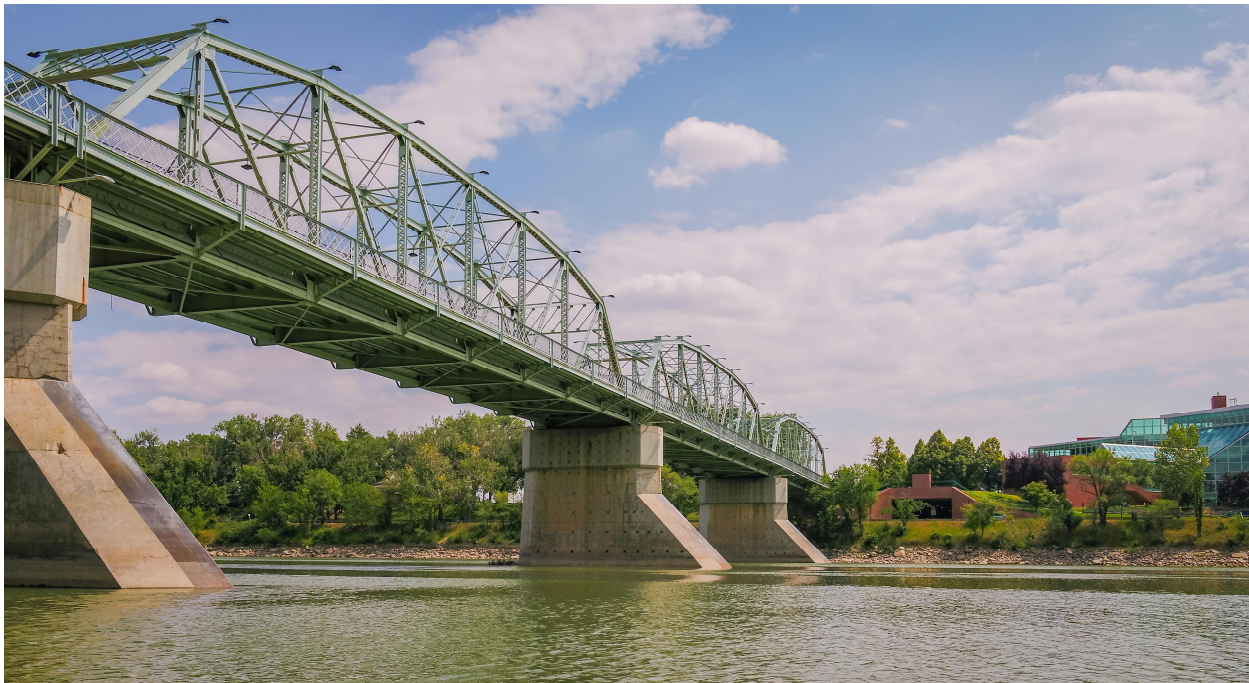
Figure 1: Medicine Hat Location (<https://www.medicinehat.ca/>) and the Finlay Bridge

The City of Medicine Hat is in southeastern Alberta, approximately 3 hours southeast from Calgary along the South Saskatchewan River (Figure 1). The River is a Class A watercourse that meanders through the middle of the City. Access is provided mainly by the historic Finlay Bridge, which was scheduled for a detailed visual inspection in 2018. The Finlay Bridge is five-span through truss structure, supported on concrete piers, carrying one-way vehicle and pedestrian traffic. It is a historic landmark for the City and is on the Alberta Register of Historic Places. Since its construction, numerous rehabilitations and repair programs have been carried out to prolong the design life, due to its importance to the City. Figure 1 shows a map view of Medicine Hat and an elevation view of the bridge.

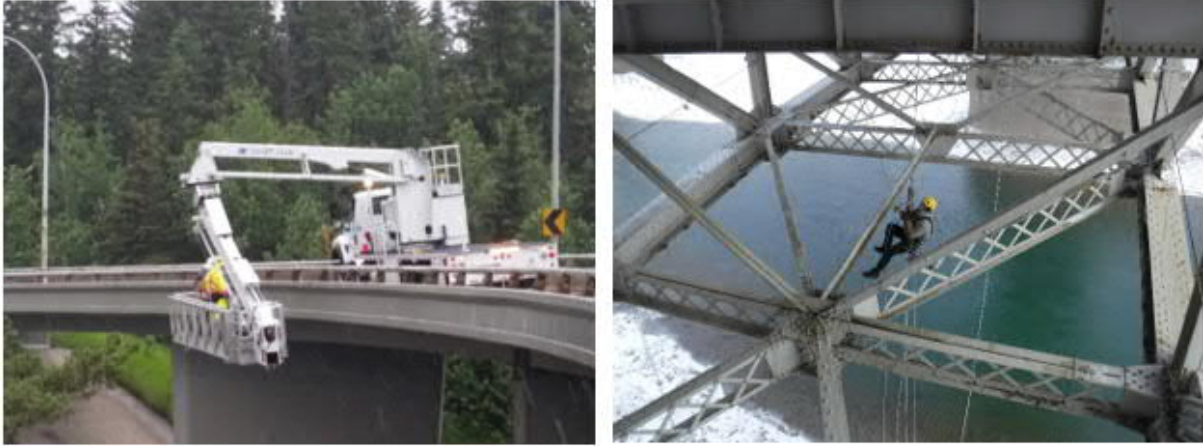
Figure 3: Recent Inspections completed using Snooper Truck and Rope Access

We then assessed different inspection methodologies considering the above criteria. The most conventional method of deck underside inspections is the use of a snooper truck. This is a useful approach for simple bridges. The structure in the Figure 3 is a concrete girder vehicle bridge in Edmonton, AB.

The other approach that was investigated was using rope access. This is done by hiring a third-party rope contractor who arrives on site and rigs up the underside to allow the inspectors full access, as seen in Figure 3 below. Work is required to determine the feasibility of using rope access, as the effectiveness of the method is highly bridge dependent. The rope access contractor would require site photos and potentially a site visit to determine if it's possible. It's also likely to require at least one lane closure to facilitate the inspectors getting on and off the system. Overall, this approach was deemed impractical given the truss configuration and time needed to carry out the inspection. Because it is a time-consuming process and requires full mobilization, set up and tear down, the costs tend to be higher.

The snooper truck was not a suitable choice in respect to the assessment criteria. Based on the configuration of the truss elements, the snooper could not physically manipulate the boom to provide access to the underside. The relatively narrow roadway width of the bridge meant that the snooper would require a full bridge closure to be used. Working out of the snooper requires safety certifications and has the inherent risk of working over water. The truck itself is unique and was not immediately available in the Medicine Hat area. It would have had to be driven from Calgary, approximately 2 hours away, thus increasing costs. Finally, and the most critical issue, based on the posted loading it was unclear if the truck could pass on the bridge.

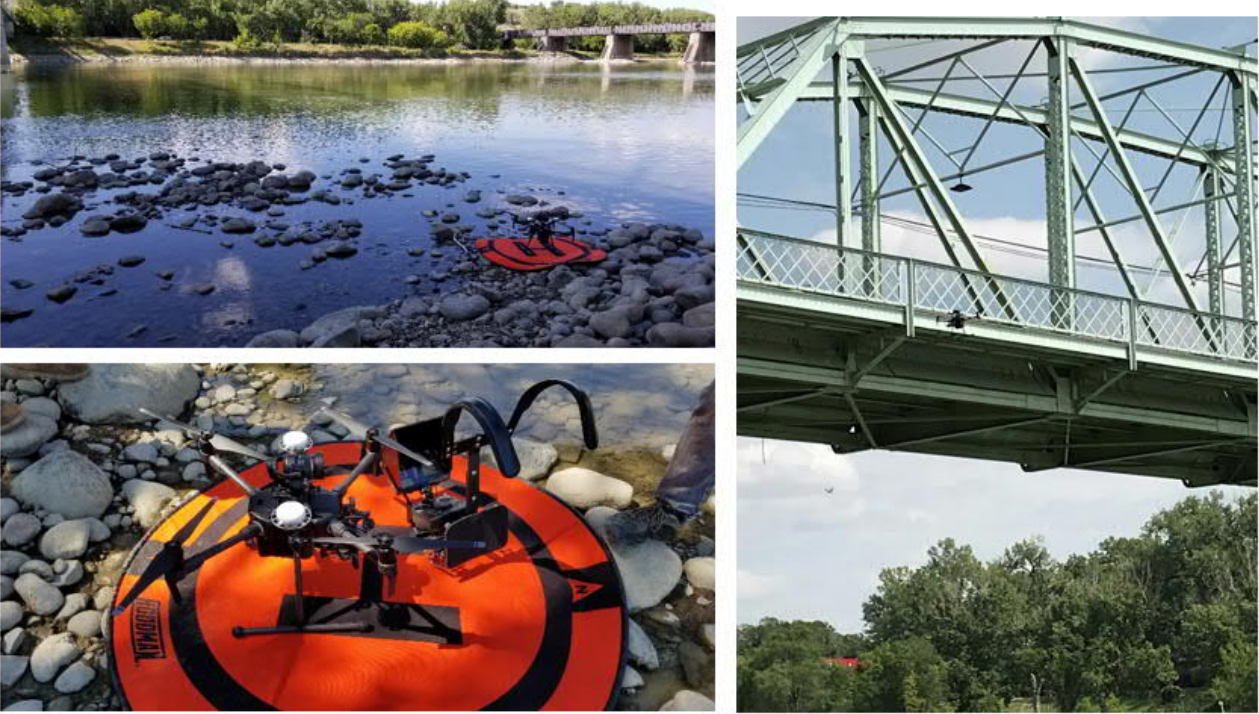
Figure 4: Using the UAV at the Finlay Bridge

A top-mounted camera gimbal allows for an unobstructed view of the bridge underside. The vehicle should be equipped with Obstacle Avoidance and the shooting capability of the camera capable to handle highlights, shadows and high contrast situations. The vehicle is also equipped with a D-RTK GPS system, which provides more accurate position when flying close-proximity to the structure. Figure 4 shows some pictures of the UAV being used at the Finlay Bridge.

The footprint needed to setup the equipment is small. The operators can set up on rocky, uneven or sloped terrain, as they just need to ensure that the UAV has a flat surface to land on, typically through use of a tripod-like table system. From here, the UAV is flown to the various bridge elements, and photos are taken of the specific areas that were flagged by the inspectors.

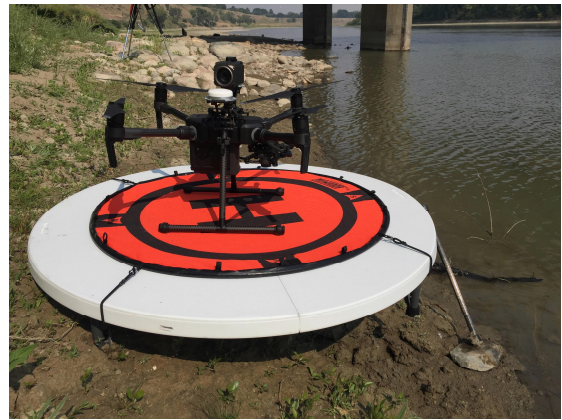
One common misconception is that the bridge inspector will be able to actively dictate inspection, however this is not practical in most situations. When operating, the pilot remains focussed on the flight plan and is in communication with the photographer. At the Finlay Bridge, the UAV team used a portable office to download images for review with the inspection team to determine if areas required reinspection or images from other angles.

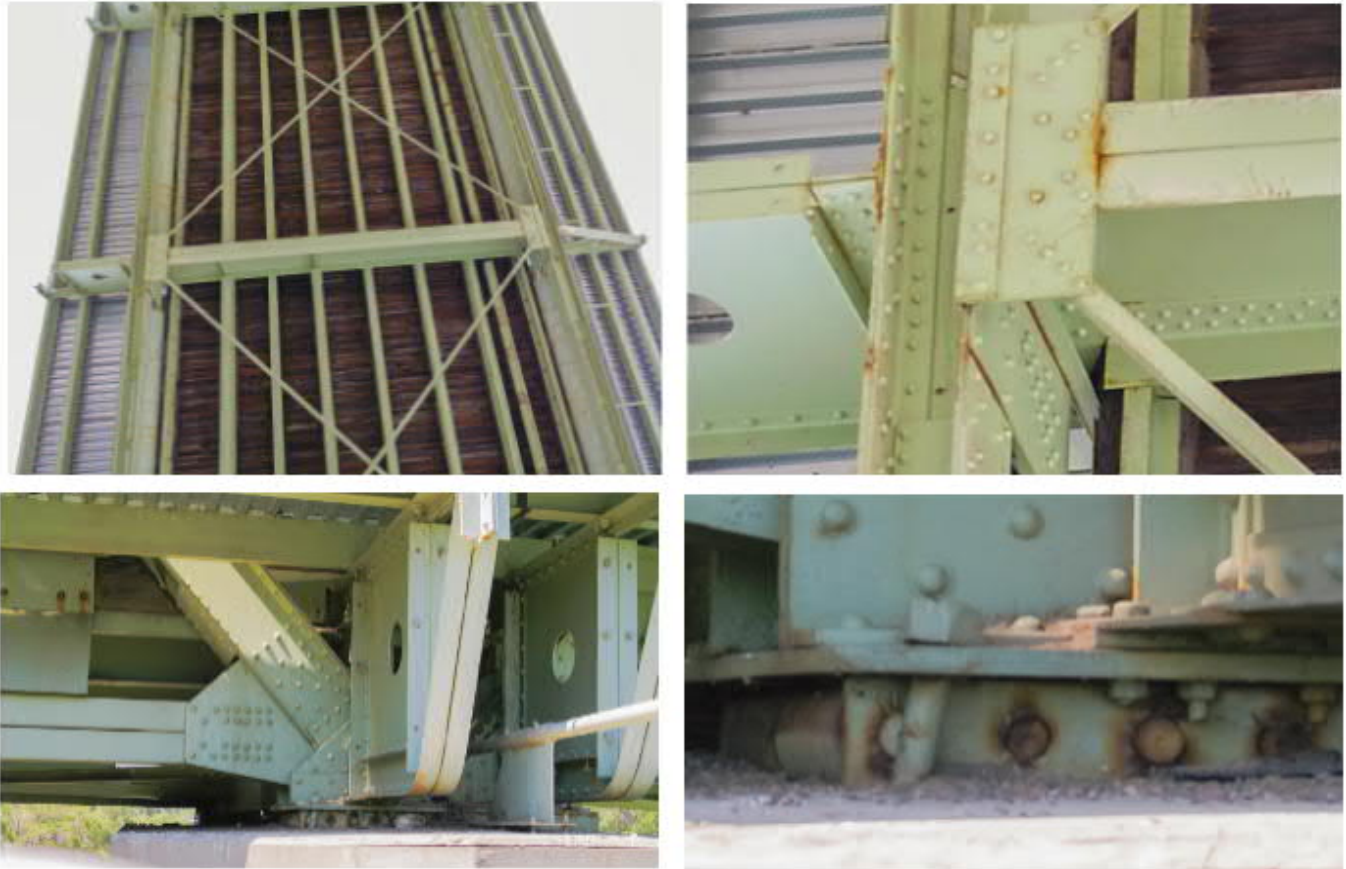
Figure 6: Optical Zoom Capabilities

Figure 6 shows sample photos taken by the UAV during the inspection and the benefit of optical zoom.

The photos on the left and right are at approximate 10% and 100% zoom, respectively. The original photos are typically in the order of 8 - 10 MB which can then be zoomed in considerably to identify any indication of deterioration. The colour quality of the photos is important as well in order to identify any discoloration in the elements (rusting, rotting, water leakage). Each photo is tagged with the element and direction.

These photos are highly effective when combined with the findings of the standard visual inspection at either abutment/approach span. With the baseline in mind, the inspector can look through and examine the photos for similar patterns of deterioration and ensure that these elements are included in any recommended rehabilitation program. It helps to strengthen the quantity estimates, which can be difficult to estimate for large bridges.
