THE EFFECT OF OVERLOAD OF A BOLTED CONNECTION ON ITS FATIGUE LIFE: A CASE STUDY

Shahin Shadlou¹, Leon D. Wegner², Timo Tikka³

Abstract:

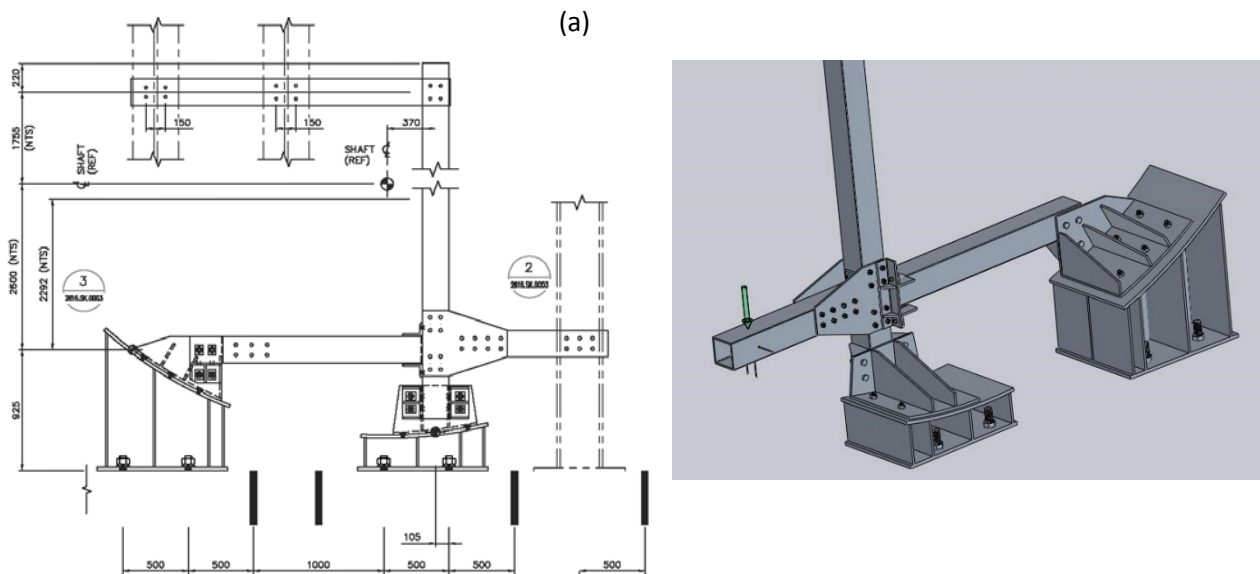
Vertical load was applied at the location indicated in Figure 1 using an MTS hydraulic actuator with a capacity of 250 kN. As can be seen, the gusset plate connection was eccentrically loaded. Based on the accelerated fatigue test plan, the structure was subjected to cyclic testing in a series of stages, each stage consisting of one million cycles. The first stage of fatigue testing was conducted at the design load of 42.6 kN, the second stage at twice the design load, and the following stages at 93 kN, 103 kN and 113 kN, respectively, each stage 10% higher than the previous one. (b)

Figure 1: (a) 2D Test setup for the sub-assembly (dimensions in mm) (b) 3D test setup for the sub-assembly

The minimum load for all stages was approximately 1.5 kN. An overload of 215 kN occurred between the second and third stages as the result of a software malfunction in the control system. The movement of the structure at different places was monitored using six linear variable differential transformers (LVDTs), as shown in Figure 1. Two gauges measured vertical displacement at the load-point, two gauges measured lateral displacement on either side of the specimen at the load point, and two gauges measured the horizontal displacement at the top and mid-height of the sample.

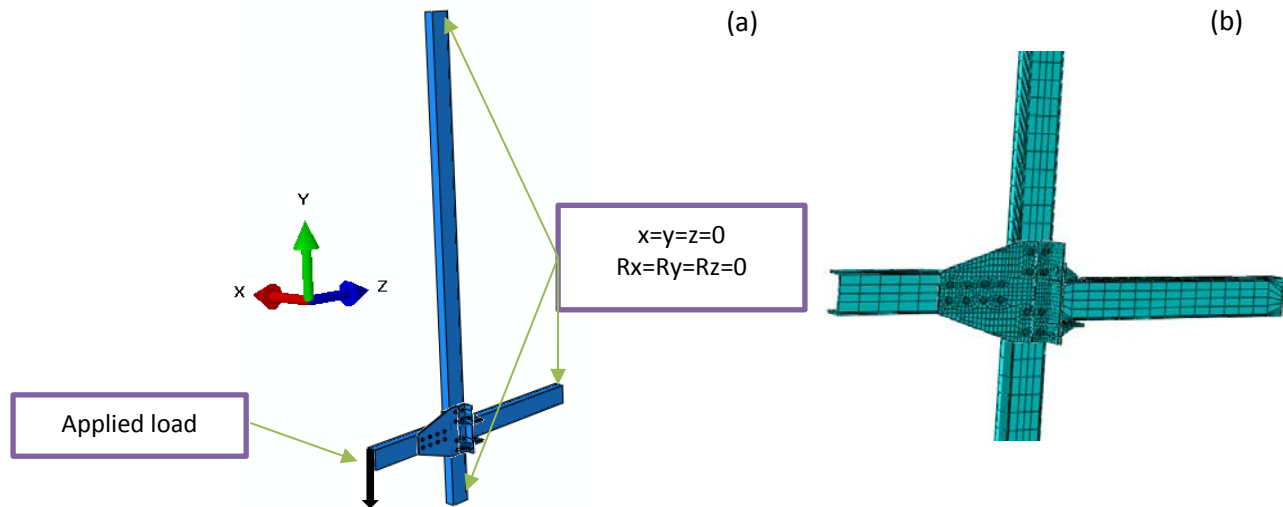
Figure 2: (a) Boundary conditions of the FE model (b) A typical FE mesh

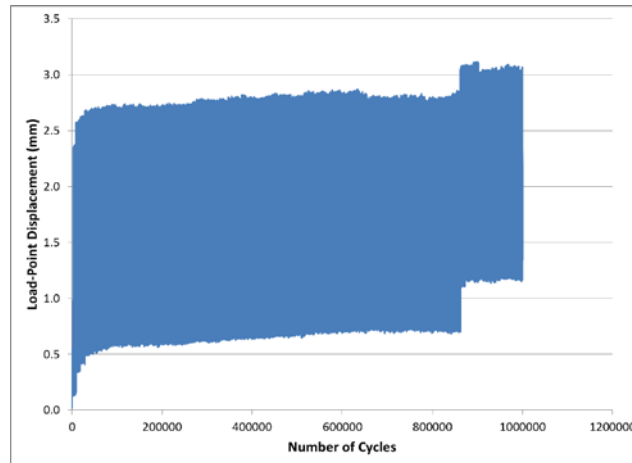
Positive values represent downward motion of the sample at the load-point. It is observed that the displacements varied from a minimum of between 0.6 and 0.7 mm at the minimum load in a cycle, to a maximum value of 2.7 to 2.8 mm when the load reached its maximum value in a cycle. The shift in the graph (values rise and range decreases) around 900,000 cycles is associated with re-tightening of the large bolts fastening the supports to the strong floor. Other than this shift, a slow increasing trend in the value of the displacement was observed while the range remained fairly constant. This increasing trend became less noticeable as the number of cycles increased. This trend suggests that the structure at the load-point was slowly moving in the load direction over the course of testing. Since this was the first stage of the fatigue test on the structure after its assembly, the trend may be explained by the release of possible residual stresses created in the structure during assembly. The absence of this increasing trend in the next stage of the test (i.e., 85 kN) confirms this hypothesis.

Figure 3: Vertical load-point displacements over one million cycles at the 42.6 kN load level.

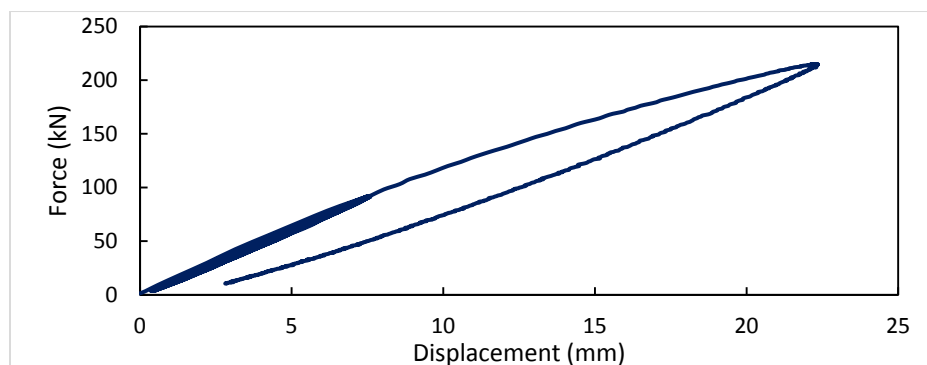
After conducting the first two stages of fatigue testing (i.e., 42.6 kN and 85 kN), because of a software malfunction, the structure was subjected to an overload of 215 kN. Figure 4 illustrates the force and displacement data from the MTS machine when the incident occurred. After the overload, a permanent displacement was observed at the load point of the structure. To determine the sources of the observed permanent deflection, a detailed investigation was conducted on the structure. It was found that the permanent deflection was partially due to slippage between the gusset plates and bolts, which was determined by observing broken paint beside some bolts. Slippage also occurred on two clip angles connecting the vertical member to the horizontal members. The location and direction of slipped bolts are shown in Figure 5. Judging by the amount of slippage (broken paint), the slippage of the clip angles is responsible for the major share of permanent deflection detected at the load point.

Figure 4: Force-displacement during overload incident

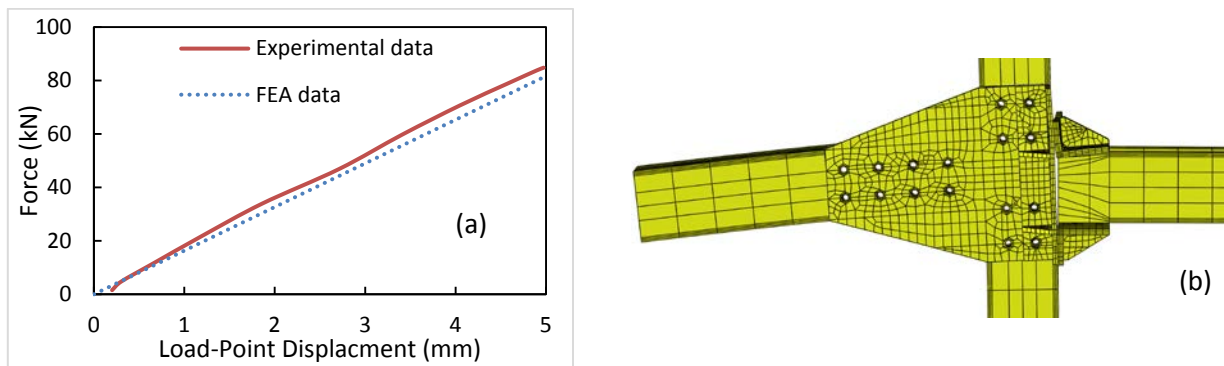
As mentioned earlier, an FE analysis was conducted to determine the share of load carried by each bolt, thus predicting the critical load required for commencement of slippage. To verify the FE model, the force-displacement curve at the load-point obtained from the FE simulation was compared with that of experimental study (see Figure 7(a)). As can be seen, there is a good agreement between the two curves. The small difference could stem from the simplifying FE assumptions such as model symmetry and using tie constraints instead of contact interaction. The exaggerated deformation of the structure when subjected to 81.6 kN is also depicted in Figure 7(b).

Figure 7: (a) Comparison of FE and experimental results (b) Exaggerated deformation (20 times) of the structure when subjected to 81.6 kN

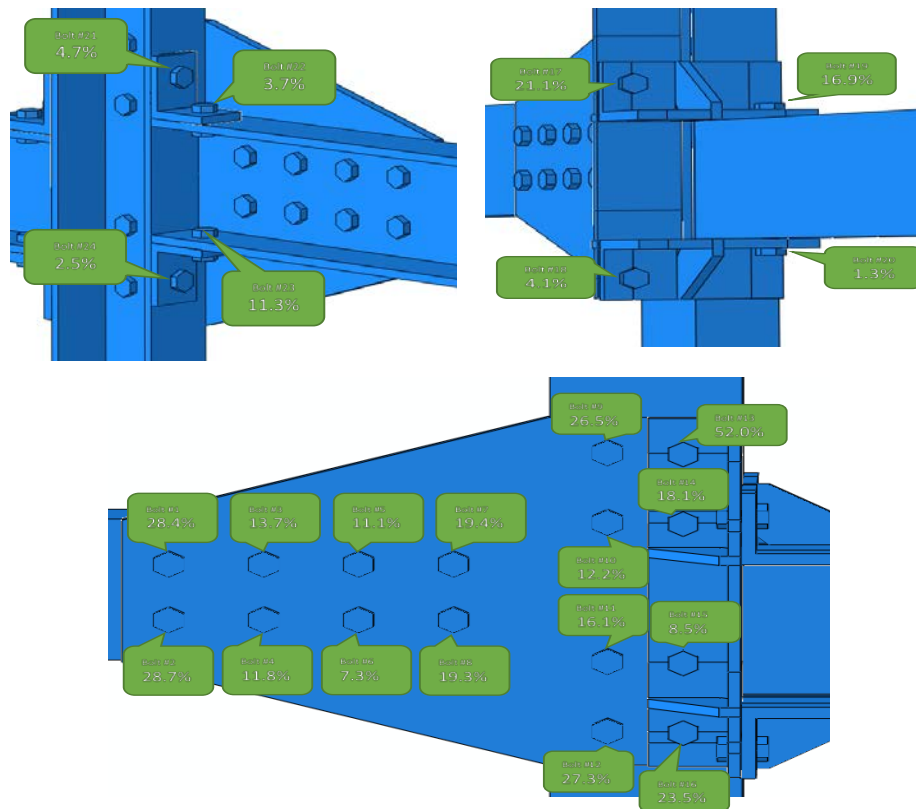
For the sake of simplicity and quick grasp of the results, the percentage of the load carried by each bolt compared to the total load applied to the structure (i.e., 81.7 kN) is shown in Figure 8. According to the Handbook of Steel Construction, for bolts with class B coating, the slip resistance is 56.1 kN. The amount of load applied to the structure during the overload incident was 215 kN. Therefore, for Class B coating, bolts with more than 26% share of loading are prone to slippage during the overload.

Based on the FE results, bolts 1, 2, 9, and 12 were exposed to a load close to the slip critical value. Figure 5 shows that after the overload all these bolts except for bolt #2 had slipped, which agrees with FE results. However, as mentioned before, in addition to these bolts (predicted by FE), some other bolts also showed signs of slippage, including bolts 3, 6, and 8. This can be attributed to the fact that slippage of the bolts not predicted by FE analysis was secondary to the initial slippage of those that were predicted. Moreover, further dis-assembly of the structure revealed that the coating of some surfaces in contact was partially worn off, which could have been due to the previous cyclic loadings or the overload itself. Lack of proper coating and/or pre-tension could explain the premature slippage of the mentioned bolts.

Figure 8: Percentage of the applied load carried by each bolt, as determined by FEA
