CASE STUDY: HISTORY AND REFURBISHMENT OF 145 YEAR OLD RAIL BRIDGE PIERS, SOUTHWEST MIRAMICHI RIVER BRIDGE IN MIRAMICHI, NEW BRUNSWICK

¹ GEMTEC Consulting Engineers and Scientists Limited, Fredericton, NB

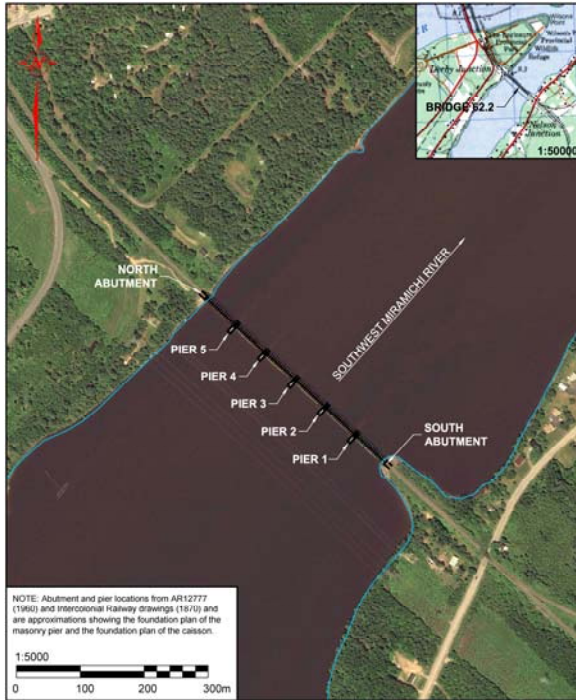
Figure 1: General arrangement of the CN Rail bridge crossing the Southwest Miramichi River (GEMTEC 2016).

Scour holes were noted around the upstream ends of the piers and very little riprap was visible. The 2015 hydrographic survey revealed that the magnitude of local scour varied from 0.5 to 3.8 m around Piers 2, 4 and 5 (see Figure 1 for pier numbering). Probing of the river bottom around the piers indicated that there was riprap buried under the sand bottom. A detailed review of the 2011, 2015, and 2016 inspections, historical records, and the hydrology/hydraulics of the site indicated that there was a total deficiency in scour protection around the piers in the order of 400 to 1,500 m³ compared to recommendations set out in the TAC Guide to Bridge Hydraulics (Transportation Association of Canada 2001).

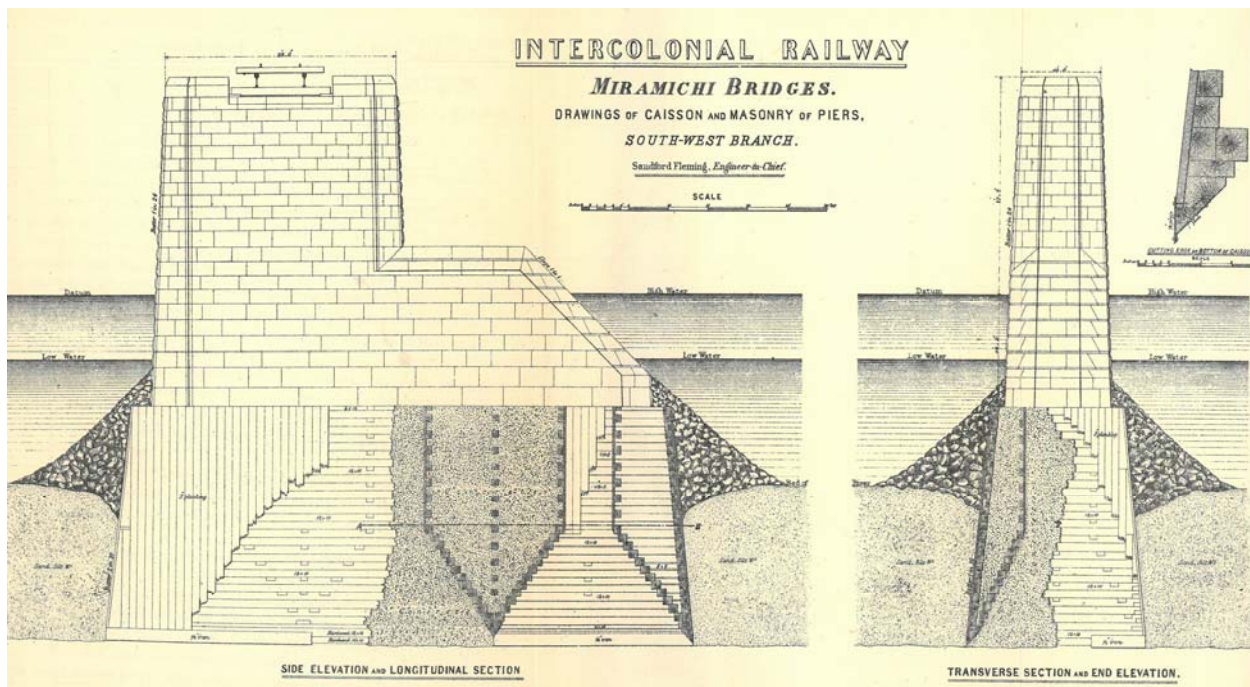
Figure 3: Details of the original pier and caisson construction (Fleming 1876).

Some scour of the river bed material was noted during construction of the caissons, generally in the order of 1.5 m around the upstream ends of some of the caissons. Scour protection in the form of mounded riprap was placed around each pier up to an elevation of -0.8 to -1.5 m, sloping down to the river bed (see Figure 3). Due to the variation in river bed elevation those piers to the north, in deeper water, had much more riprap than those to the south, in shallower water. This scheme would have inadvertently increased the effective width of the piers, resulting in additional local scour.
