Fredericton, Canada

June 13 – June 16, 2018/ Juin 13 – Juin 16, 2018

ATLIN RUFFNER MINE REMEDIATION AND WATER MANAGEMENT: CAN'T PLUG THE SOURCE? PLUG THE FLOW

Walker, Graham^{1,3}, Mills, Ryan¹ and Runnells, Joanna²

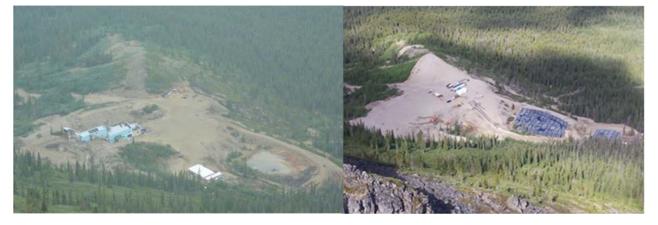
Figure 1: Site photo (left, 2010) taken prior to remedial activities; mill building left and tailings pond right. Site photo (right, 2017) taken during remedial activities; mill building demolished, site capped and liner being installed on tailings and sedimentation ponds.

Phase One of the remedial activities were completed in 2012 and included the demolition of the mine mill facility, removal or contained onsite disposal of hazardous waste, and the installation of a 1.0 metre thick capping layer over the accessible contaminated areas of the site including the mill facility, tailings pond, two sedimentation ponds, and access/connection roads. The cap was constructed using non-contaminated onsite material to physically isolate contaminated soils. A geotextile layer was used to visual demarcate the clean capping materials from the underlying visually similar contaminated materials.
